Palo Verde Nuclear Generating Station

Mid-Cycle Outage
March 1994

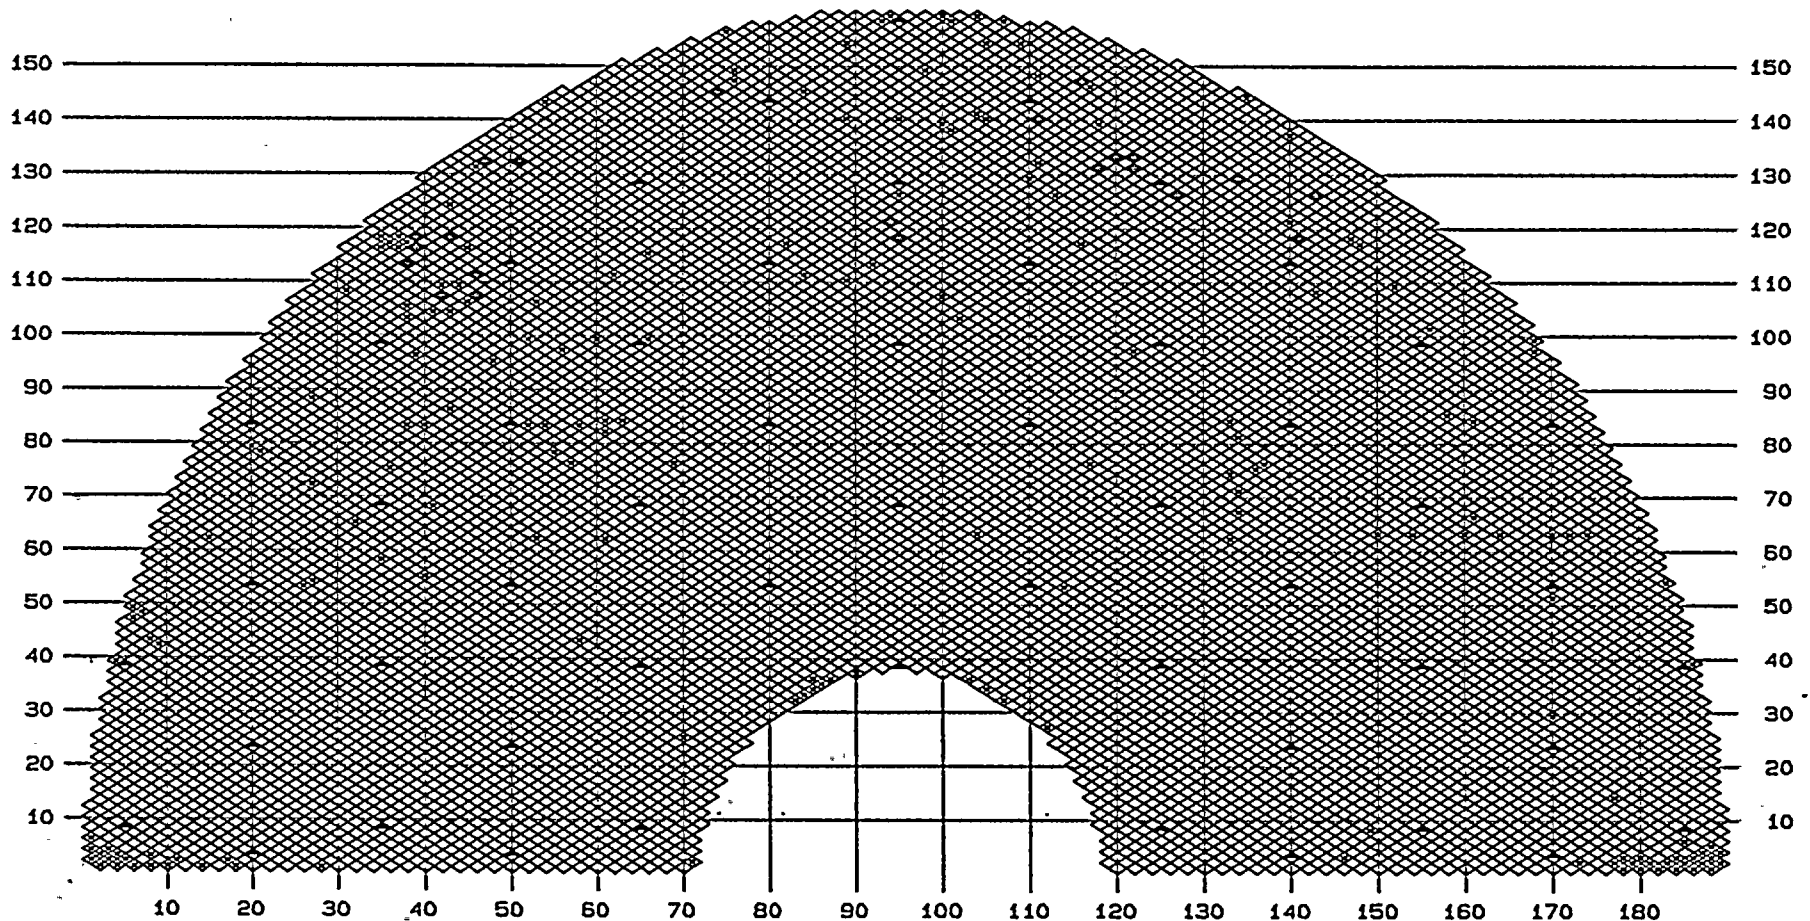
FIGURE A-2

Appendix A to this document contains tubesheet maps illustrating those tubes with indications, along with a detailed report on these indications. A total of 22 and 308 tubes were identified as having axial crack indications in SG 21 and SG 22 respectively. An additional 2 tubes are indicated in the SG 22 report and tubesheet map (Appendix A) due to plug removal and reexamination of 1993 axial indication. The four tubes with tubesheet circumferential cracks were located in SG 22.

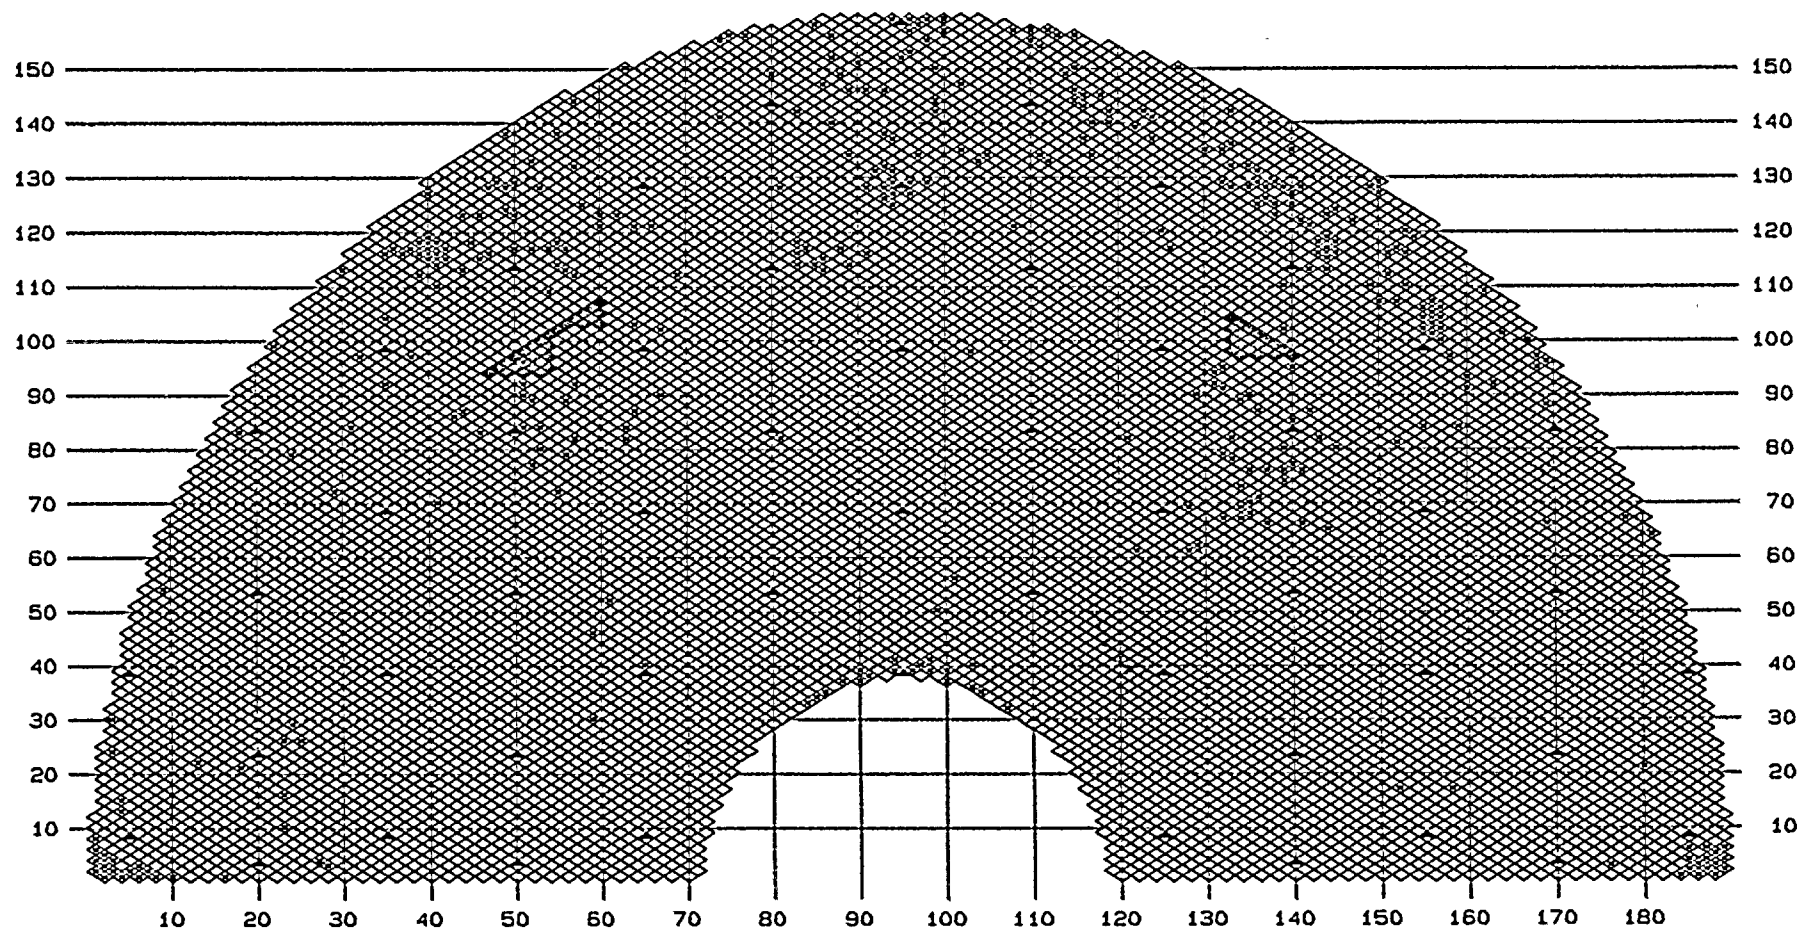
The second area of expansion was for axial indications detected in the bobbin arc. Several axial indications were detected, prior to chemical cleaning in both steam generators. As a result, an area surrounding the MRPC arc was added. The expansion included 980 tubes in SG 21 and 949 tubes in SG 22. The tubesheet maps shown in Figures V-7 and V-8 are provided to illustrate this expansion area. The examinations included MRPC from the BW1 through the 1st VS in SG 21 and 08H through the 1st VS in SG 22. Additional indications were found in this expansion in SG 22 and an additional 49 tubes were added to bound the indications by 5 tubes (Figure V-9).

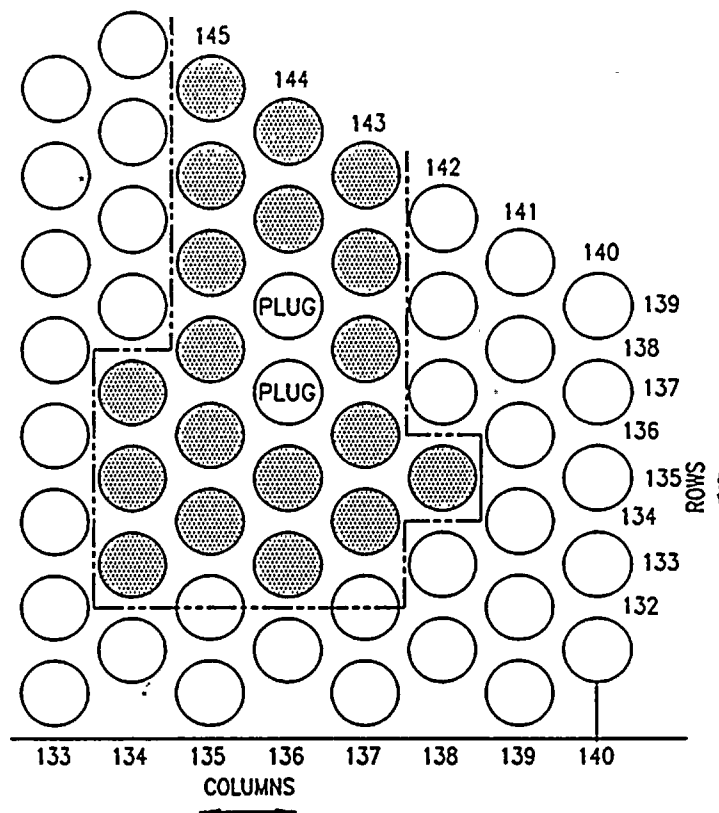
Figure V-10

SECONDARY SIDE TUBE PULL
TARGET TUBE LOCATIONS
