UNITED STATES
NUCLEAR REGULATORY COMMISSION
OFFICE OF NUCLEAR REACTOR REGULATION
WASHINGTON, DC 20555-0001

December 13, 2017

NRC INFORMATION NOTICE 2017-05, Revision 1: POTENTIAL BINDING OF SCHNEIDER
ELECTRIC/SQUARE-D MASTERPACT
NT AND NW 480-VAC CIRCUIT
BREAKER ANTI-PUMP FEATURE

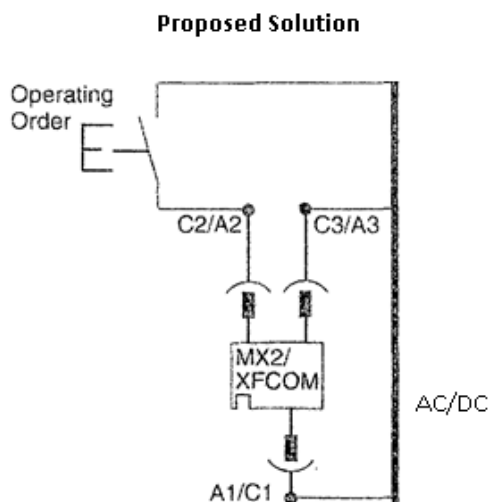
Appendix B, "Quality Assurance Criteria for Nuclear Power Plants and Fuel Reprocessing Plants," to 10 CFR Part 50, Criterion III, "Design Control," requires, in part, to subject design changes to control measures commensurate with those applied to the original design. The Masterpact breakers used at River Bend Station and at several other sites are a modification from the original General Electric AKR electrically-operated breakers. The original breakers used an electrical anti-pump interlock feature. The change from the electrical anti-pump interlock to a mechanical anti-pump interlock feature introduces mechanical binding as a potential failure mode.

Additional breaker testing by Schneider Electric identified the following five scenarios in which the circuit breaker could be more susceptible to the mechanical binding condition that would prevent the breaker from being able to reclose on command:

- (1) The closing circuit is continually energized during charge and/or open operations.
- (2) An anti-pump condition is present.
- (3) The breaker receives a command to open electrically before or at the same time as the close command is initiated.
- (4) The operator initiates a local or remote electrical closing action that may hold the close signal for longer than 200 milliseconds, which would extend into the closing spring charging cycle.¹
- (5) The logic scheme has a component controlling the close circuit that would apply the voltage to the close coil for longer than 200 milliseconds, extending into the closing spring charging cycle.¹

Figure 1: The XF coil in the original logic is replaced by an XFCOM coil, which releases the close coil plunger as soon as the close signal is received, eliminating the potential for binding.

In Technical Bulletin TB-12-007, Revision 3, which is attached to the referenced 10 CFR Part 21 report (ADAMS Accession No. ML16278A471), AZZ/NLI provided a proposed modification to the breaker and an updated circuit diagram, shown in Figure 1 of this document. This modification replaces the normal XF (closing) coil in the breaker with an XFCOM coil. The XFCOM coil acts as a oneshot and releases the close coil plunger immediately after the close signal is applied to the breaker and will not reactivate the close coil plunger unless power is first removed from the operating order signal of the XFCOM and then re-applied. With the closing coil plunger retracted, this modification is designed to eliminate the potential for mechanical binding from the anti-pump feature.
