Report

Millstone Unit 1

Diesel Generator DC Field Rewind

July 15, 1991

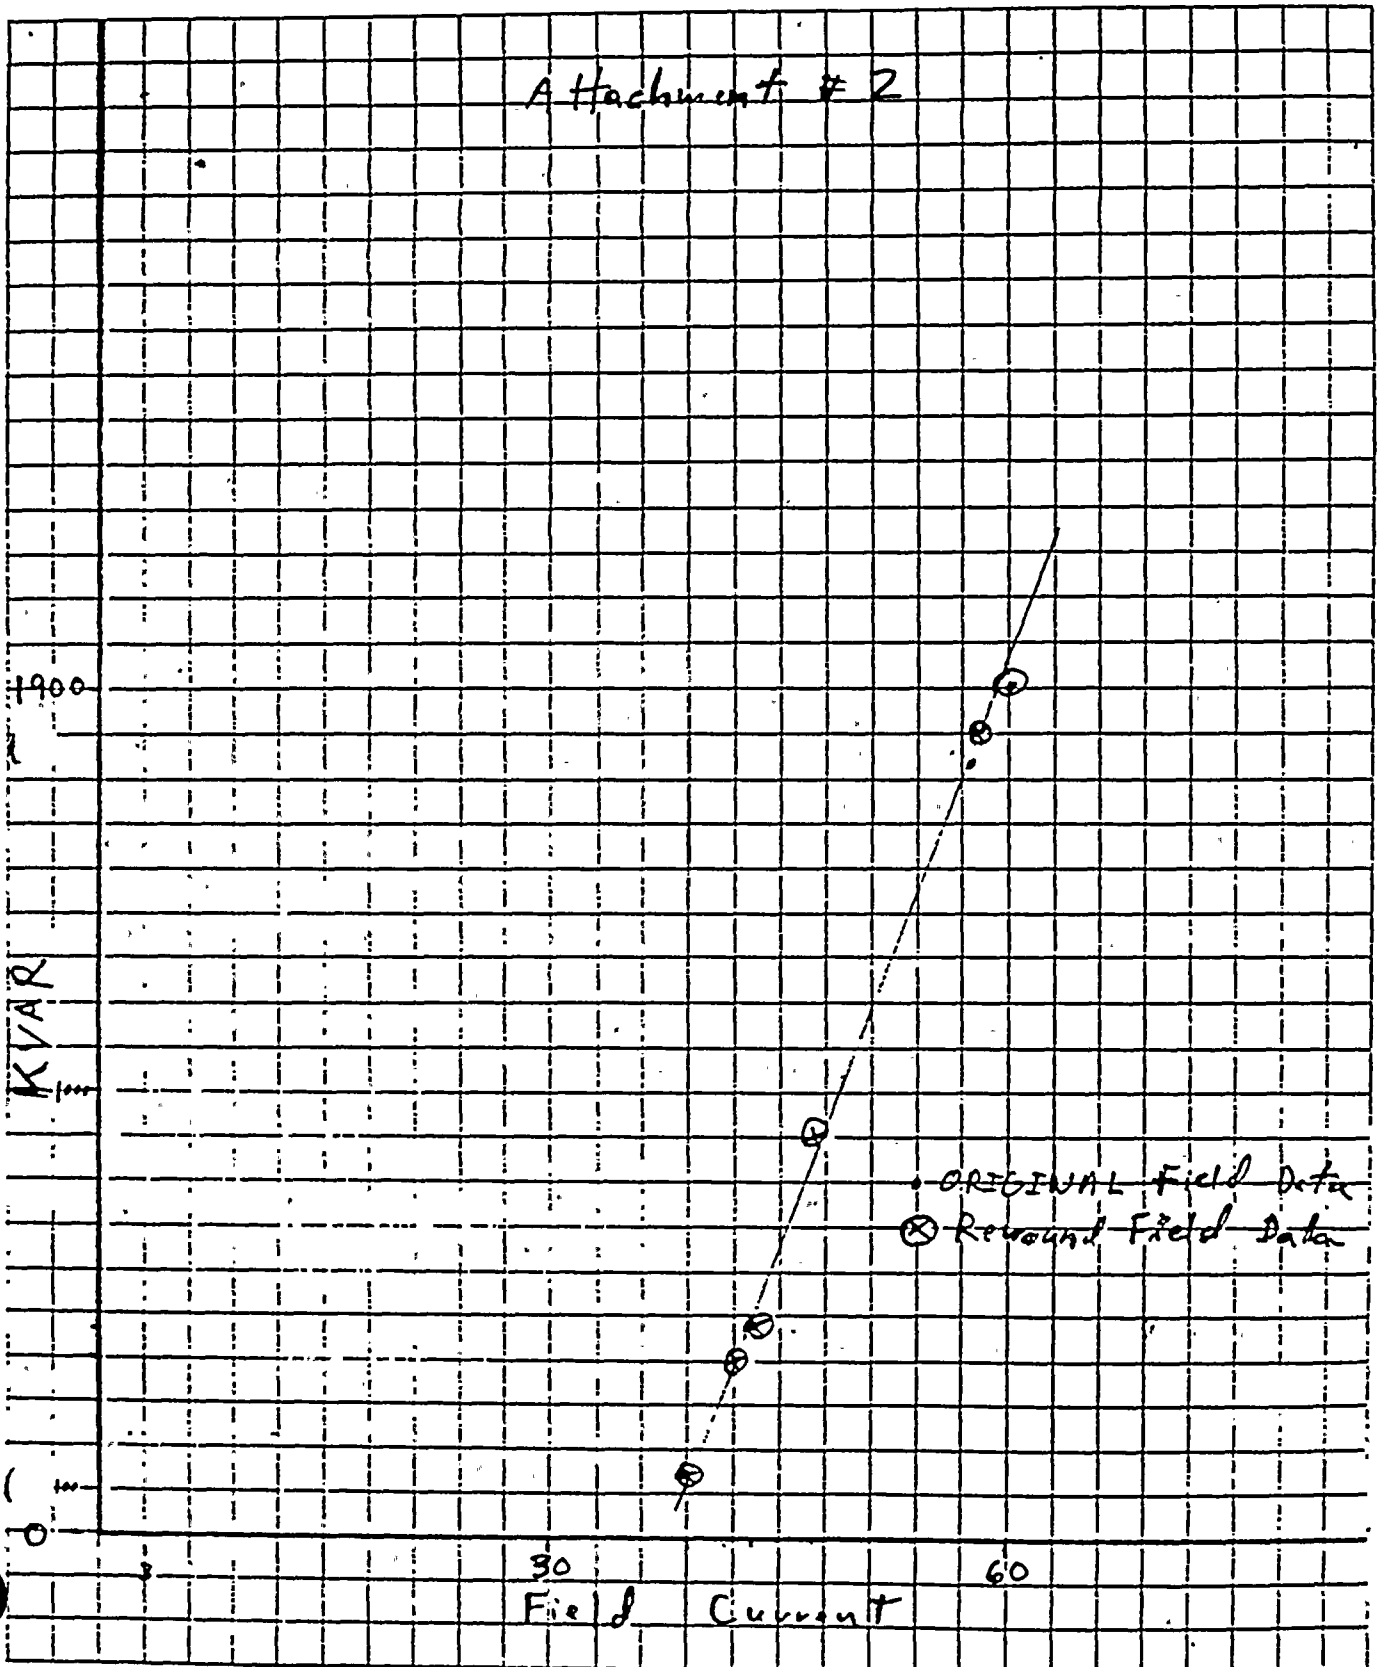
SUBJECT MP#1 Diesel Generator
Field Rewind
Full Load Test Results

The no-load tests showed that for a range of field voltages the output voltage was within 5% of the original generator test results. The next test was to operate the generator at full load for one hour, stop the generator and perform an inspection to discover any changes in the field winding configuration. Although the generator output during test reached 2665 KW, rated KW, the full 3330 KVA rating of the generator was not achieved due to system conditions that prevented full KVAR capability output. However, the generator was loaded to approximately 3058 KVA, 91% of rated KVA. The resulting inspection with the generator shut down showed no degradation of the field winding. Temperature measurements of the field winding were taken at the end of the test run. The field winding temperature was approximately 50°C well below the 180°C temperature rating of the insulation system. The generator was restarted and completed an additional 23 hour run at 91% of rated output. The static tests showed that there was no degradation of the field winding during the tests. A comparison of the these test results with initial test results indicate that the operating characteristics of the generator are unchanged. Since rated KVA of the generator was not achieved due to electrical system voltage restrictions, a comparison was made of the original and present field current vs generator KVAR. This graph, attached, shows that for a given field current the generator provides the same kvar. The generator response for a given load remains essentially unchanged.
