Palo Verde Nuclear Generating Station

Status of PVNGS Steam Generator Activities

August 1994

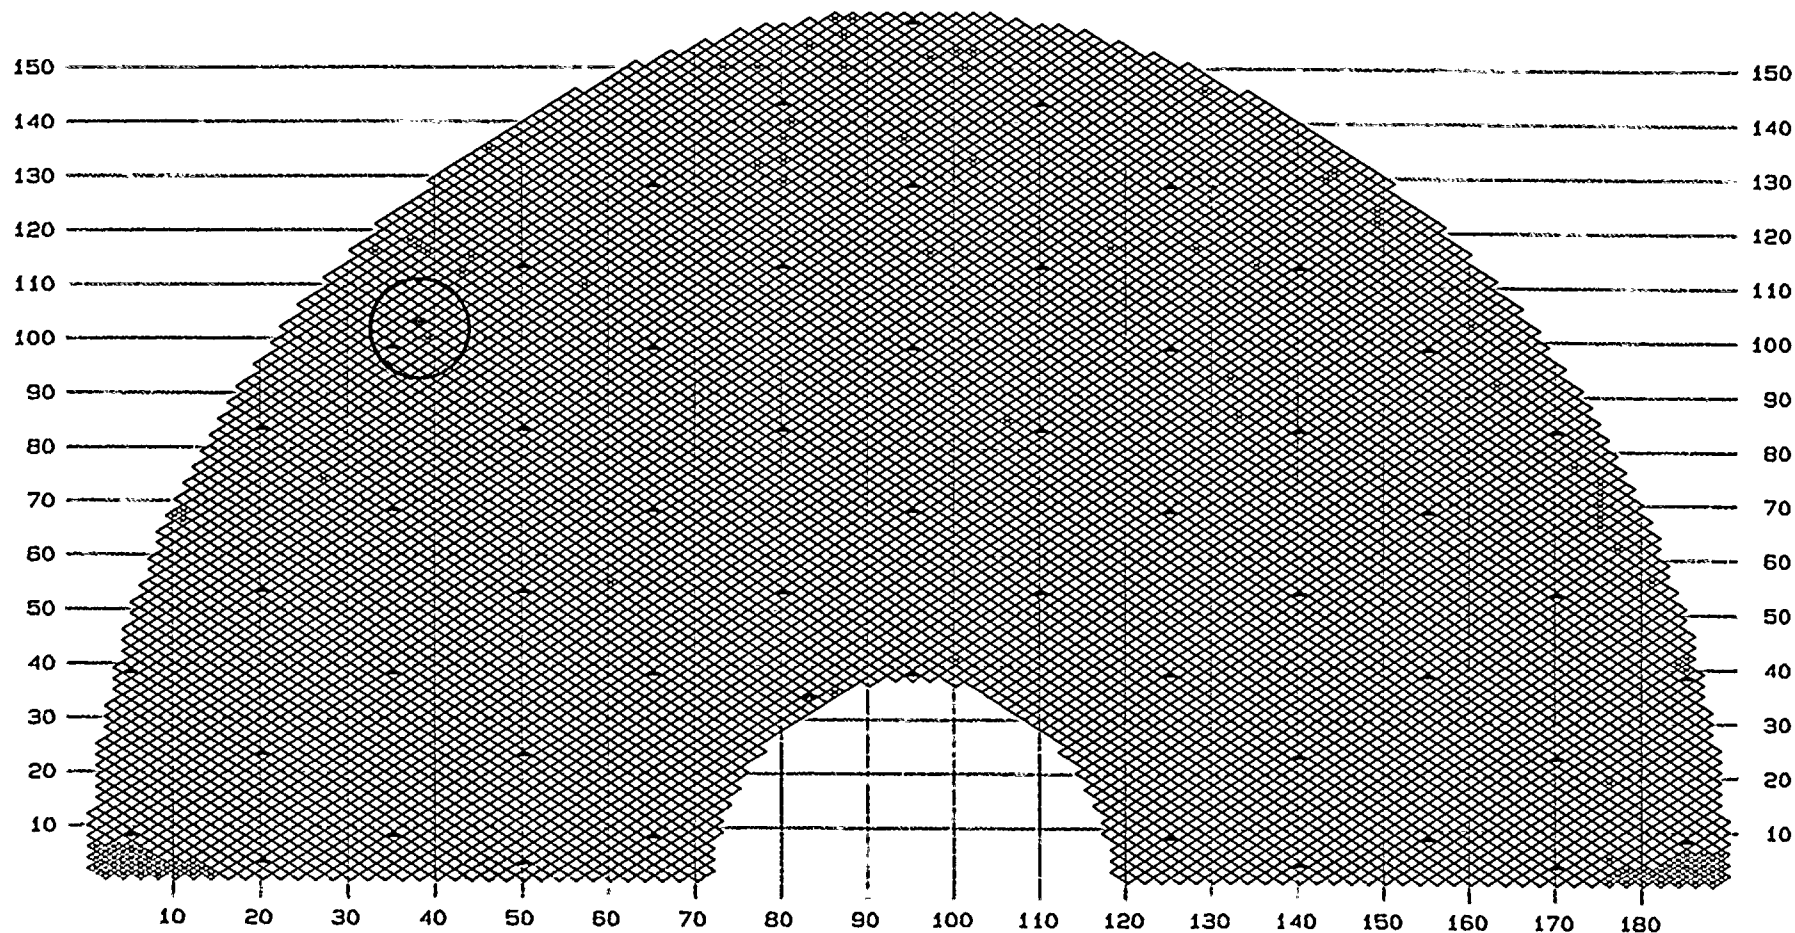
FIGURE III-5 SG 3-1 ARC REGION DEFECT - U3R4

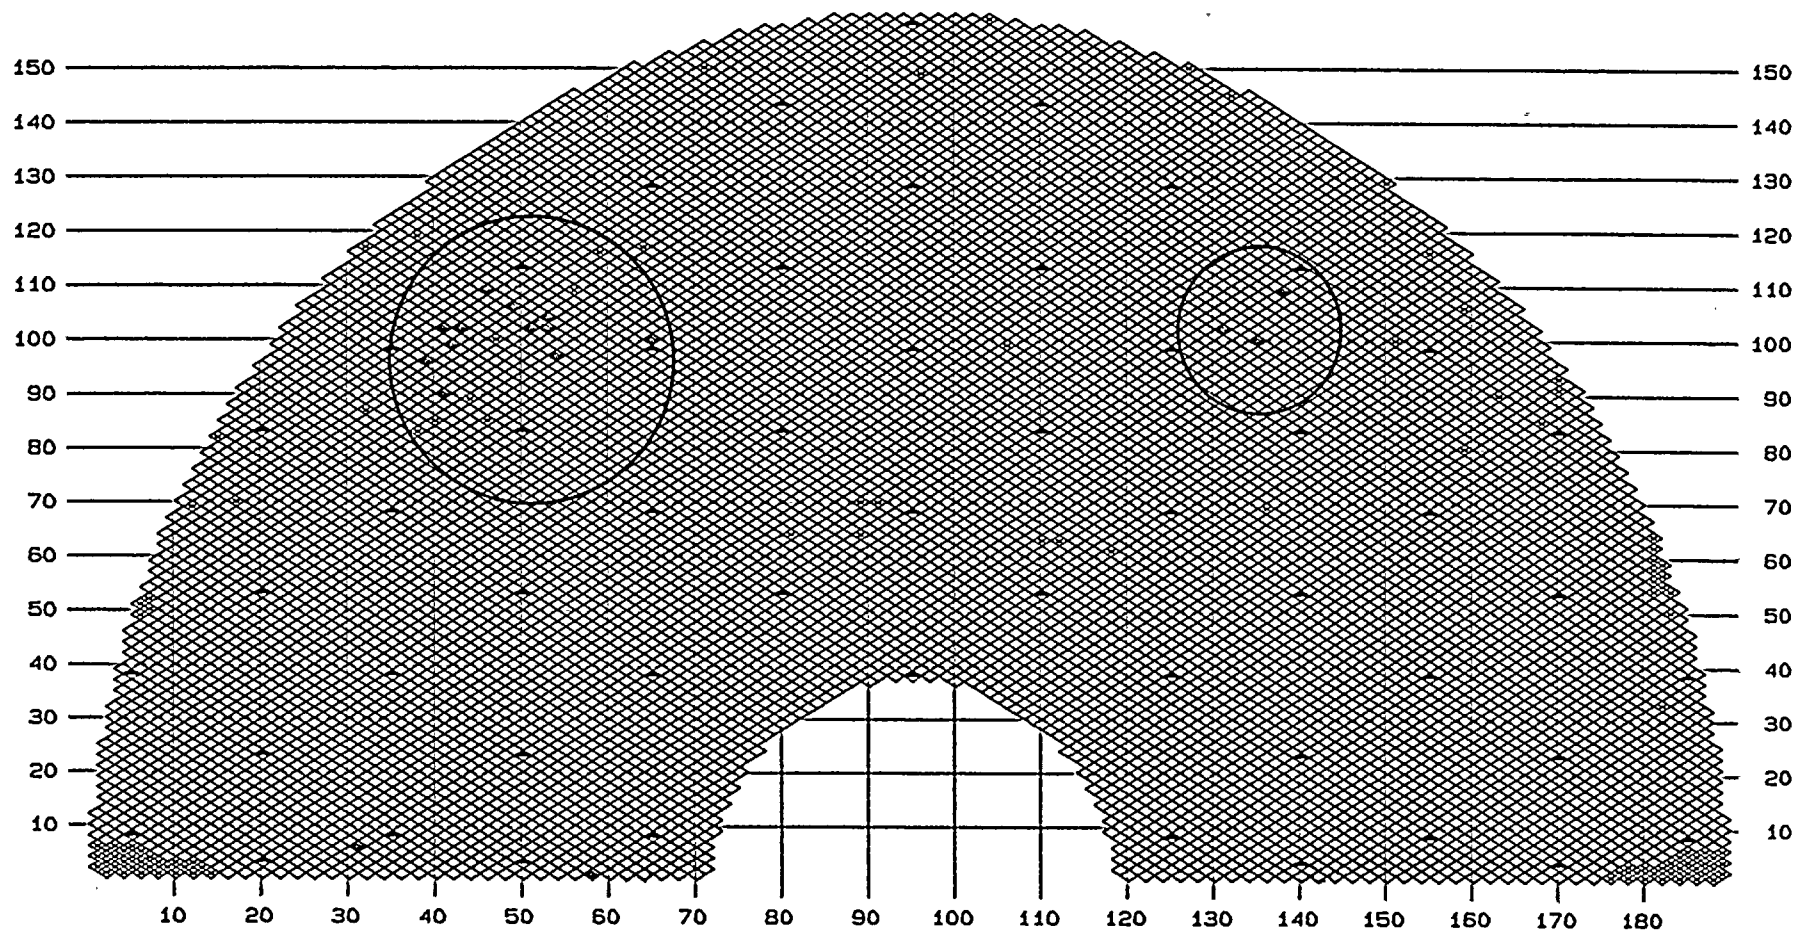
FIGURE III-7 SG 3-2 ARC REGION DEFECTS - U3R4

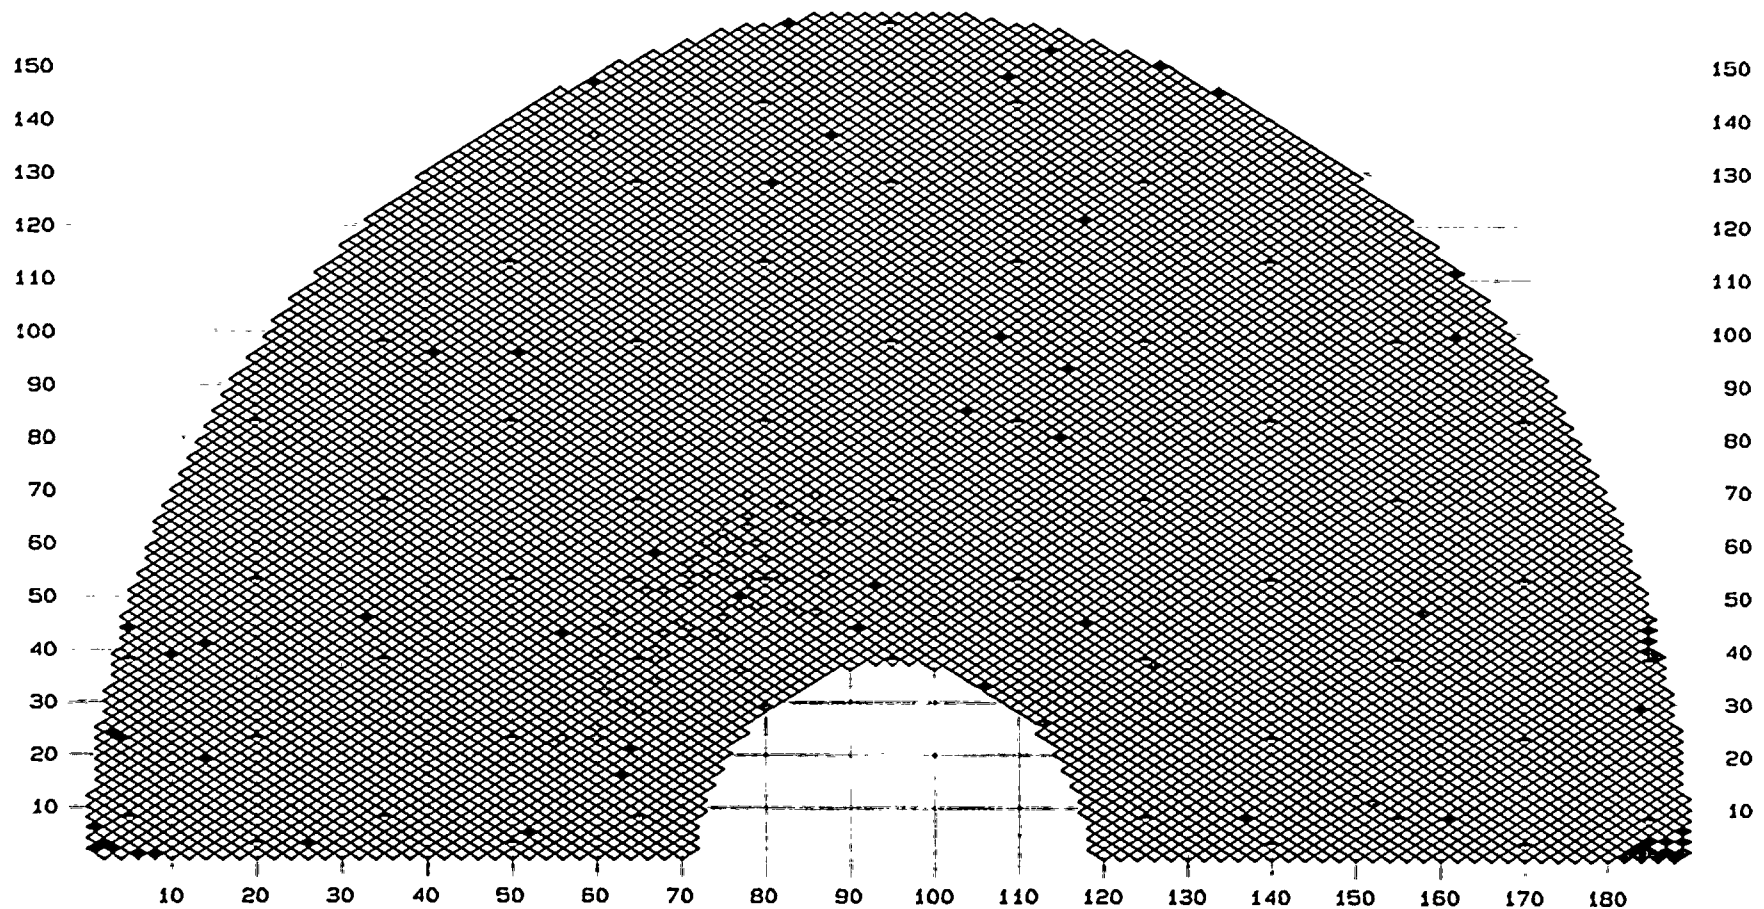
With regard to tubesheet circumferential SCC, there is indication that pre-1993 hot leg sludge piles were larger in Unit 1 than in either Units 2 and 3. As can be seen by comparing defect location with sludge pile depths in Figures III-8 through III-13, there is a consistent sludge pile/defect relationship. This relationship has been observed in other Combustion Engineering units. The insulating effect of the sludge pile may contribute to the initiation and propagation of primary initiated defects within the sludge pile. APS sludge lanced Unit 1 during U1R4 in an effort to minimize this condition.

FIGURE III-9 SG 1-2 CIRCUMFERENTIAL DEFECTS - U1R4

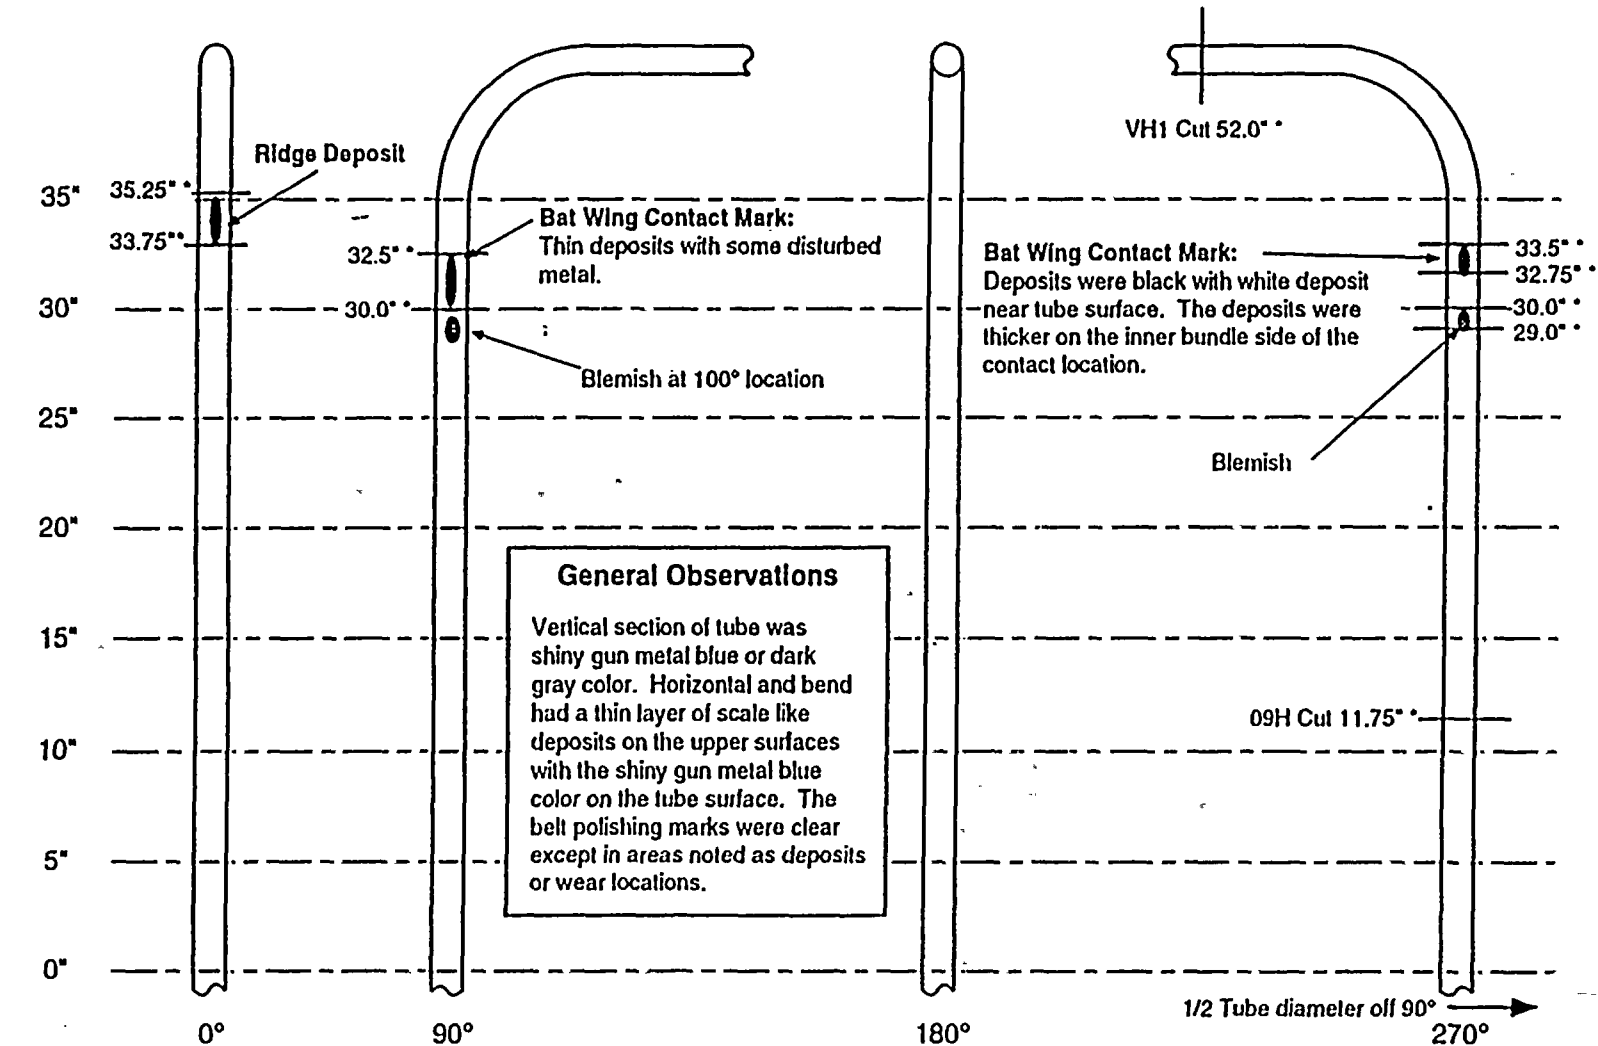
Figure IV-2. Summary of initial Visual Observations of Tube A

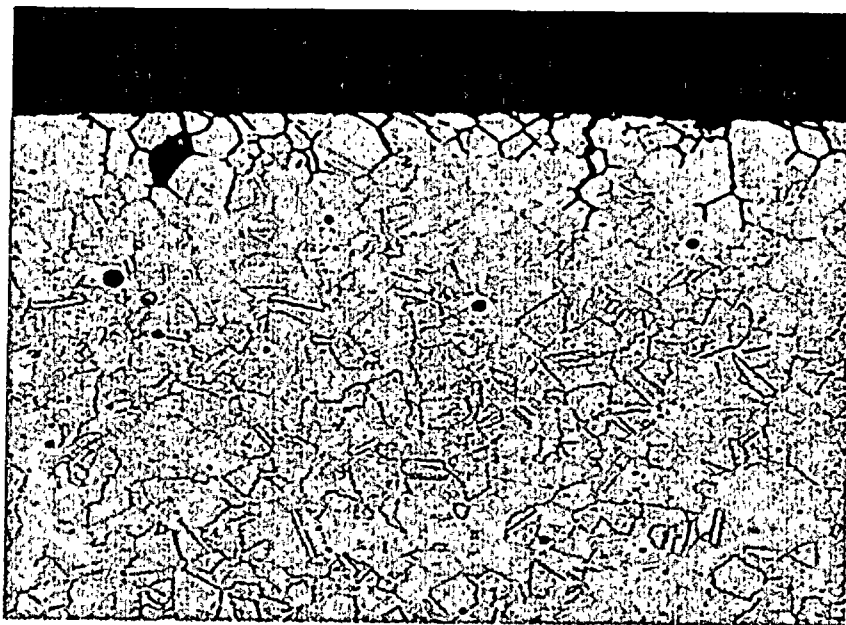
Figure IV-4. Shallow IGA at the 30° Orientation of Tube R134L135 (D) in the Area of a Field Eddy Current Indication. (Glyceregia Etch)

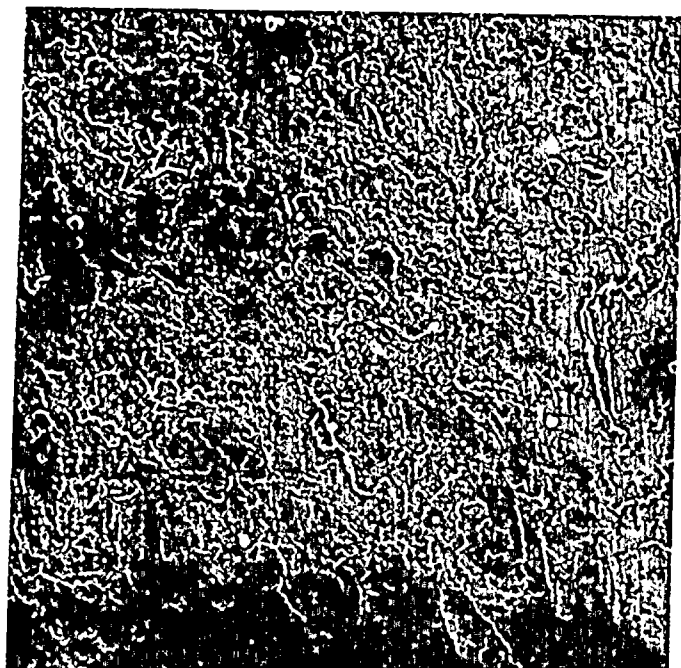
Figure IV-6. Higher Magnification Micrographs of Wear Scar on Tube R139L136 Zero-Degree Extrados Location
