Palo Verde Nuclear Generating Station

Unit 3

Steam Generator

Inspection Report

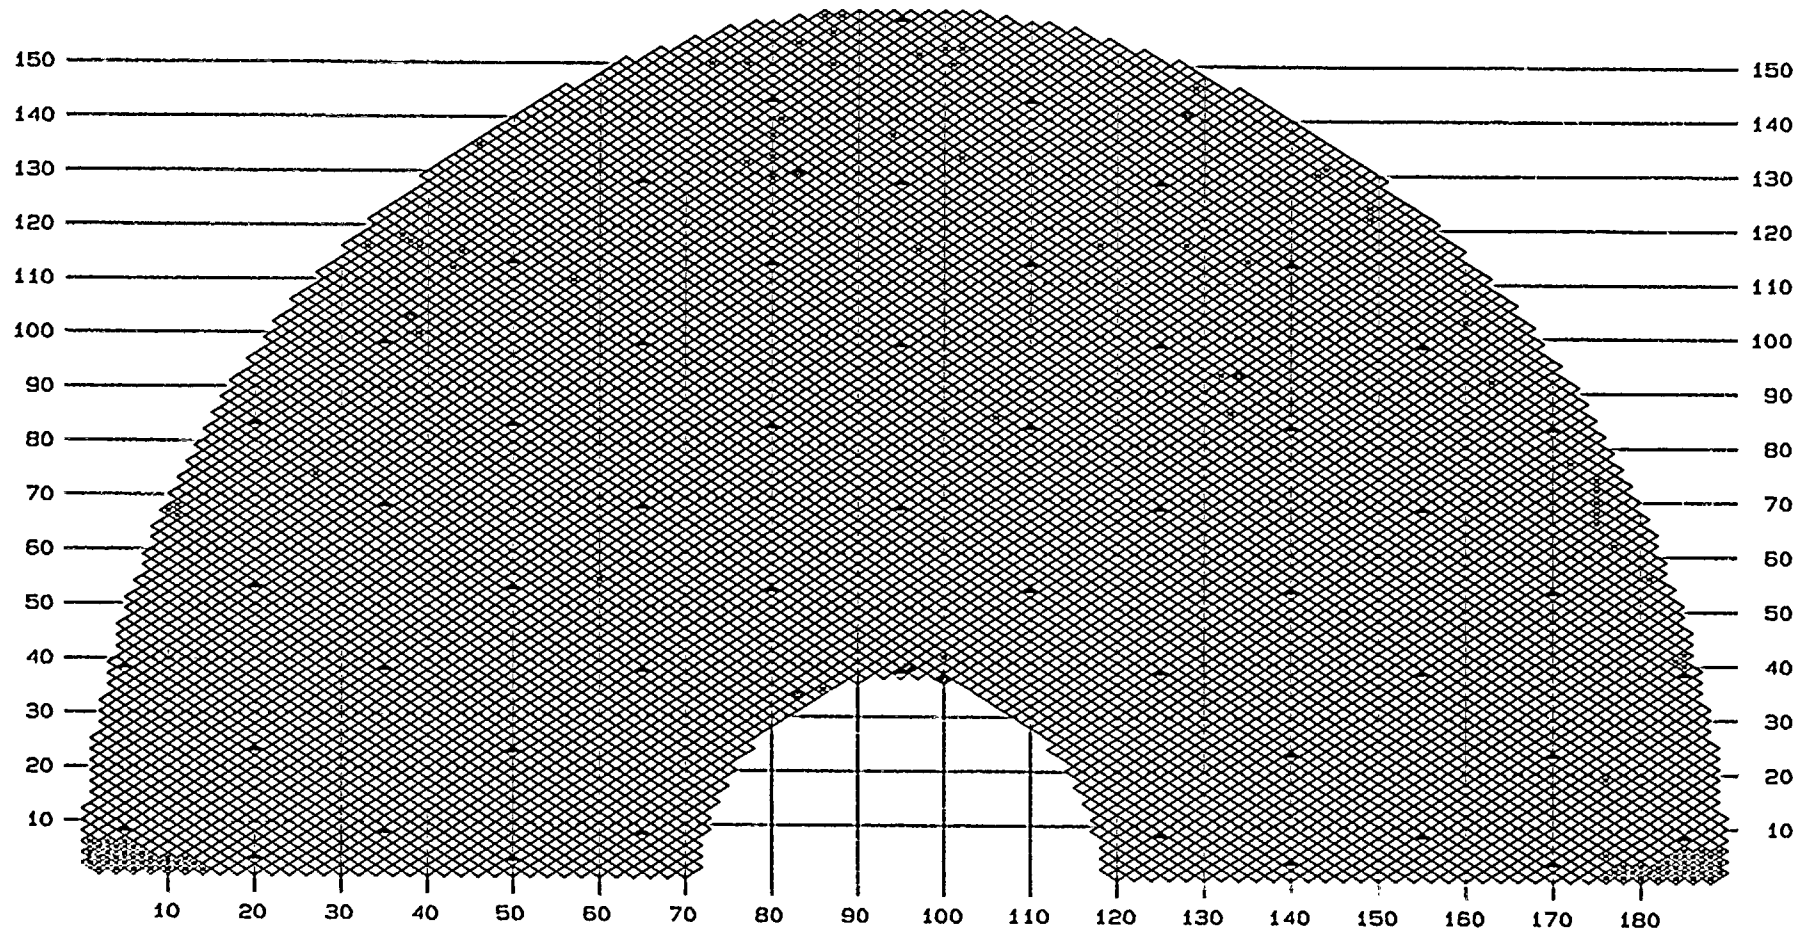
TABLE A-1: STEAM GENERATOR 3-1 TUBE PLUG SUMMARY REPORT

| Row | Column | ET Call | Degradation | Elevation | Hot Leg Configuration | Cold Leg Configuration | Outage/Date Removed |
|---|---|---|---|---|---|---|---|
| 39 | 96 | 28% | Bat Wing Stay Cylinder Wear | BW1-2.01 | B&W Rolled Plug + 390" Stake | B&W Rolled Plug | U3R4 - 5/94 |
| 37 | 100 | 23% | Bat Wing Stay Cylinder Wear | BW2-1.97" | B&W Rolled Plug + 384" Stake | B&W Rolled Plug | U3R4 - 5/94 |
| 141 | 128 | 41% | Vertical Support Wear | VS5+0.83" | B&W Rolled Plug | B&W Rolled Plug | U3R4 - 5/94 |
| 93 | 134 | 41% | Bat Wing Wear | BW1+2.72" | B&W Rolled Plug | B&W Rolled Plug | U3R4 - 5/94 |
