SUBJECT: LER 95-005-00:on 950407,determined that tubesheet blockage found in EDG B jacket water cooler would have reduced min required heat rejection through cooler.Caused by failure of epoxy coating.Reassessment of cleaning times.W/950502 ltr.

**Subject: Palo Verde Nuclear Generating Station (PVNGS)
Unit 1
Docket No. STN 50-528 (License No. NPF-51)
Licensee Event Report 95-005-00**

TITLE (4)
Emergency Diesel Generator Inoperable Due to Debris in Cooling Water Heat Exchanger

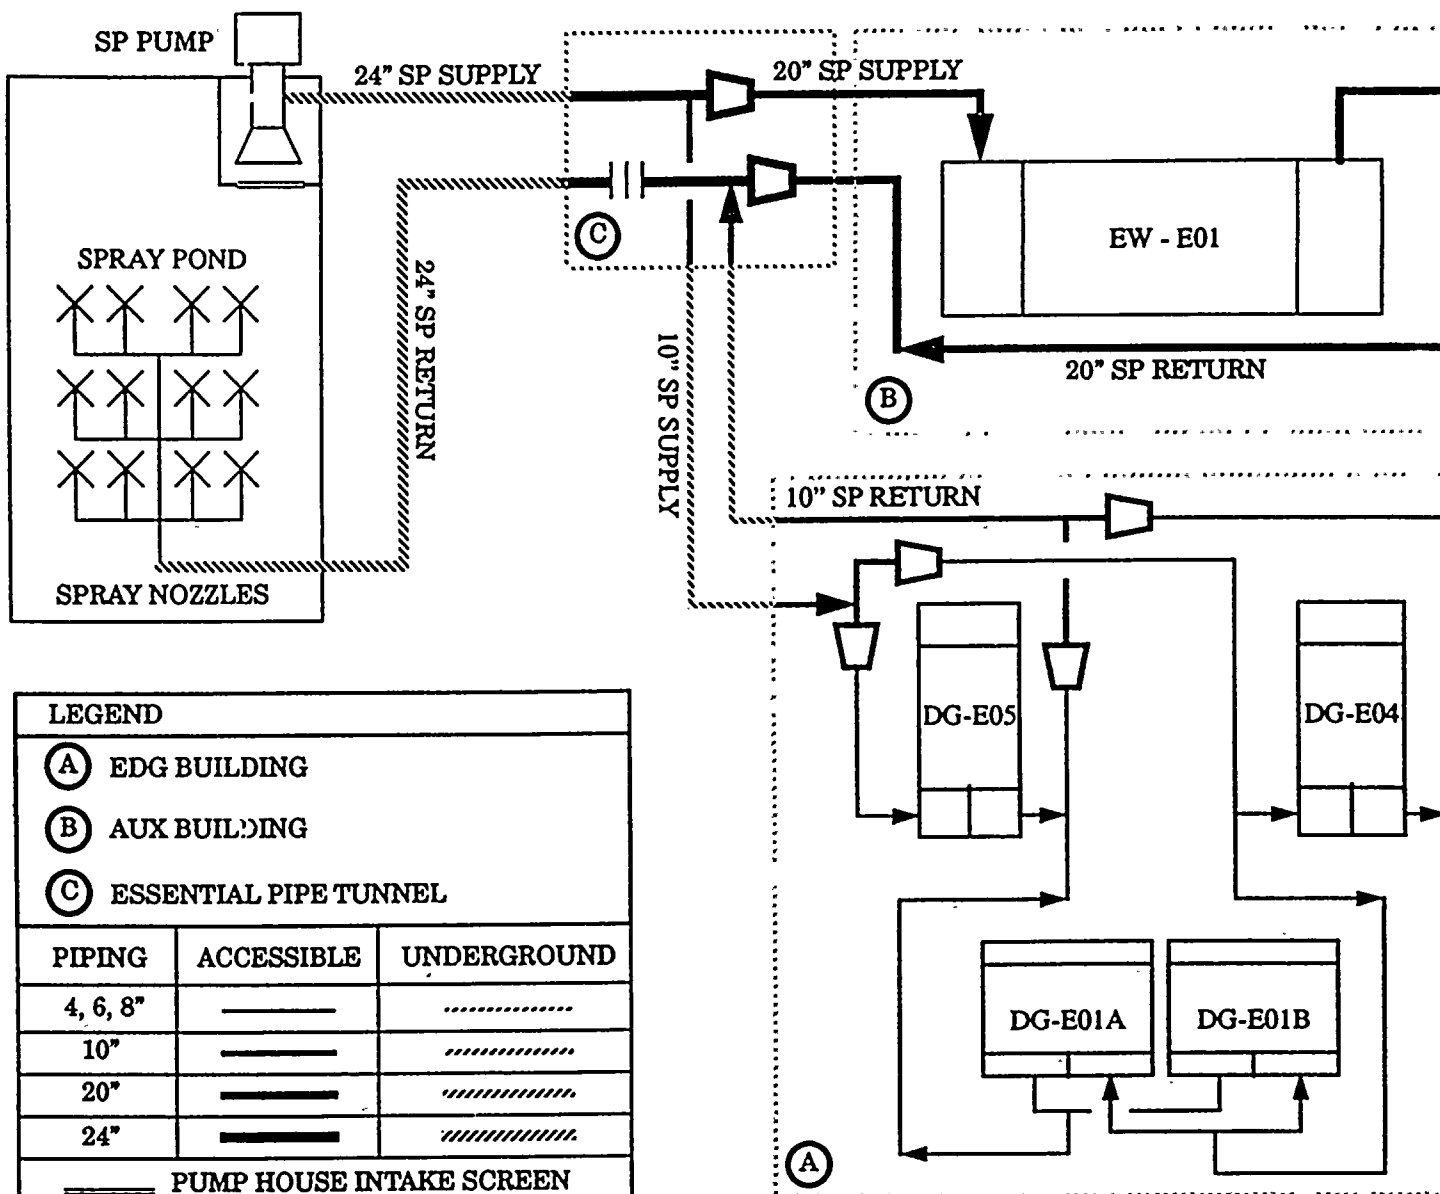
Spray Pond System Single Train Flow Diagram:

The spray pond system supply piping is configured as follows: 24-inch piping carries the total discharge flow [nominal 17,000 gallons per minute (gpm)] from the spray pond pump. The 24-inch line branches into a 10-inch line to the EDG heat exchangers (nominal 1,500 gpm) and a 20-inch line to the essential cooling water heat exchangers (nominal 15,500 gpm). Based on the pipe size and flow rates, the flow velocity through the 24-inch line is approximately 13 feet per second (fps). The flow velocity through the 20-inch line is also approximately 13 fps and flow velocity through the 10-inch line is approximately 6 fps.
