SUBJECT: LER 95-016-00: on 951212, containment spray TS violation
 occurred due to unrecognized valve failure. Shim/band was
 placed around stator of 1JSIBUV665 motor operator to
 maintain stator in correct position. W/960222 ltr.

**Subject: Palo Verde Nuclear Generating Station (PVNGS)
Unit 1
Docket No. STN 50-528 (License No. NPF-41)
Licensee Event Report 95-016-00**

TITLE (4)
Containment Spray Technical Specification Violation Due to Unrecognized Valve Failure

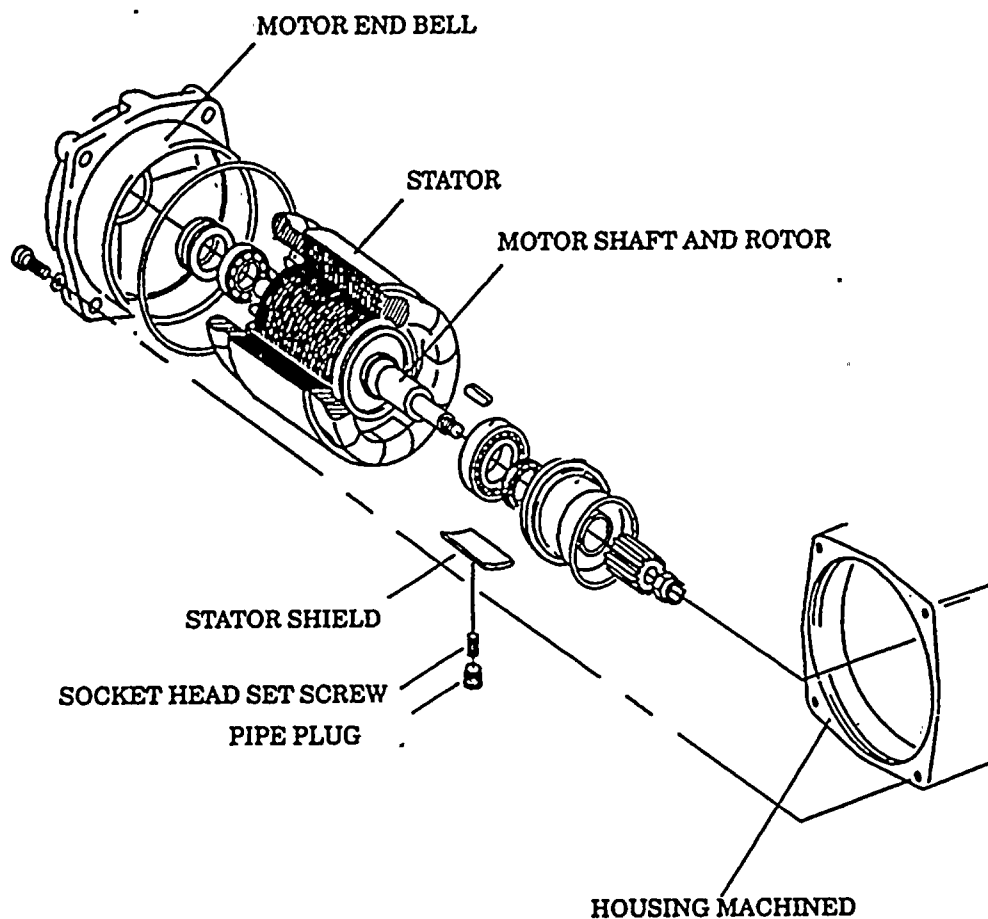
Figure 1 Limitorque SMC-04 Motor Actuator

On October 23, 1995, at approximately 1620 MST, Palo Verde Unit 1 was in Mode 1 (POWER OPERATION), operating at approximately 100 percent power, when 1JSIBUV665 failed to open during Engineered Safety Features Actuation System (ESFAS)(JE) relay surveillance testing. Valve Services Engineering (VSE) personnel (other utility personnel) performed a root cause evaluation and determined that the valve had failed due to a motor ground fault which had occurred because the stator had made contact with the motor end bell (see Section 8, Figure 1). Visual examination revealed the stator had incurred minor insulation damage.

It was determined that the stator had contacted the motor end bell because the stator shield was not properly positioned beneath the set screw, or the set screw was not sufficiently tightened which allowed the stator to shift toward the end bell. Additionally, it was determined that the physical orientation of the motor was also a contributing factor, because the actuator was oriented such that gravity and vibration assisted in moving the stator toward the end bell.

On December 20, 1995, a shim/band was placed around the stator of 1JSIBUV665's motor operator to maintain the stator in the correct position. 1JSIBUV665 was tested and declared operable on December 21, 1995.

On December 20, 1995, 1JSIBUV665's motor actuator was re-oriented to a horizontal position. Work Requests have been initiated to re-orient all applicable SMC-04 operators to a horizontal position. This action will be completed in all three units no later than the end of Unit 3's sixth refueling outage, which is scheduled to end May 07, 1997.
