# LICENSEE EVENT REPORT (LER)

FACILITY NAME (1) <b>Palo Verde Unit 1</b>	DOCKET NUMBER (2) <b>0 5 0 0 0 5 2 8</b>	PAGE (3) <b>1 OF 1 0</b>
---	---	-----------------------------

TITLE (4) <b>Adverse Affect of Low Bench Set on Fisher Air Operated Letdown/Containment Isolation Valves</b>
---

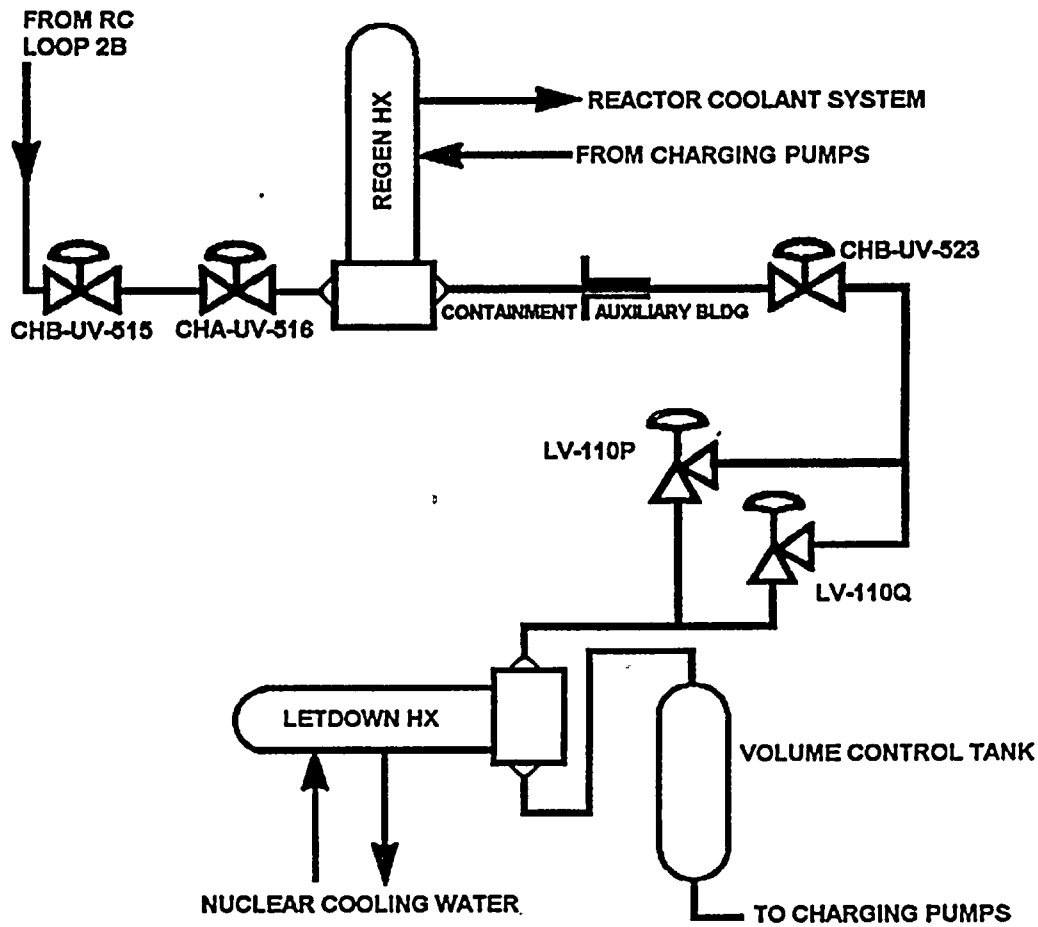
**FIGURE 1 - LETDOWN LINE  
CONFIGURATION THROUGH THE  
LETDOWN HEAT EXCHANGER**

Figure 1, page 10, illustrates the letdown system. The following Unit 1, 2, and 3 letdown line isolation valves were affected by this event: CHB-UV-515 Upstream Containment Isolation Valve, CHA-UV-516 Downstream Containment Isolation Valve, and CHB-UV-523 Outside of Containment Letdown Isolation Valve.
