Palo Verde Nuclear
Generating Station

**Subject: Palo Verde Nuclear Generating Station (PVNGS)
Units 1, 2, and 3
Docket Nos. STN 50-528/529/530
Response to Generic Letter 97-06: "Degradation of Steam Generator
Internals"**

**Response to Generic Letter 97-06:
"Degradation of Steam Generator Internals"**

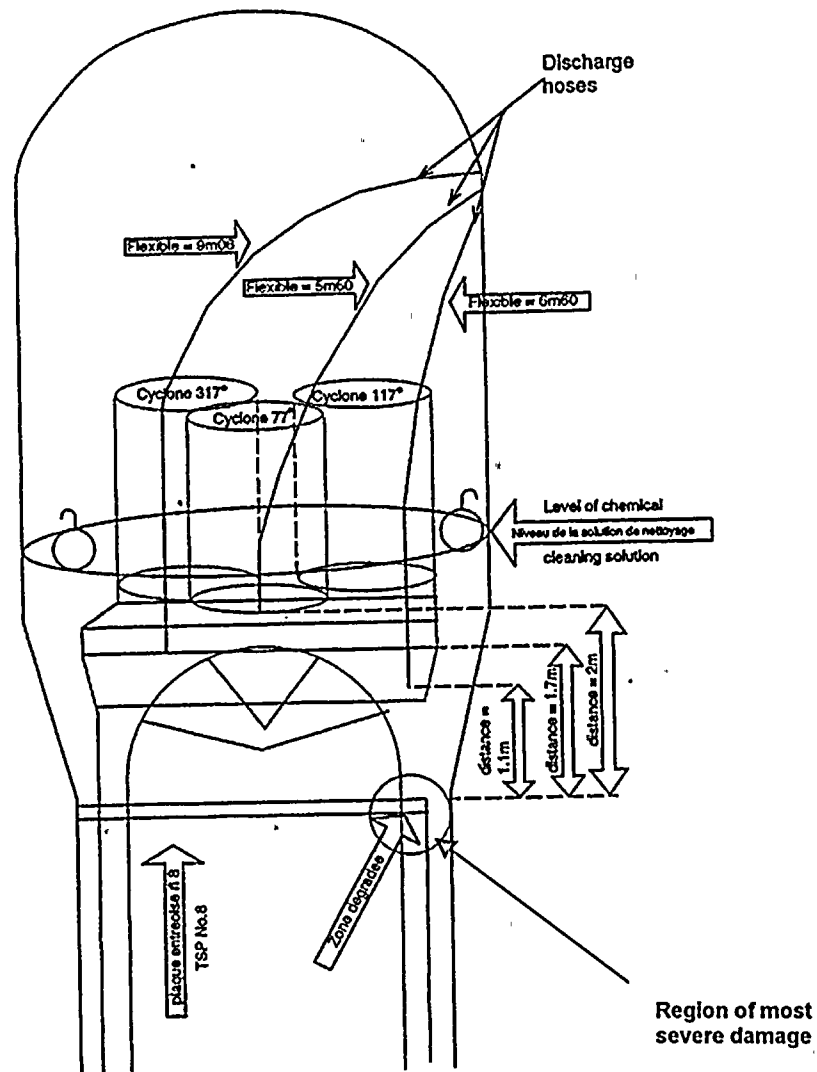
Figure 2

The corrosion process at Fessenheim Unit 2 was further aggravated by the direct impingement of process chemicals on the upper tube support plates. EdF noted that in the most affected steam generator (steam generator 3), the solvent recirculation hoses had been misplaced to within 1.1 meters of the eighth support plate (See Figure 2). Conversely, the PVNGS solution was applied at the tubesheet level so as not to impinge directly on the tube supports. Post-cleaning video inspections revealed no indication of corrosion/erosion damage.

Chemical Cleaning at Fessenheim Unit 2

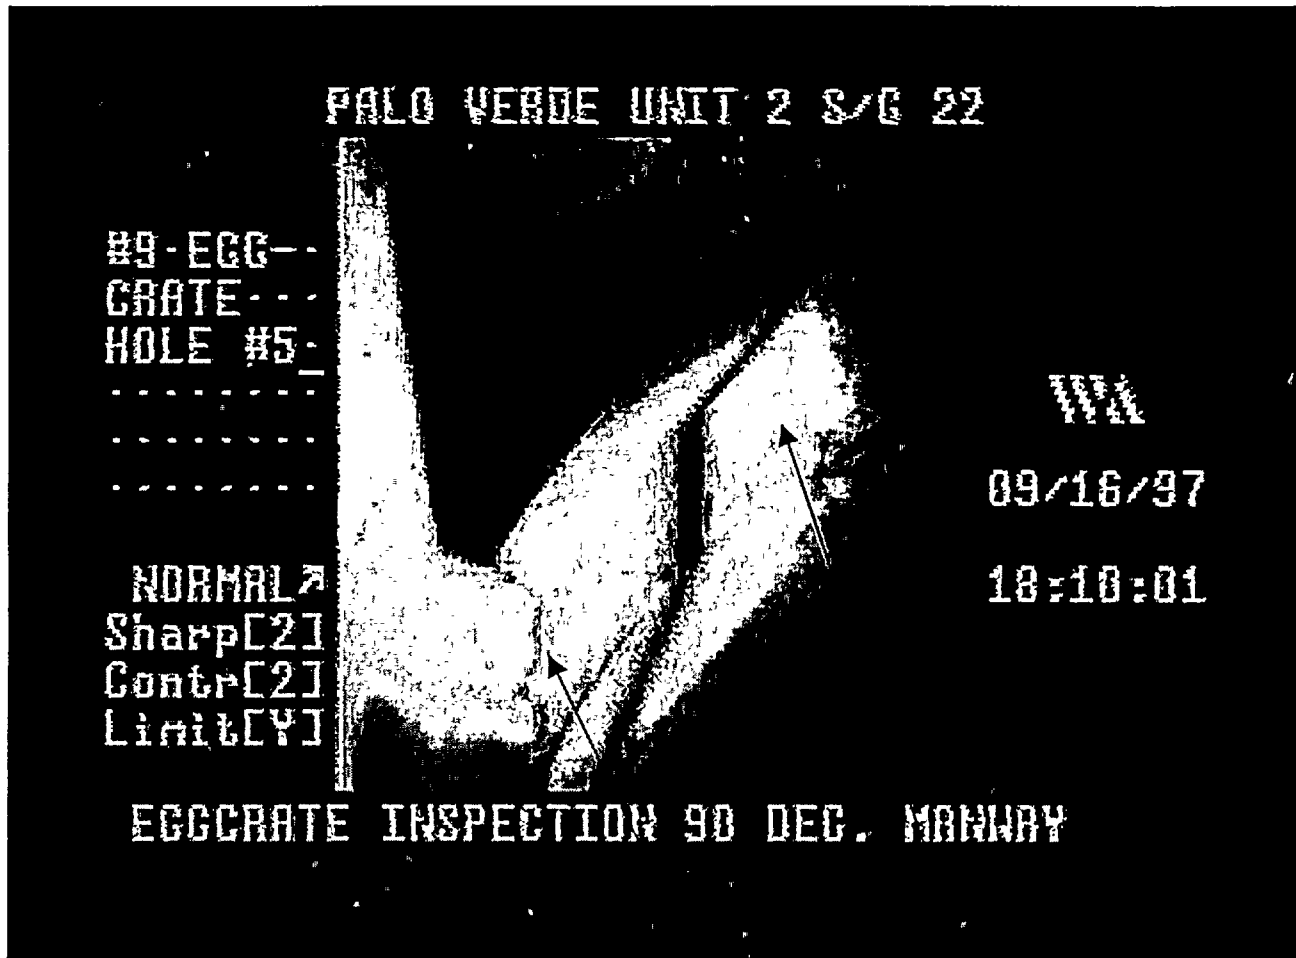
Figure 6

This position has also been supported by a number of video inspections conducted by PVNGS either as result of steam generator tube pulls and steam generator modifications, or a specific secondary eggcrate inspection performed in Unit 2 in 1997 as a result of the findings at SONGS Unit 3. The PVNGS Unit 2 video inspection (Reference 10) was performed for the upper three eggcrate supports at two periphery locations on the hot leg side of steam generator 22. The batwing supports near these locations were also examined. None of these inspections found any evidence of erosion, thinning or fouling at the inspected locations. One small crack was observed at an eggcrate joint (Figure 6). The defect appears shallow, and was assessed by ABB-CE and APS to pose no threat to tube support integrity. The defect appears to be fabrication related and not operationally induced. Other bars in the general area showed no evidence of bending or cracking. Additional examples of findings from the 1997 inspection are provided in Figures 7-9. Based on this evaluation, the inspection findings, and the ABB-CE conclusions and recommendations contained in Reference 7, APS plans no further inspections at this time. APS will continue to monitor operational chemistry, and eddy current testing results, as well as trend industry information, to determine if future actions are required.

Crack at Tack Weld

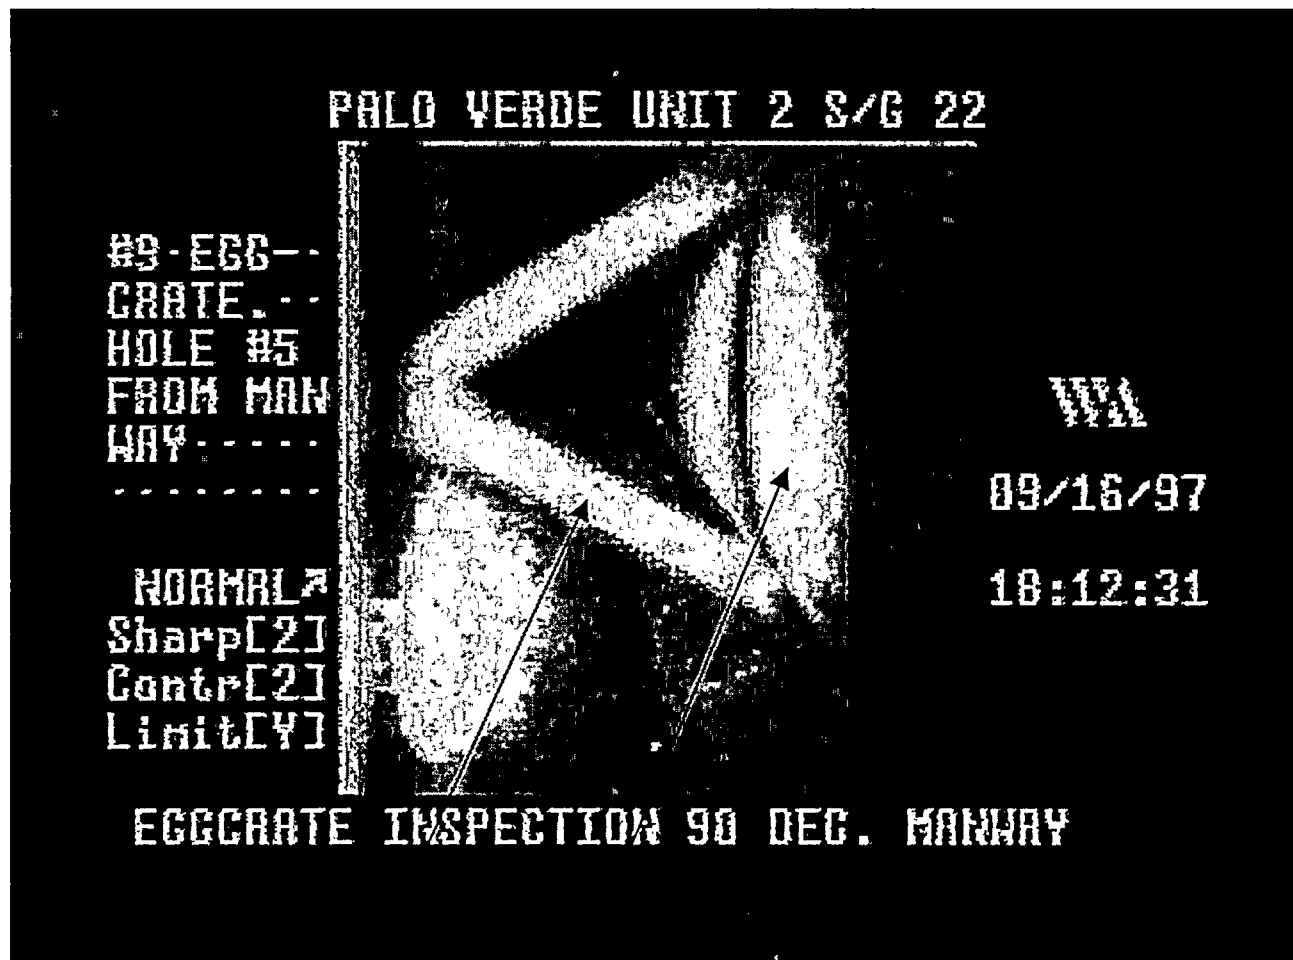
Figure 7

Unit 2 SG 22 # 9 (09H) EGGCRATE

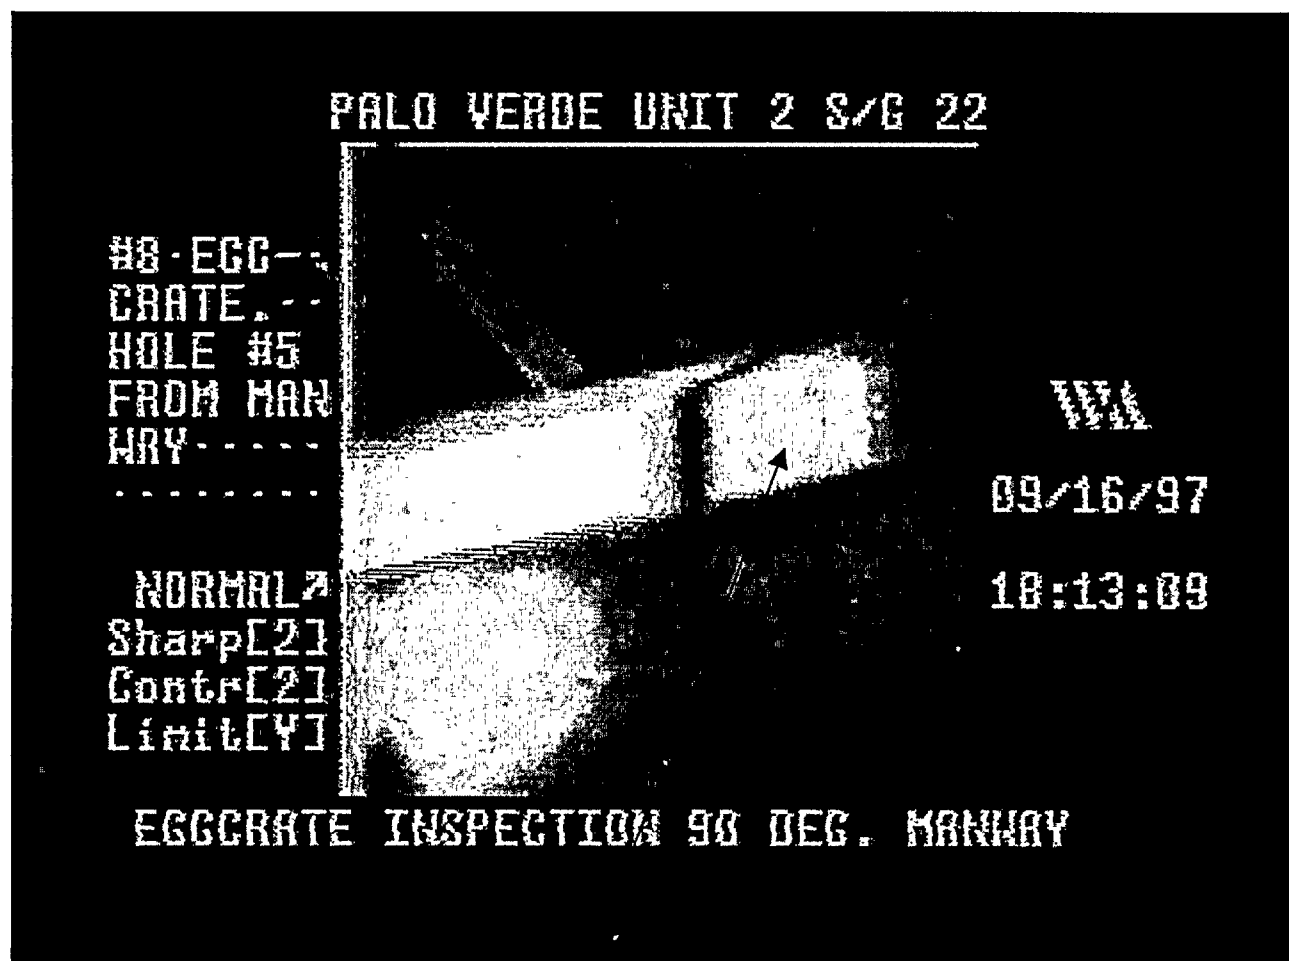
Figure 8

Unit 2 SG 22 # 8 (08H) EGGCRATE
