ACCESSION NBR: 7906150334 DOC. DATE: 79/06/07 NOTARIZED: NO DOCKET #
 FACIL: 50-315 Donald C. Cook Nuclear Power Plant, Unit 1, Indiana & 05000315
 50-316 Donald C. Cook Nuclear Power Plant, Unit 2, Indiana & 05000316
 AUTH. NAME AUTHOR AFFILIATION
 SHALLER, D.V. Indiana & Michigan Power Co.
 RECIP. NAME RECIPIENT AFFILIATION
 Region 3, Chicago, Office of the Director

SUBJECT: LER 79-019/01L-0 on 790519: cracks found in 16-inch feedwater elbows adjacent to nozzle welds caused buildup of non-radioactive water in containment sump. 16-inch elbows in generators being replaced. Causes being determined.

1.0 GENERAL INFORMATION

2.0 METALLURGICAL EVALUATION OF MAIN FEEDWATER LINE CRACKS

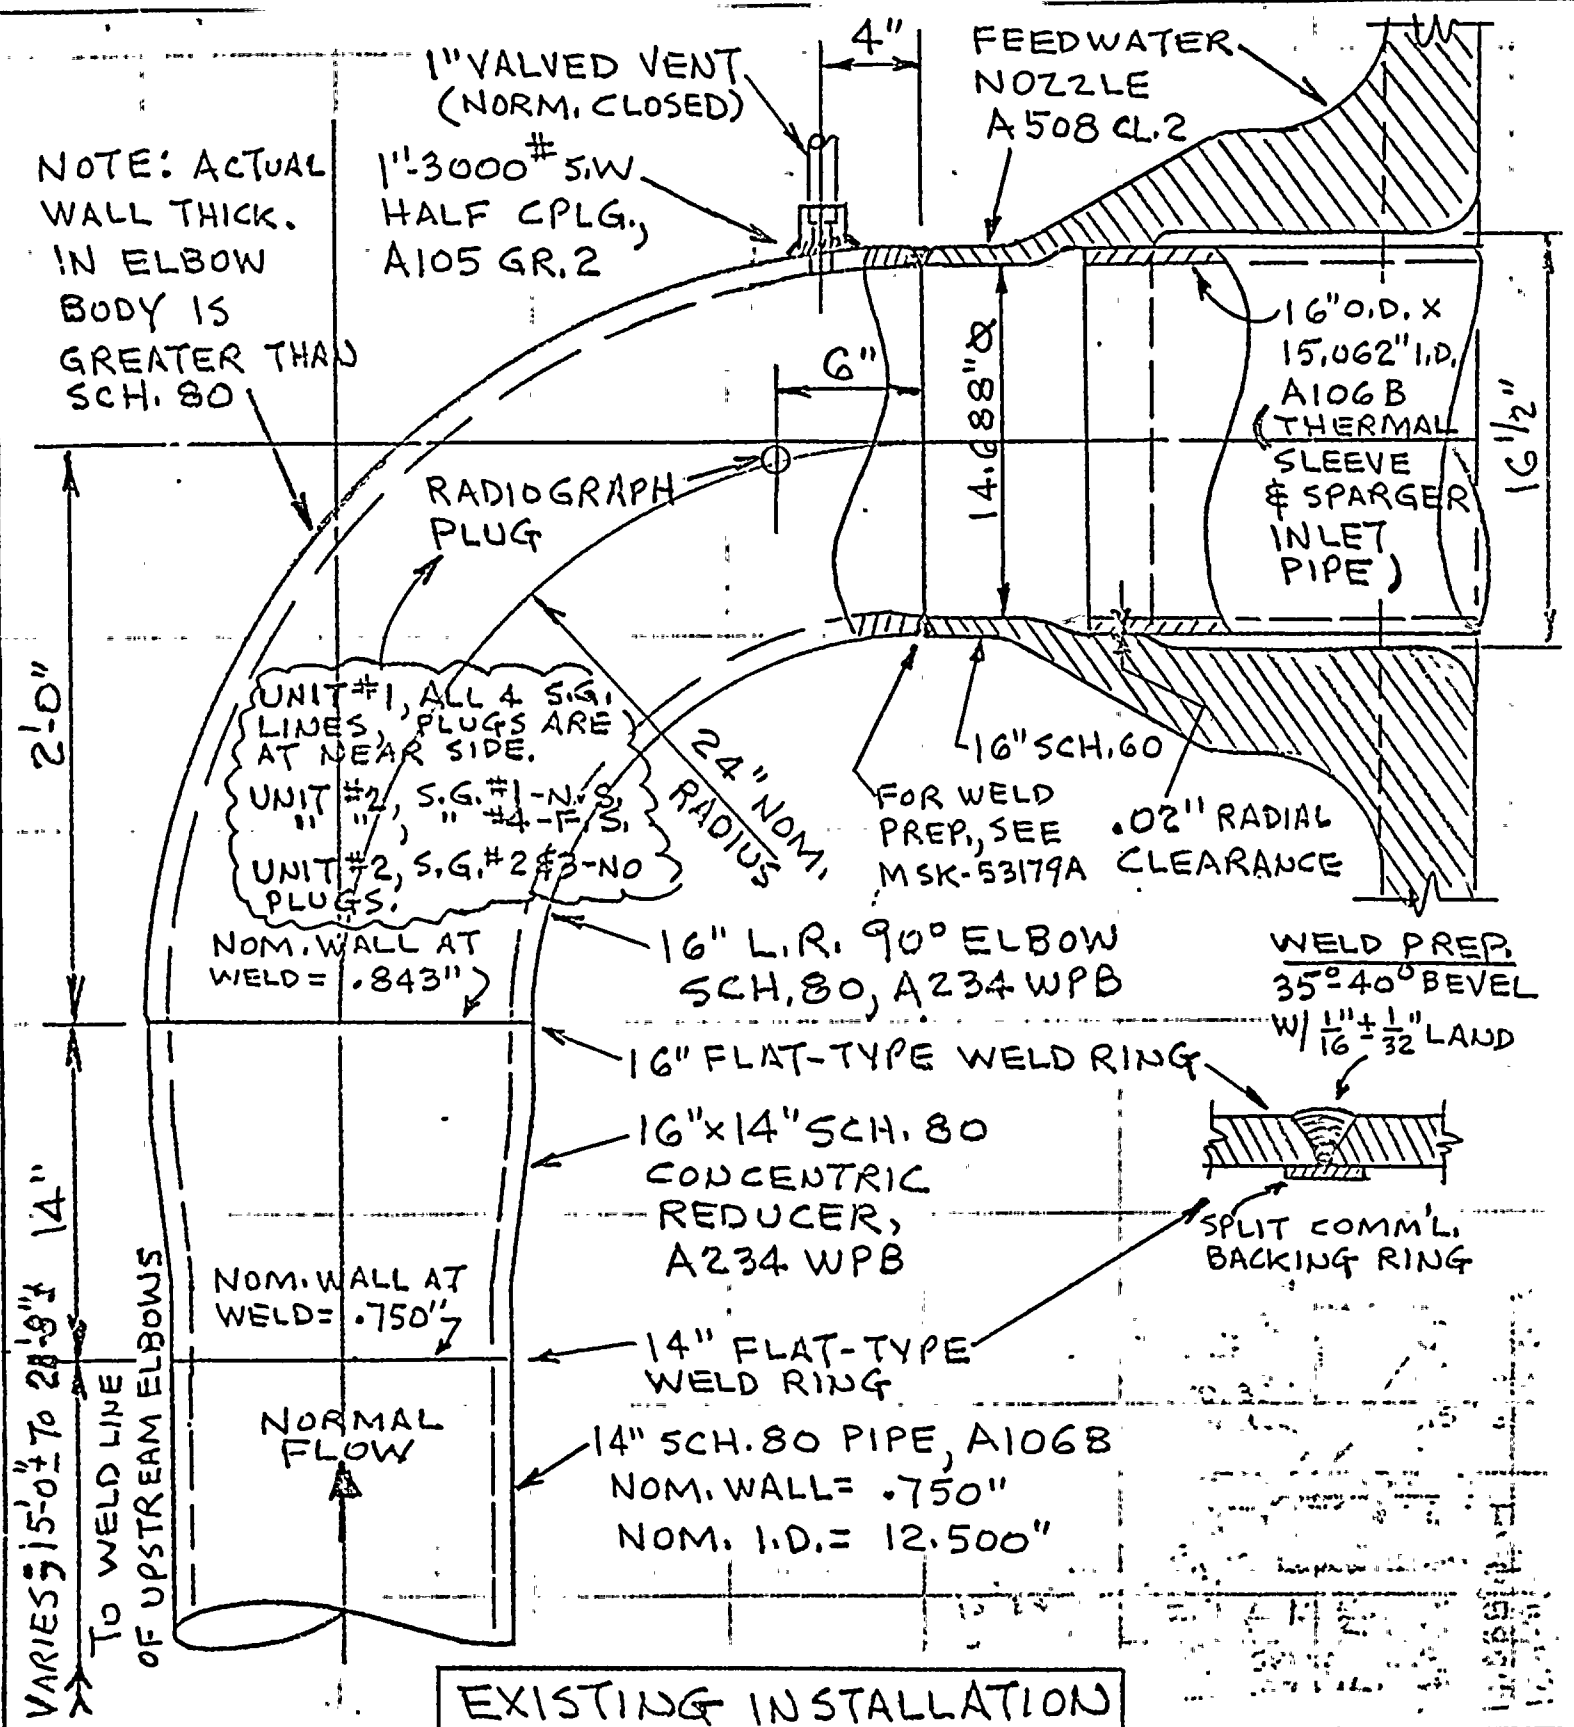
ARRGT. OF FEEDWATER CONN. TO STEAM GEN. NOZZLE

The cracks in the 16-inch feedwater elbows initiated from the inner wall outside of the heat affected zone of the weld at the discontinuity of the weld end preparation counterbore. Through-wall cracks existed in the 16-inch elbows to Steam Generators Nos. 1 and 4 of Unit 2. The most severe through-wall crack occurred in S.G. No. 1 and was $3\frac{1}{2}$ inches in length on the outer surface. Cracks in the other elbows were smaller.

After the feedwater elbows were removed, liquid penetrant examination of the steam generator nozzles was performed. Results of this examination have shown light pitting and intermittent linear indications along the circumference of the counterbore discontinuity on all eight steam generator nozzles. Figure 1 depicts the steam generator nozzle and feedwater elbow in elevation. Figure 2 is a full scale section of the nozzle to the elbow weld.

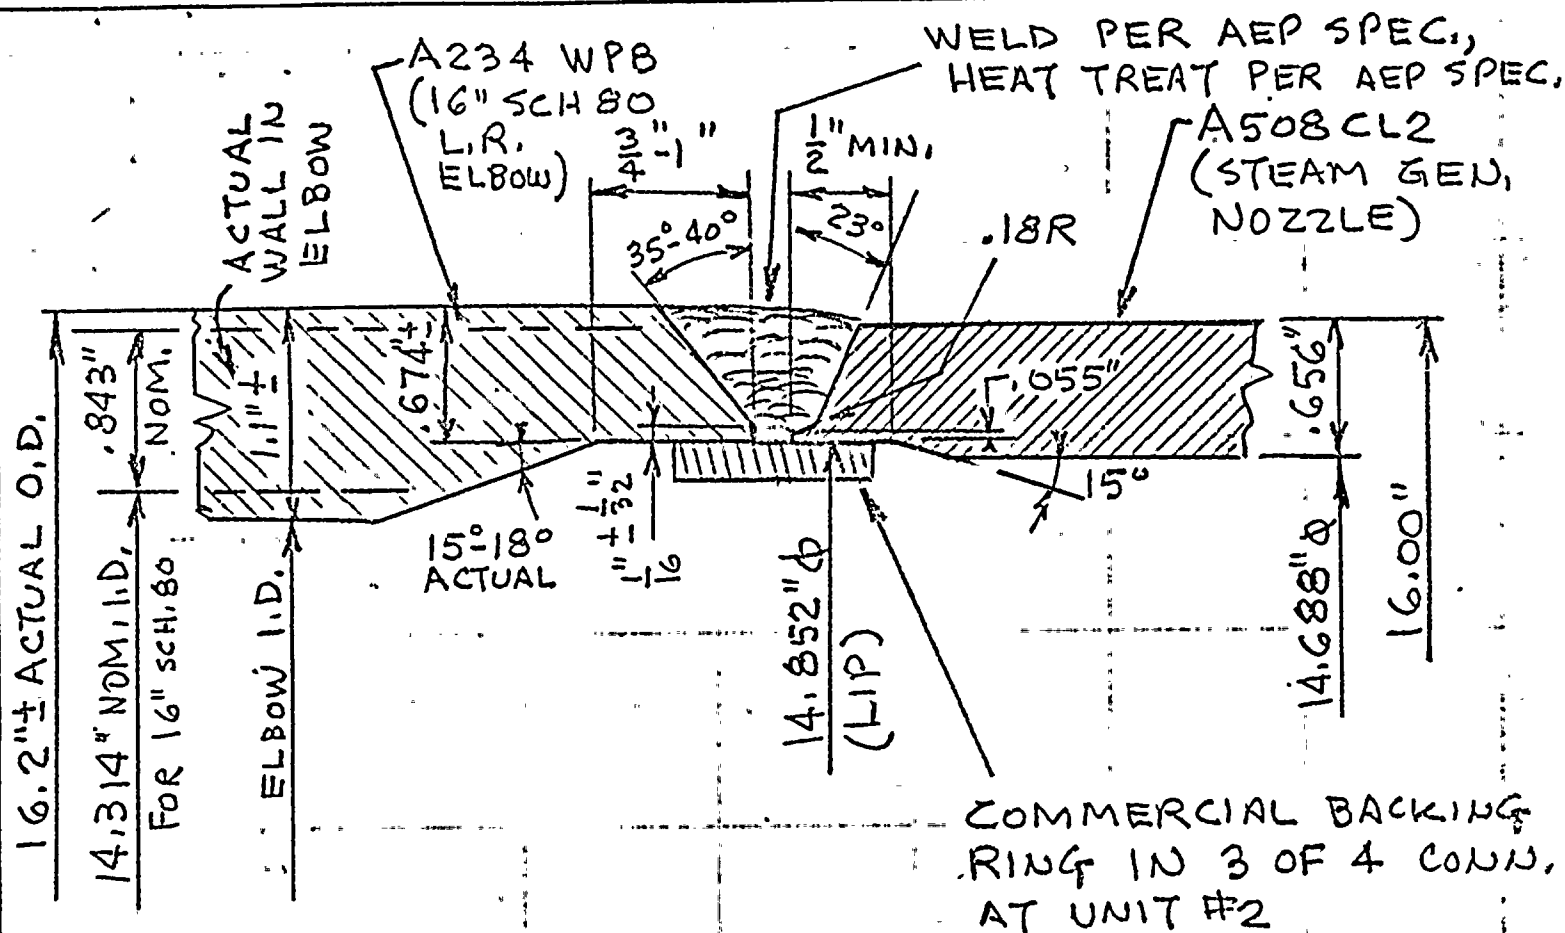
FULL SCALE SECTION OF EXISTING
WELD BETWEEN 16" SCH. 80 L.R. ELBOW IN
 AEP FEEDWATER LINE AND 16" SCH 60 WELD
 CONNECTION OF (W) STEAM GENERATOR

The wall thickness of the 16-inch elbow is approximately 50 percent greater than that of the steam generator nozzle. To compensate for this difference in wall thickness, the weld preparation included machining and beveling a step on the inside of the elbow to match the thickness of the steam generator nozzle at the point of the weld. Stresses concentrated in this thinner section adjacent to the weld and were magnified at the point of discontinuity.

Chicago Service and Westinghouse laboratories reported that the primary crack was at the change in section where the counterbore had been machined on the inside surface as part of the weld end preparation. Both laboratories reported several additional cracks on the inside surface near the primary crack. Both reported oxide in the cracks and pitting corrosion. The primary crack, and adjacent smaller cracks, were not in the weld or heat affected zone, but were about 1/2 inch away at the inside surface.
