Final ASP Program Analysis – Precursor

Accident Sequence Precursor Program – Office of Nuclear Regulatory Research			
Arkansas Nuclear One – Unit 1		Automatic Start of an Emergency Diesel Generator Following a Partial Loss of Offsite Power due to Severe Weather	
Event Date: 04/26/2017	LER: 313-2017-001 IR: 05000313/2017002		CCDP= 1×10 ⁻⁵
Plant Type: Pressurized Water Reactor (PWR); Babcock & Wilcox Two-Loop with a Large, Dry Containment			
Plant Operating Mode (Reactor Power Level): Mode 1 (100% reactor power)			
Analyst: Ian Gifford	Reviewer: Christopher Hunter	Contributors: N/A	Approval Date: 12/06/2017

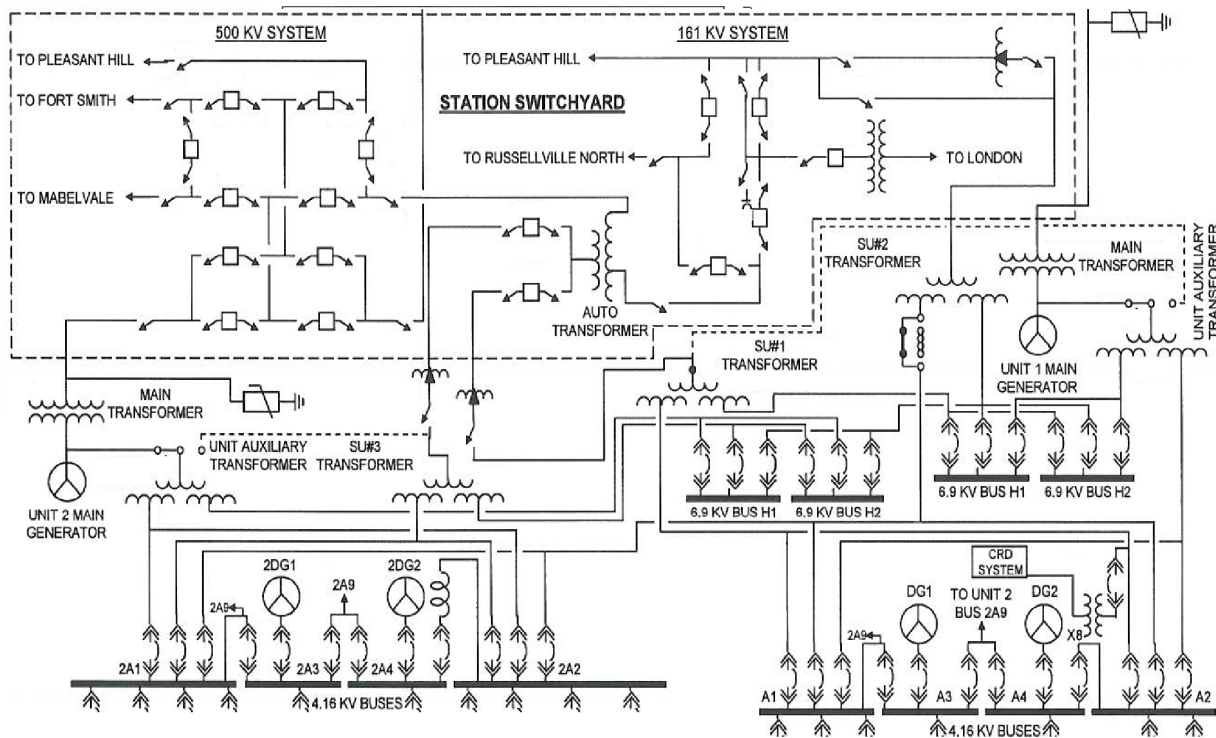
Figure 1. ANO-1 Simplified Electrical Diagram.

Additional Plant Information. During normal operation of ANO-1, station equipment is supplied from the main generator through the UAT. During startup and shutdown conditions, station equipment is supplied from the offsite utility grid through SUT 1 (preferred) or SUT 2 (non-preferred). Following a turbine generator trip, station loads are designed to automatically fast transfer to SUT 1 or SUT 2 without a loss of power to the plant loads. The UAT and SUT 1 are capable of providing power to all four Unit 1, 4.16 kV buses (A1, A2, A3, and A4). Because SUT 2 is shared between both units, it is only aligned to automatically power buses A1 and A3. If all normal and offsite power sources are lost, engineered safety feature (ESF) buses A3 and A4 are powered by their respective EDGs. As a final protection in the event of a station blackout, power to the ESF buses can be provided by the alternate AC diesel generator. A simplified electrical diagram is shown in Figure 1.

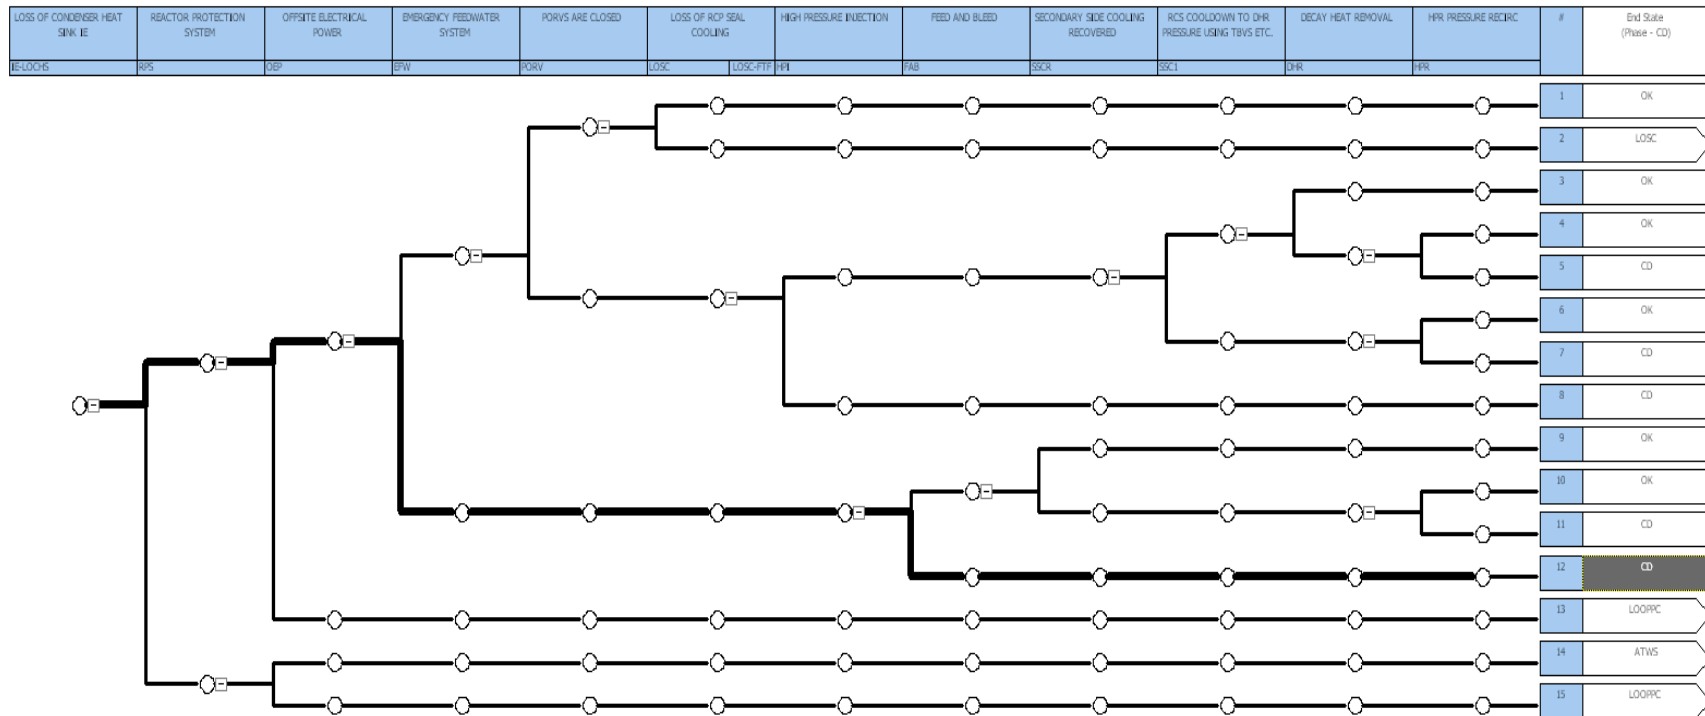
Figure A-1. Arkansas Nuclear One Loss of Condenser Heat Sink Event Tree

Dominant Sequence. The dominant accident sequence is loss of condenser heat sink sequence 12 (CCDP = 9.4×10^{-6}) that contributes approximately 94 percent of the total internal events CCDP. [Figure A-1](#) in Appendix A illustrates this sequence. The sequences that contribute to at least 1 percent of the total internal events CCDP are provided in the following table:

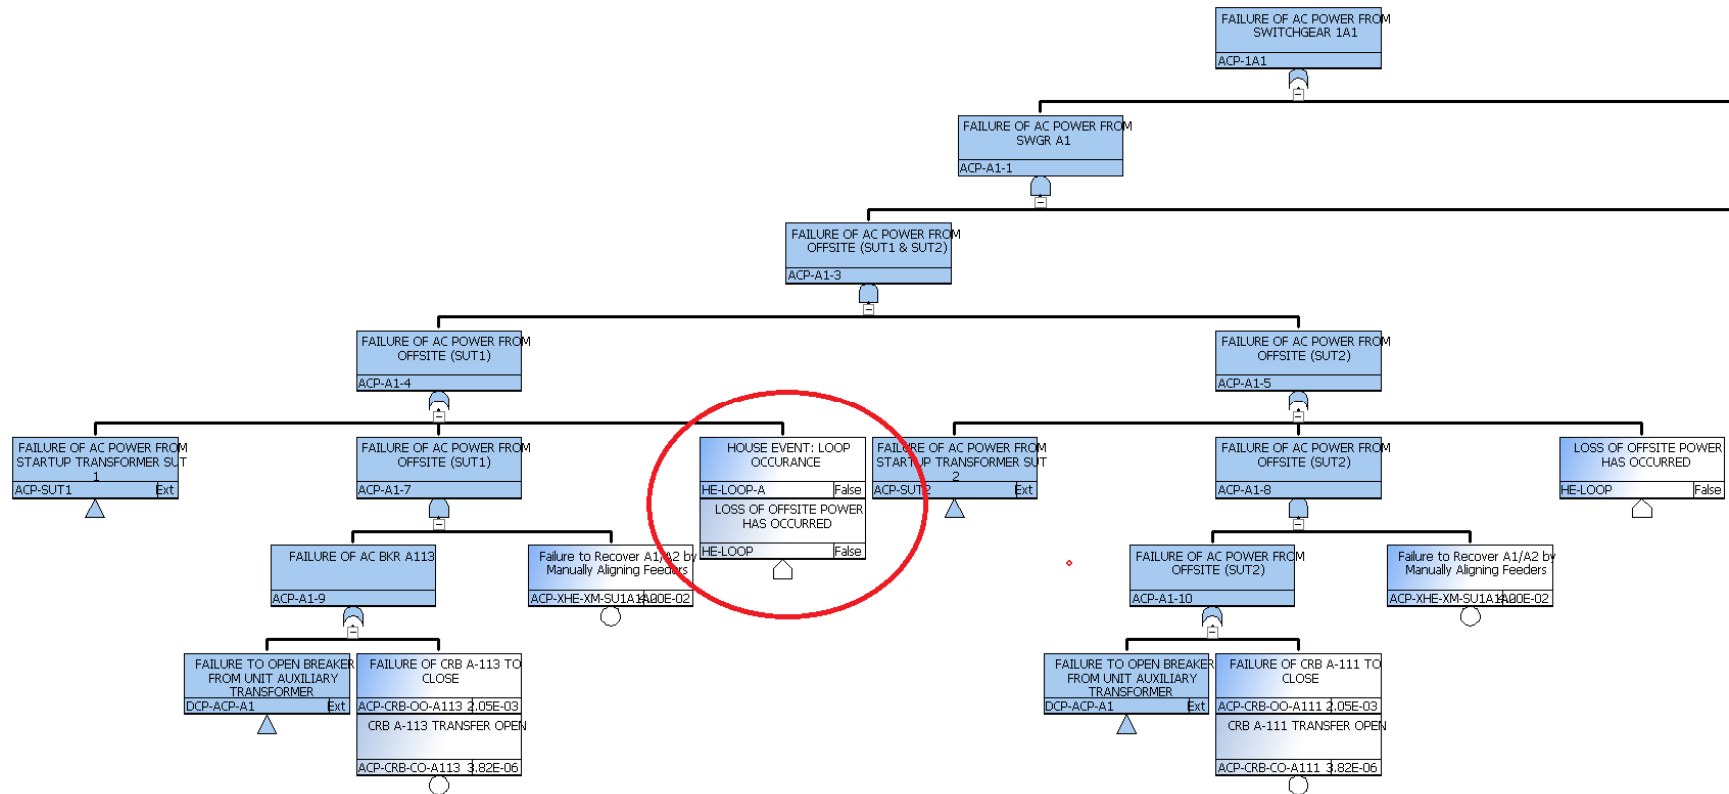
Figure B-1. Modified ACP-1A1 Fault Tree

- In the fault tree ACP-1A1 (*failure of AC power from the switchgear 1A1*), house event HE-LOOP-A (*house event: LOOP occurrence*) was inserted under the OR gate ACP-A1-4 (*failure of AC power from offsite (SUT 1)*). This modification is shown in [Figure B-1](#).

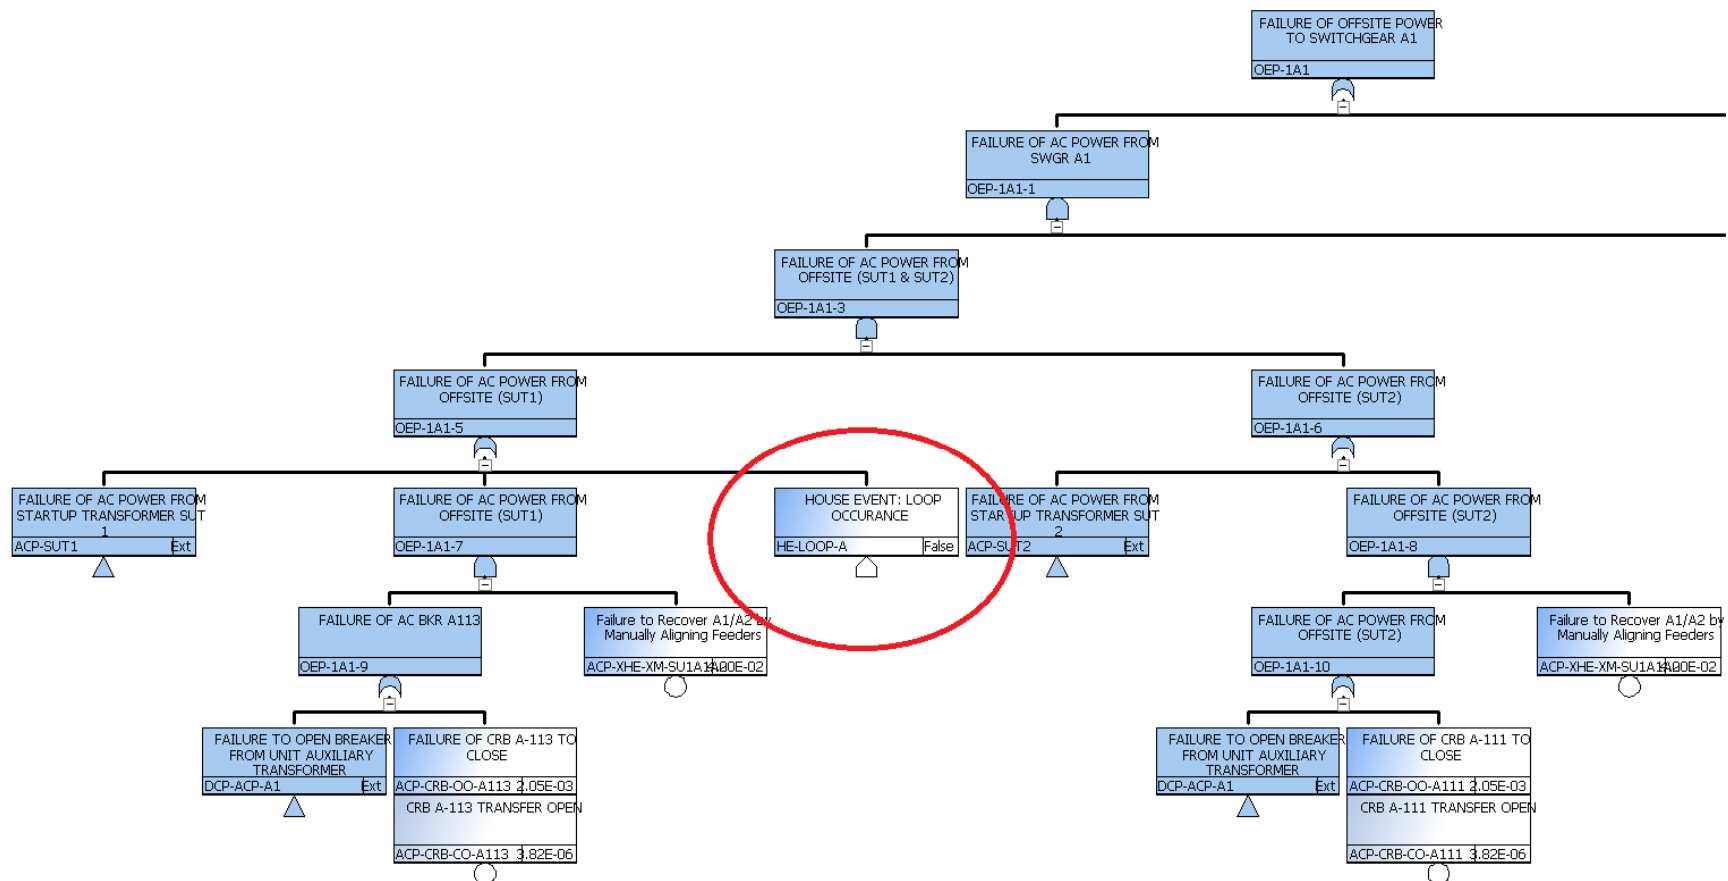
Figure B-2. Modified OEP-1A1 Fault Tree

- In the fault tree OEP-1A1 (*failure of offsite power to switchgear A1*), house event HE-LOOP-A was inserted under the OR gate OEP-1A1-5 (*failure of AC power from offsite (SUT 1)*). This modification is shown in [Figure B-2](#).

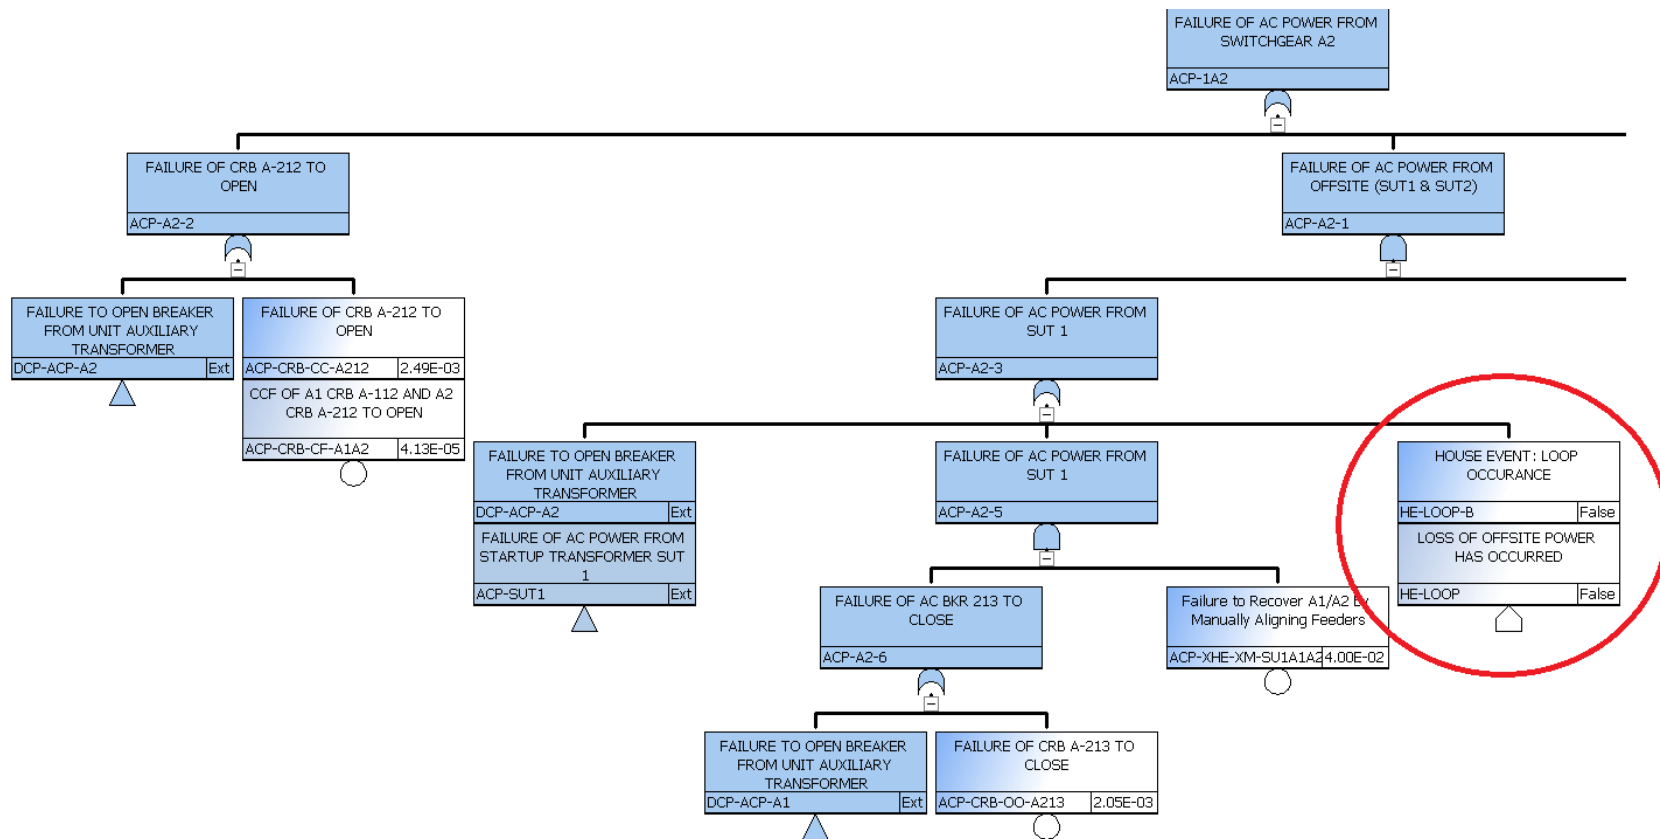
Figure B-3. Modified ACP-1A2 Fault Tree

- In the fault tree ACP-1A2 (*failure of AC power from switchgear A2*), house event HE-LOOP-B (*house event: LOOP occurrence*) was inserted under OR gate ACP-A2-3 (*failure of AC power from SUT 1*). This modification is shown in [Figure B-3](#).

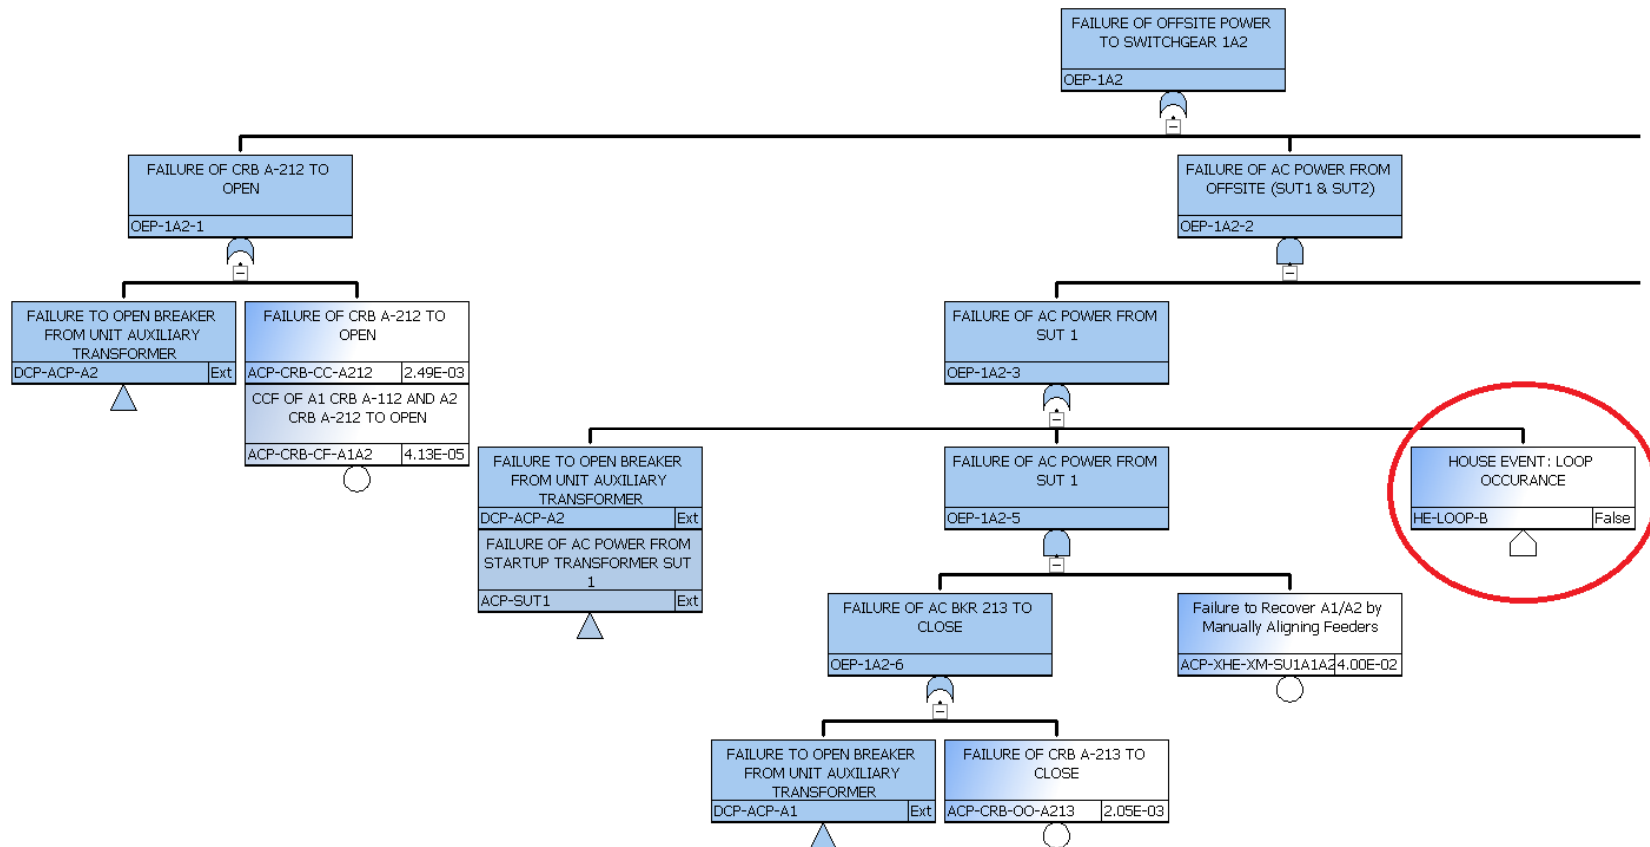
Figure B-4. Modified OEP-1A2 Fault Tree

- In the fault tree OEP-1A2 (*failure of offsite power to switchgear A2*), house event HE-LOOP-B was inserted under the OR gate OEP-1A2-3 (*failure of AC power from SUT 1*). This modification is shown in [Figure B-4](#).
