STEAM GENERATOR REPAIR REPORT

DONALD C. COOK NUCLEAR PLANT UNIT NO. 2

Donald C. Cook Nuclear Plant  
Unit No. 2

U.S. Nuclear Regulatory Commission  
Docket No. 50-316  
License No. DPR-74

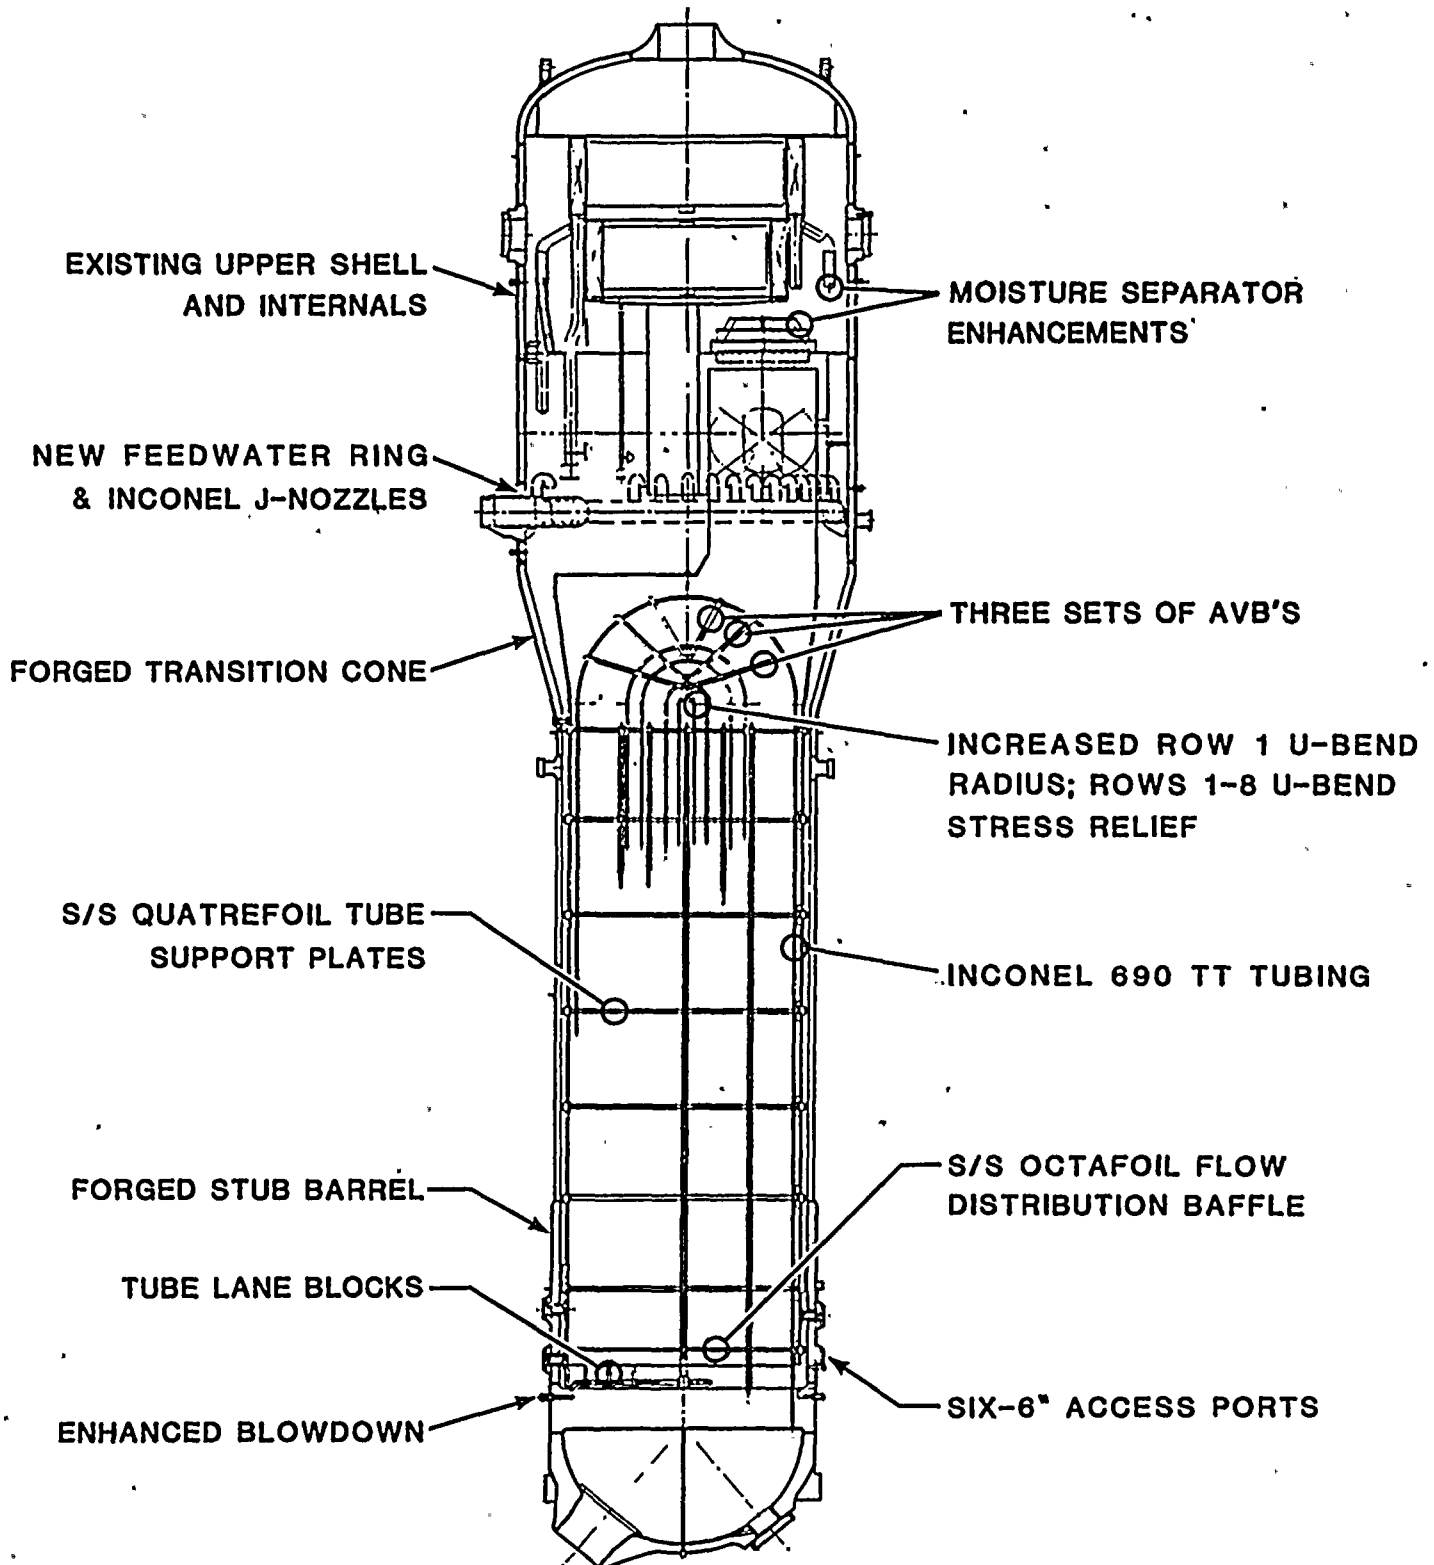
FIGURE 2.2-1

The replacement steam generator lower assemblies are designed and fabricated to be physical duplicates of the original lower assemblies. All major dimensions and orientation angles for both the existing and replacement components are identical. Dry weight, wet weight, and center of gravity will remain essentially the same. Therefore, changes to the existing supports and other plant components will not be necessary. Comparison of the key items such as outer dimensions and nozzle orientations are provided in Table 2.2-1. Sketches of the repaired steam generator are shown in Figures 2.2-1 and 2.2-2.

## REPAIRED STEAM GENERATOR GENERAL ARRANGEMENT

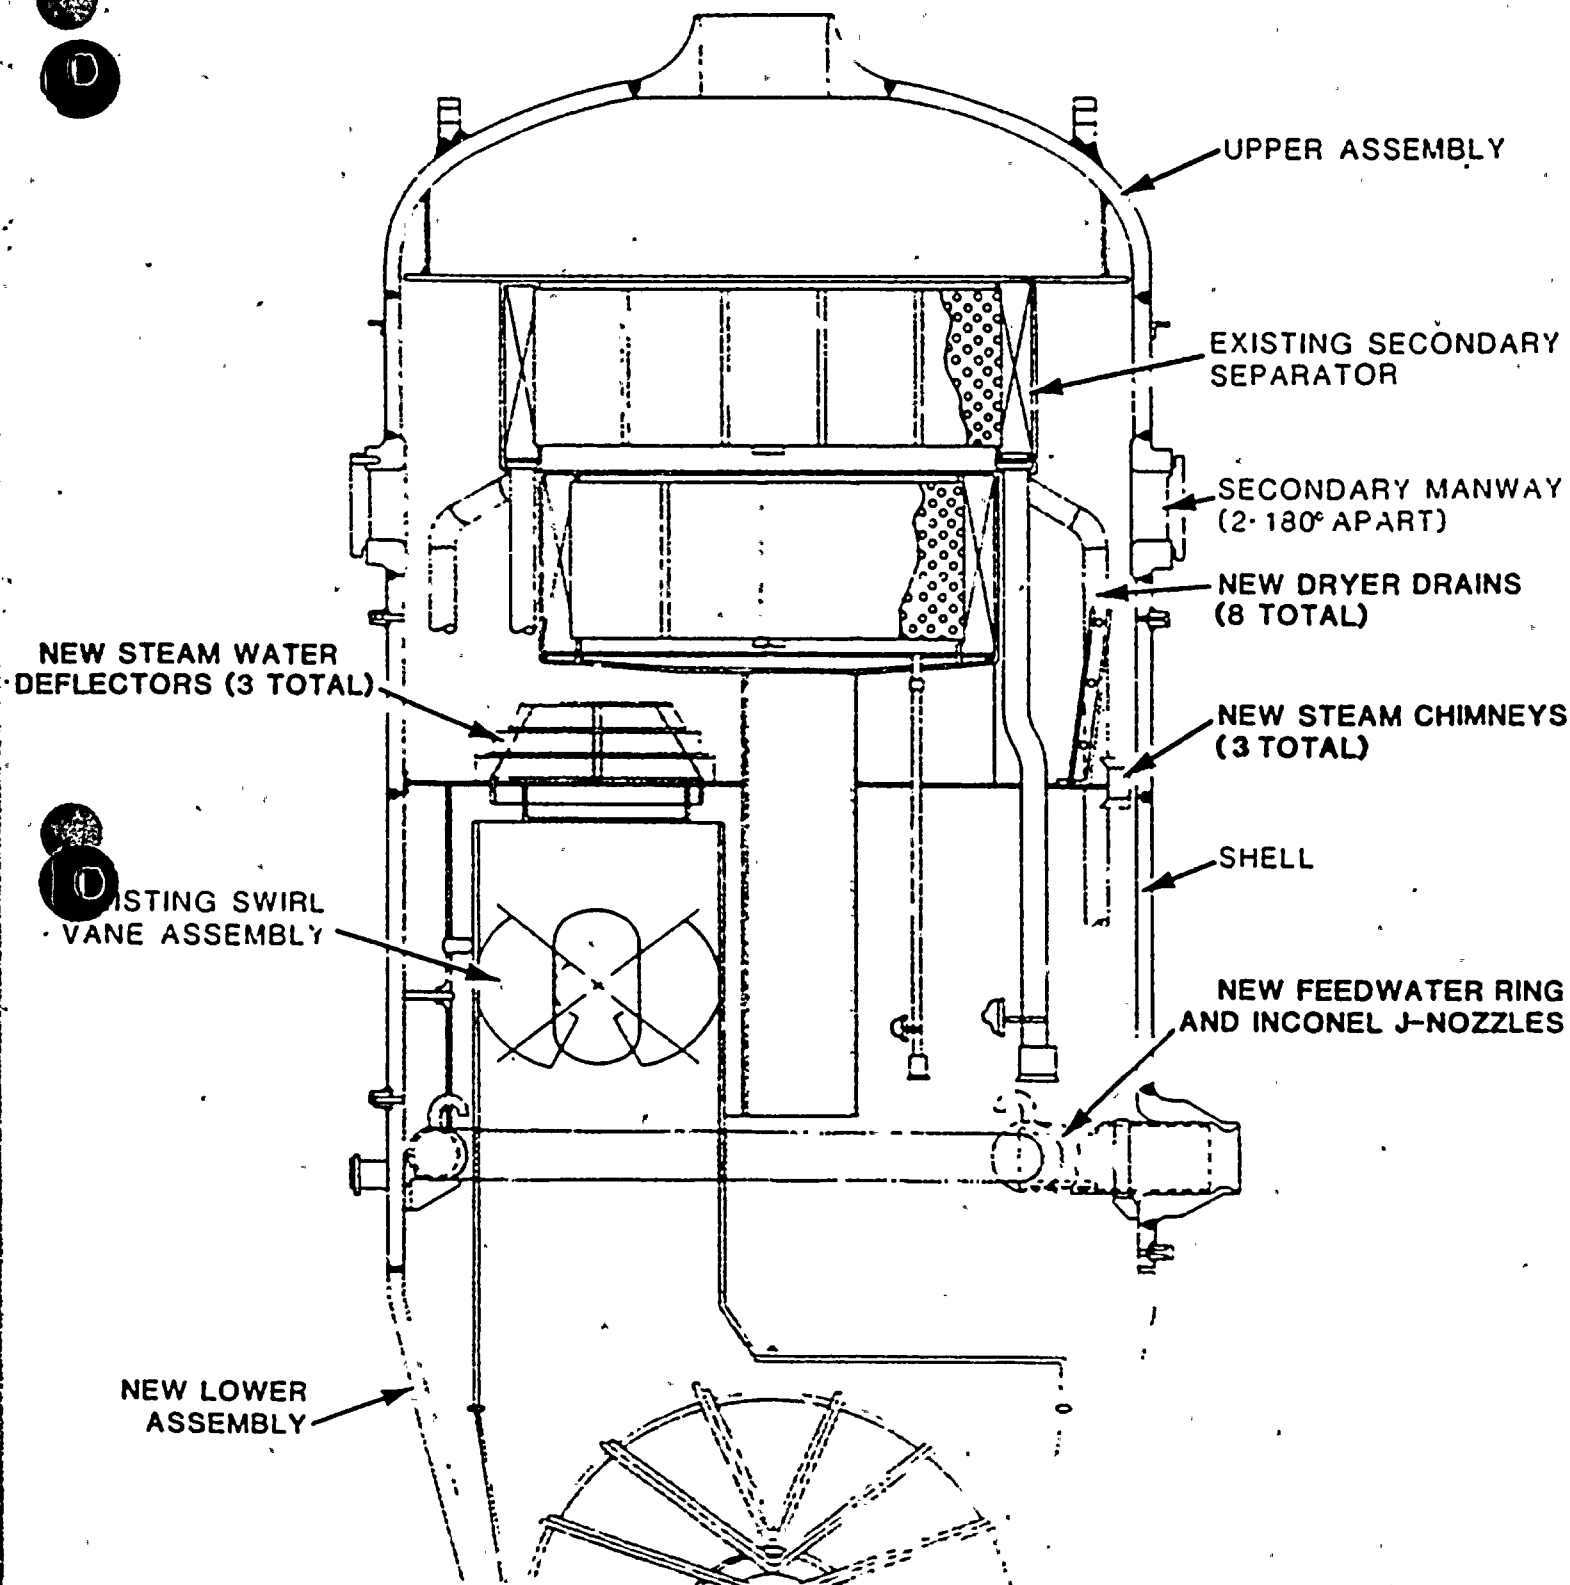
# FIGURE 2.2-2 MODIFICATIONS TO UPPER ASSEMBLY INTERNALS

Only the lower assembly, up to and including the transition cone, will actually be replaced. The upper assembly, which includes the steam separating equipment, will be reused after refurbishing with a new feedring with Inconel 600 J-nozzles and upgrading the separators to enhance performance. Refurbishment of the upper assembly will be performed in the field.
