LICENSEE EVENT REPORT (LER)

FACILITY NAME (1) D. C. COOK NUCLEAR PLANT, UNIT 2										DOCKET NUMBER (2) 0 5 0 0 0 3 1 6				PAGE (3) 1 OF 0 6																	
TITLE (4) ICE BUILDUP IN ICE CONDENSER FLOW PASSAGES DUE TO SUBLIMATION																															
EVENT DATE (5)			LER NUMBER (6)				REPORT DATE (7)			OTHER FACILITIES INVOLVED (8)																					
MONTH	DAY	YEAR	YEAR	SEQUENTIAL NUMBER	REVISION NUMBER	MONTH	DAY	YEAR	FACILITY NAMES				DOCKET NUMBER(S)																		
0	3	0	5	8	7	8	7	—	0	0	2	—	0	0	0	4	0	3	8	7					0	5	0	0	0		
OPERATING MODE (9) 5			THIS REPORT IS SUBMITTED PURSUANT TO THE REQUIREMENTS OF 10 CFR §: (Check one or more of the following) (11)																												
POWER LEVEL (10) 0 0 0			20.402(b)				20.405(c)				50.73(a)(2)(iv)				73.71(b)

Between March 5 and 6, 1987, with Unit 2 in Mode 5 (Cold Shutdown), flow passage inspections of the ice condenser revealed frost and ice buildup on the lattice frames of greater than 3/8 inch in eighteen flow passages in two of the twenty-four ice condenser bays. Subsequent investigation indicated that there was also frost and ice formation between the walls and ice baskets adjacent to the walls.

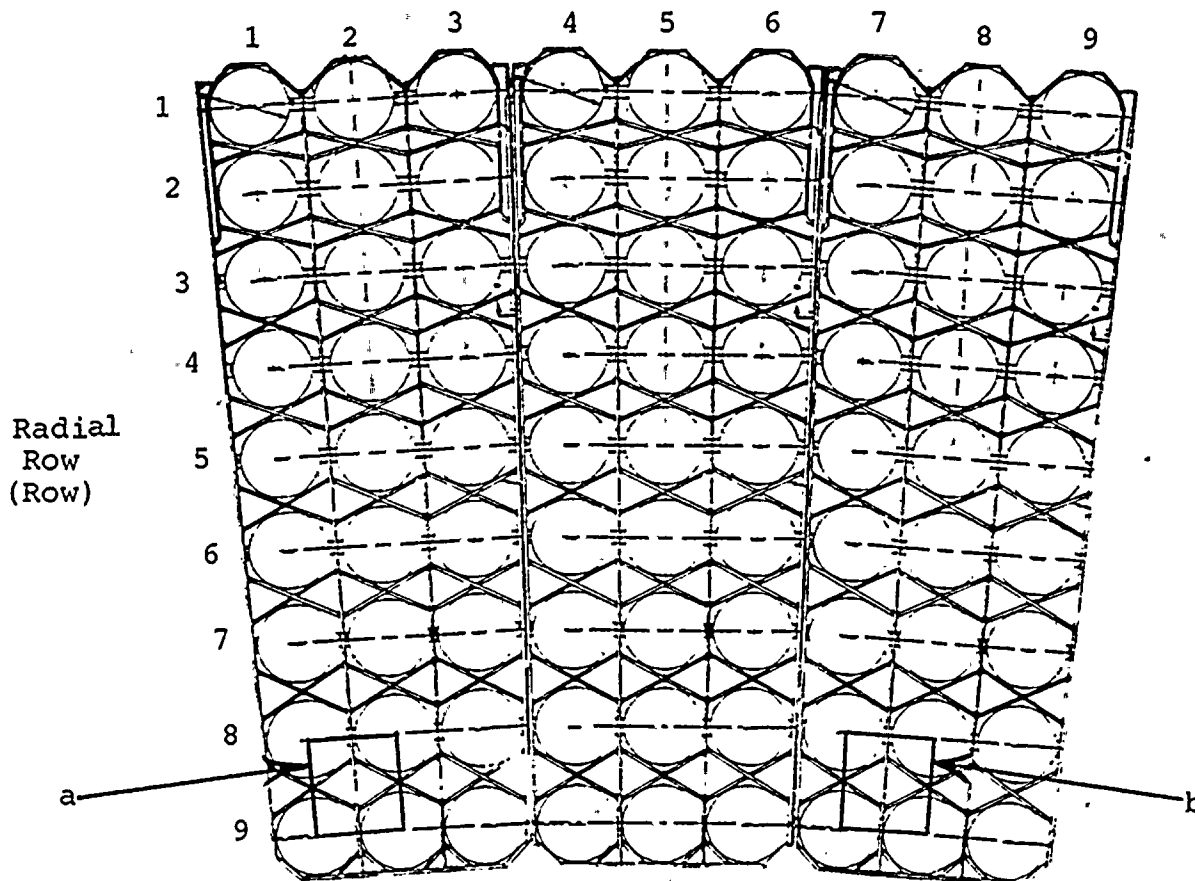
ATTACHMENT 1

Bay 1 (of 24 total)

The flowpaths indicated by boxed areas a and b had ice buildup of approximately 1/2 inch on top of the framework with a lip of ice over the framework edge approximately 1/2 inch down the framework. This affected framework down to the third cruciform (cruciforms are installed every 6 feet within the 48 foot ice basket).

The corrective action was to defrost the ice condenser, including manual scraping of the ice, to remove the accessible frost and ice buildup. Another surveillance was then successfully performed.

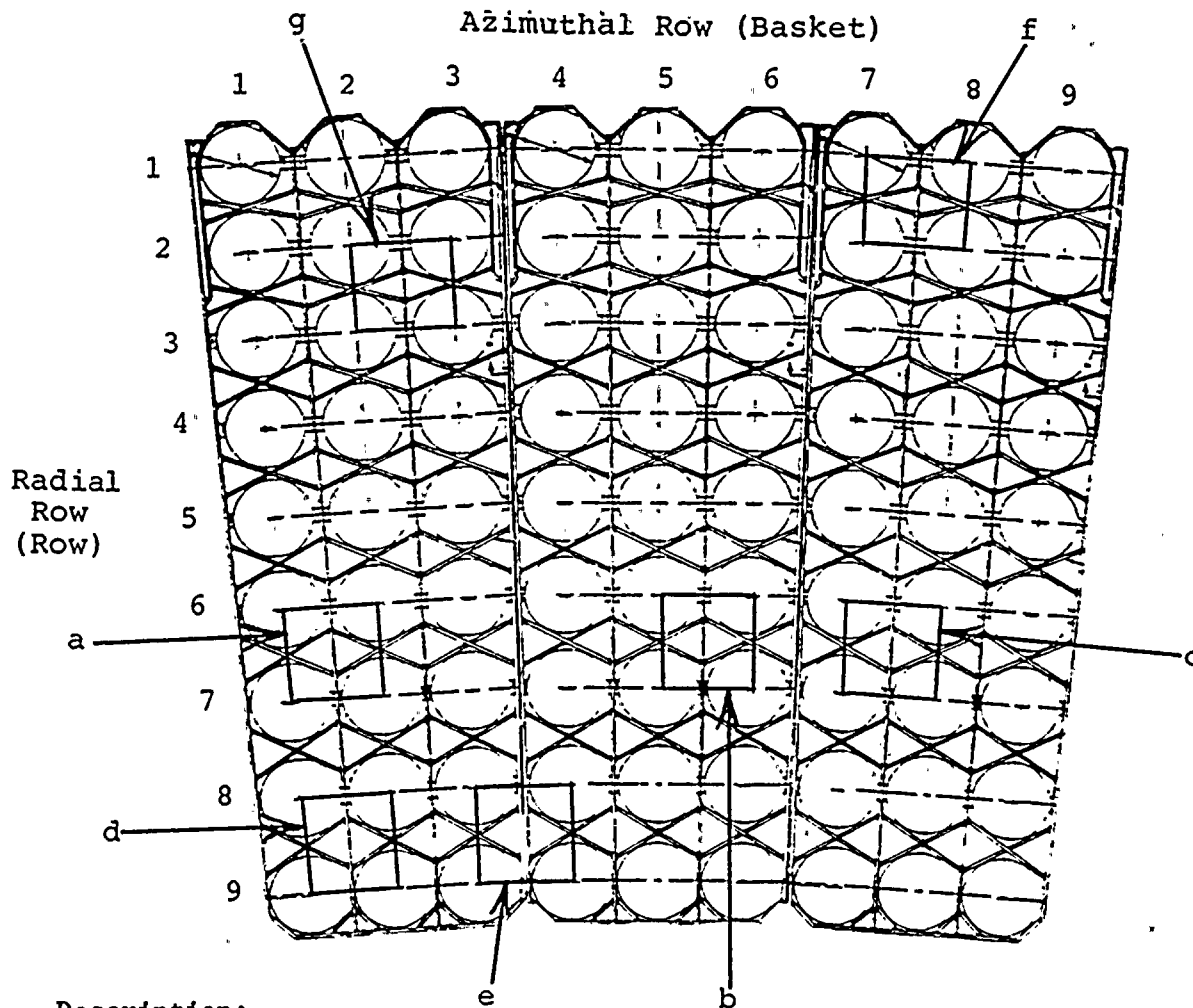
ATTACHMENT 2

Bay 11 (of 24 total)

The flowpaths indicated by the boxed areas a, b and c had heavy frost buildup of approximately 3/4 inch on the top and sides of the framework. This affected the top framework only.

The flowpaths indicated by the boxed area d had ice buildup of approximately 3/4 inch on top of the framework with a lip of ice over the edge of the framework approximately 3/4 inch thick extending 1/2 inch down the framework. This affected framework down to the third cruciform.

The flowpaths indicated by the boxed areas e, f and g had ice build as described for boxed area d, but only approximately 1/2 inch thick. Areas e and f were affected down to the third cruciform. Area g was affected down to the second cruciform.

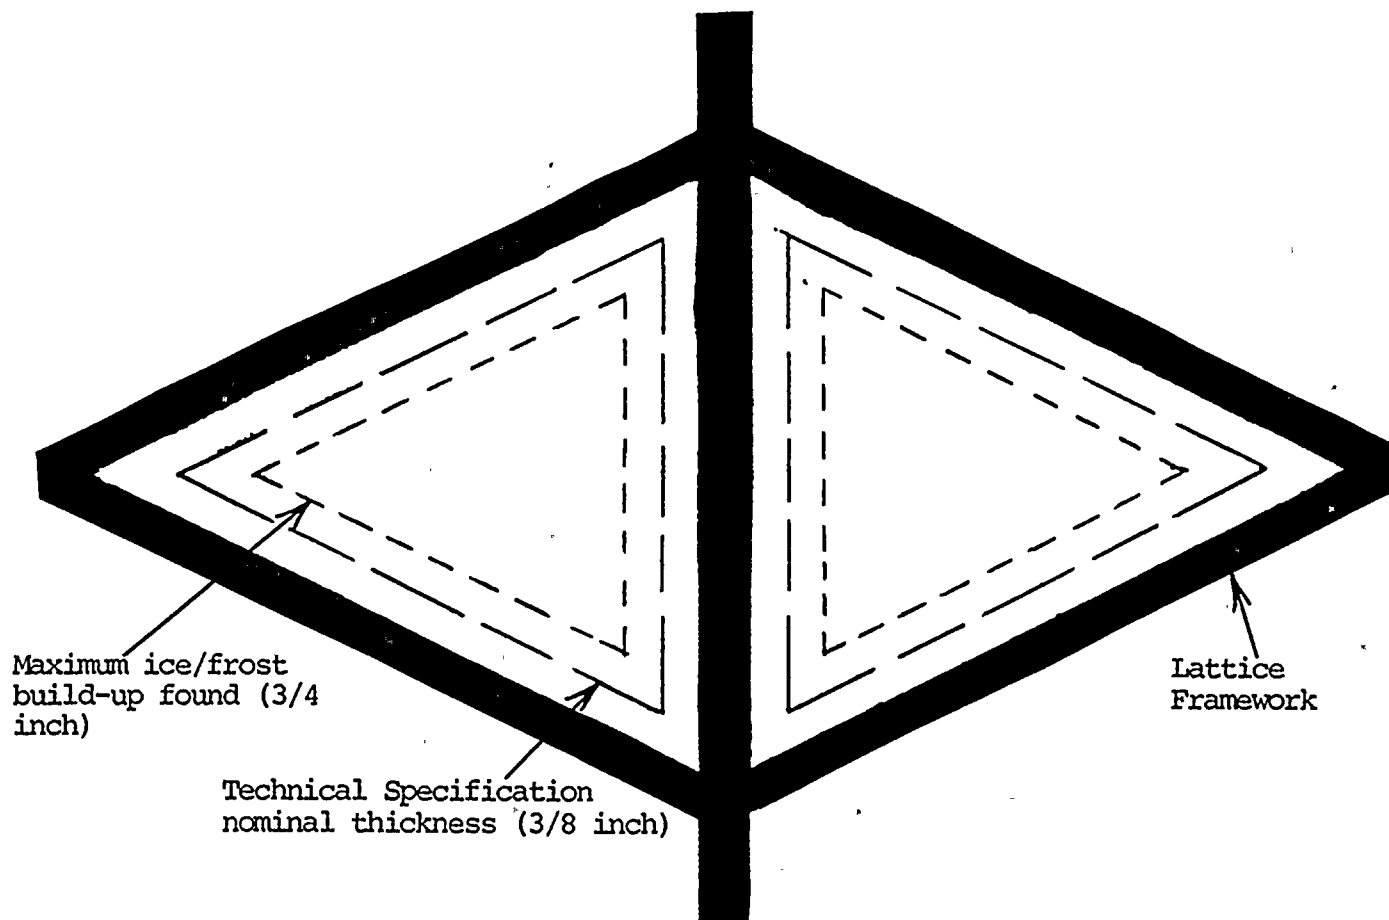
ATTACHMENT 3

Representative Diagram of Ice/Frost Build-up in Two Flow Passages
