SUBJECT: LER 86-026-00: on 860912, determined that valve alignment used placed unit in unanalyzed condition per LOCA analysis in FSAR. Caused by misunderstanding of Tech Spec 3.5.2 re ECCS operability. Administrative controls created. W/870407 ltr.

LICENSEE EVENT REPORT (LER)

FACILITY NAME (1) D. C. Cook Nuclear Plant - Unit Two										DOCKET NUMBER (2) 0 5 0 0 0 3 1 6 1 OF 0 5						PAGE (3)										
TITLE (4) Lack of Specificity in Technical Specification Requirements Resulted In Operation With Unanalyzed Emergency Core Cooling System Configuration																										
EVENT DATE (5)			LER NUMBER (6)				REPORT DATE (7)			OTHER FACILITIES INVOLVED (8)																
MONTH	DAY	YEAR	YEAR		SEQUENTIAL NUMBER		REVISION NUMBER	MONTH	DAY	YEAR	FACILITY NAMES				DOCKET NUMBER(S)											
0	9	0	4	8	6	8	6	0	2	6	0	1	0	4	0	7	8	7					0 5 0 0 0			
OPERATING MODE (9)			THIS REPORT IS SUBMITTED PURSUANT TO THE REQUIREMENTS OF 10 CFR §: (Check one or more of the following) (11)																							
POWER LEVEL (10)			20.402(b)				20.405(c)				50.73(a)(2)(iv)				73.71(b)											
0 8 0			20.405(a)(1)(i)				50.36(c)(1)				50.73(a)(2)(v)				73.71(c)

D. C. Cook Nuclear Plant - Unit Two

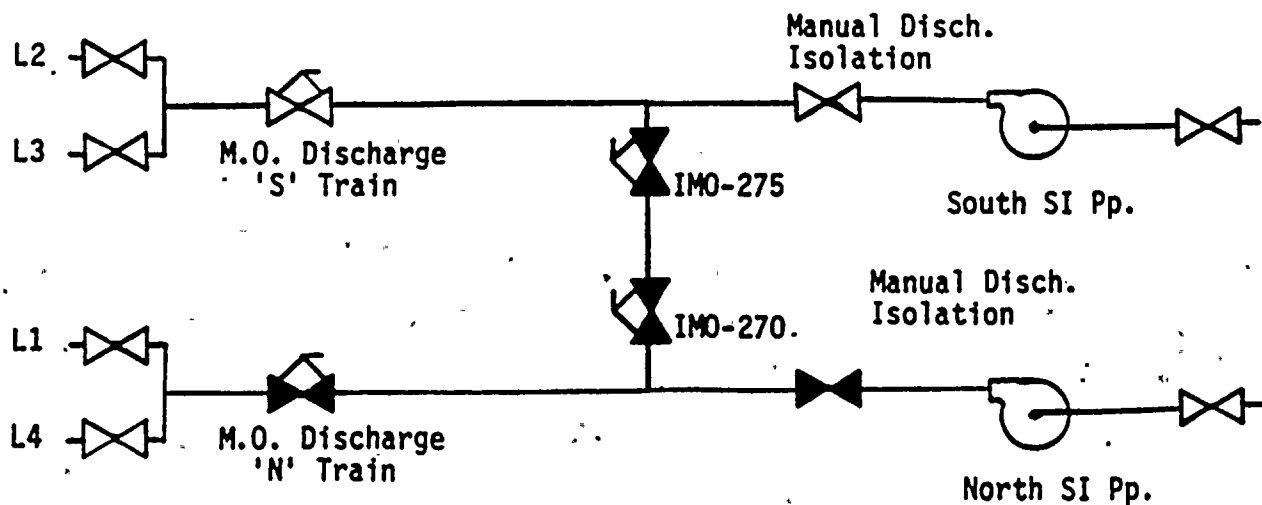
The Safety Injection system outage began on September 4, 1986, at 0645 hours and lasted for a period of 18 hours and 53 minutes. At this time Unit Two was in Mode 1 (Power Operation) operating at 80 percent reactor thermal power. The purpose of this outage was to repair a body to bonnet leak on IMO-270, one of the two Safety Injection discharge cross-tie valves (EIIS-MOV). This required the isolation of both the motor operated (EIIS-MOV) and manual discharge isolation valves (EIIS-ISV) for the North Safety Injection Pump (EIIS-BQP) and the remaining discharge cross-tie (IMO-275). As a result the injection points to two of the four loops was lost.

As a result of the isolation boundary established for required maintenance being performed on one of the Safety Injection system cross-tie valves, the North Safety Injection Pump was not available for service and the South Safety Injection Pump was only capable of delivering flow to two, rather than four injection points. This condition lasted for approximately 19 hours while the valve was being repaired.
