SUBJECT: LER 86-021-01: on 860925, RHR sys may have been in analyzed configuration re LOCA analysis. Caused by misunderstanding of Tech Spec 3.5.2. Caution tags placed on safety injection & RHR sys to prevent isolation. W/870407 ltr.

LICENSEE EVENT REPORT (LER)

FACILITY NAME (1) D. C. Cook Nuclear Plant, Unit 1										DOCKET NUMBER (2) 0 5 0 0 0 3 1 1 5					PAGE (3) 1 OF 0 7		
TITLE (4) Lack of Specificity in Technical Specification Requirements Resulted in Operation With Unanalyzed Emergency Core Cooling System Configuration (Residual Heat Removal)																	
EVENT DATE (5)			LER NUMBER (6)				REPORT DATE (7)			OTHER FACILITIES INVOLVED (8)							
MONTH	DAY	YEAR	YEAR	SEQUENTIAL NUMBER	REVISION NUMBER	MONTH	DAY	YEAR	FACILITY NAMES				DOCKET NUMBER(S)				
0	9	25	86	86	021	0	1	04	07	87	D. C. Cook, Unit 2				0 5 0 0 0 3 1 1 6		
OPERATING MODE (9) 1			THIS REPORT IS SUBMITTED PURSUANT TO THE REQUIREMENTS OF 10 CFR §: (Check one or more of the following) (11)														
POWER LEVEL (10) 0 9 0		20.402(b)				20.405(c)				50.73(a)(2)(iv)				73.71(b)

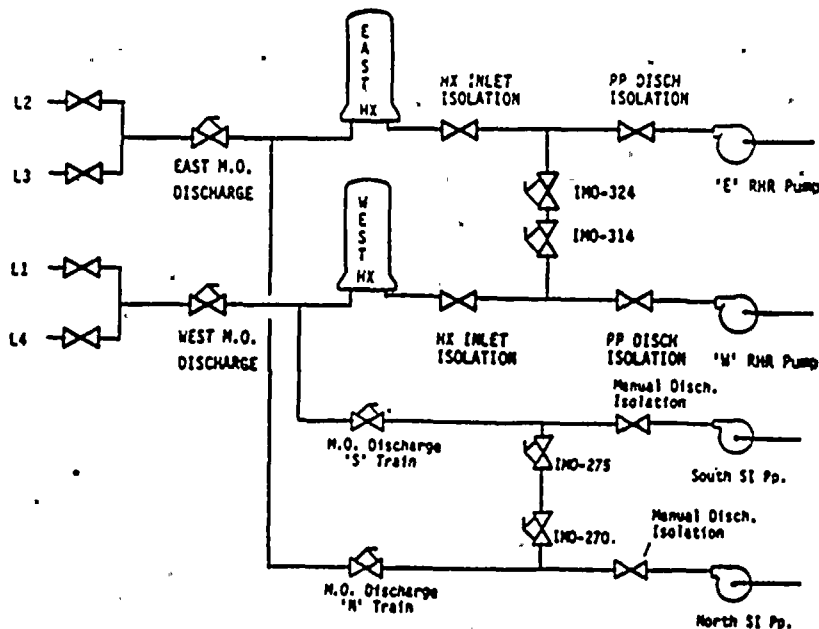
If a single RHR pump (EIIS-BPP) were to fail, these flow paths are assured by maintaining the motor-operated valves IMO-314 and IMO-324 in the cross-tie between two pumps in the open position. An internal investigation revealed that past surveillance and maintenance valve configurations have resulted in injection paths available to only two of the four cold legs.

In researching past surveillance practices, we determined that both safety injection (SI) (EIIS-BQ) and RHR cross-ties have been closed several times to test a complete subsystem simultaneously. It was later determined that the simultaneous testing of an entire subsystem was not necessary. The procedures were revised in April 1985 to discontinue the simultaneous testing. Subsequent to the procedure revision, there were tests performed in which only one cross-tie (Either RHR or SI but not both) was closed. (Drawing on page 3).

- 1) Administrative controls, in the form of caution tags, were placed on the safety injection and residual heat removal systems in both units to prevent isolation of injection points.
- 2) An Operations Department memo, dated October 3, 1986, was issued to identify the affected valves.
