INDIANA & MICHIGAN ELECTRIC COMPANY
DONALD C. COOK NUCLEAR PLANT UNIT 2

STEAM GENERATOR TUBE INTEGRITY - APRIL 1987
An Assessment of the Next Operating Interval Length
Attachment 1 to AEP:NRC:0936J

American Electric Power Service Corporation
One Riverside Plaza
Columbus, Ohio 43216

May 18, 1987

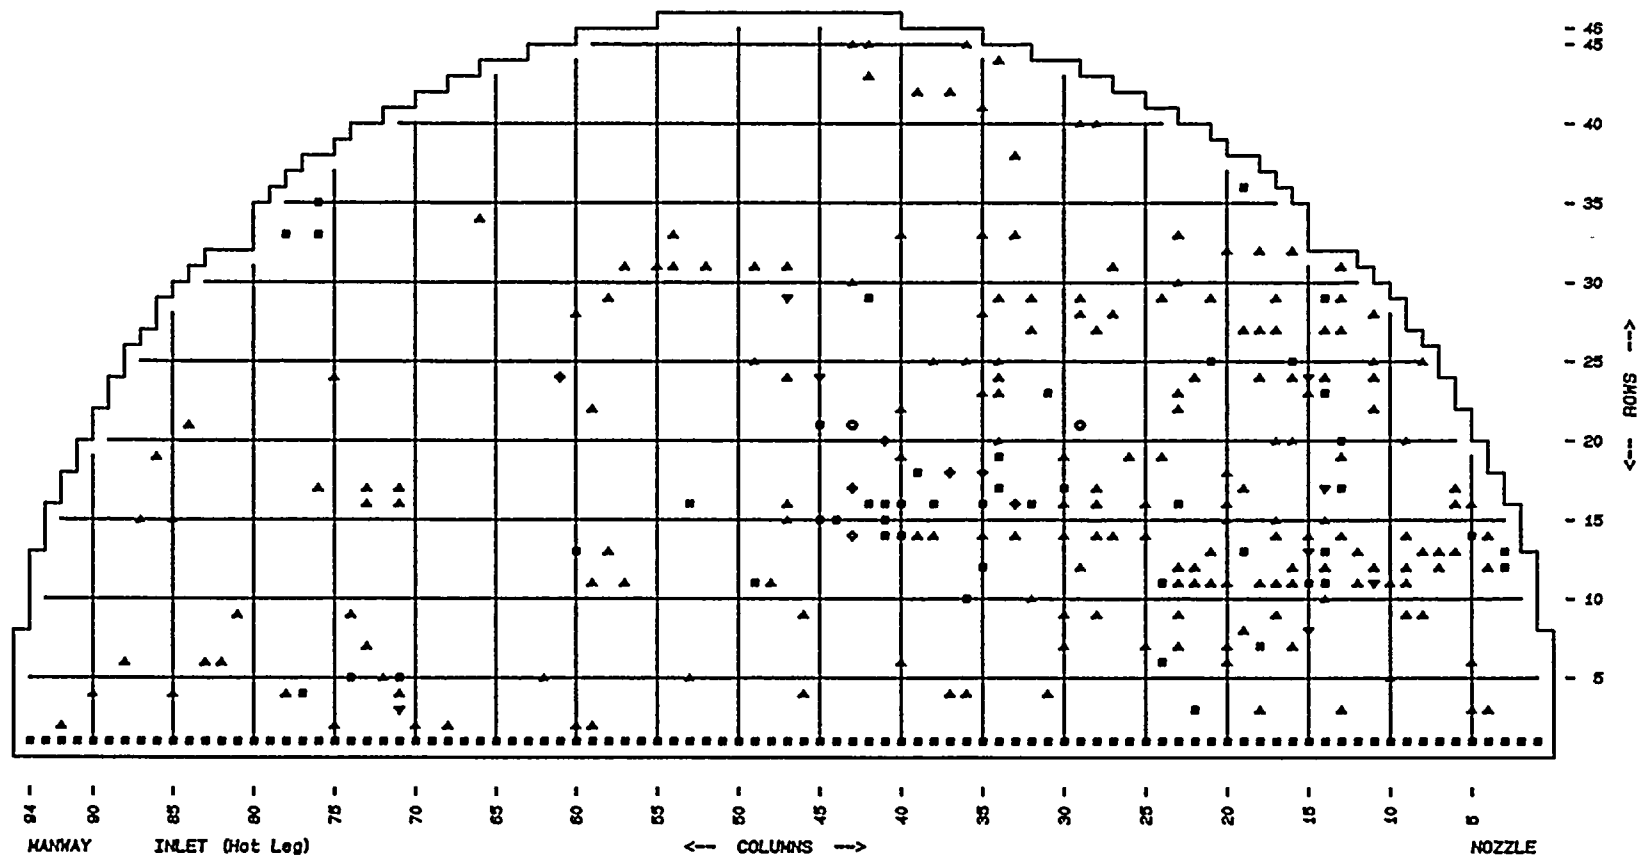
Figure 1

Figures 1, 2, 3, and 4 are tubesheet maps for each Cook 2 steam generator showing the location and extent of wall degradation in the steam generator tubing. Indications plotted are those contained in Table 1-A.

EC INSPECTION RESULTS - MARCH 1987

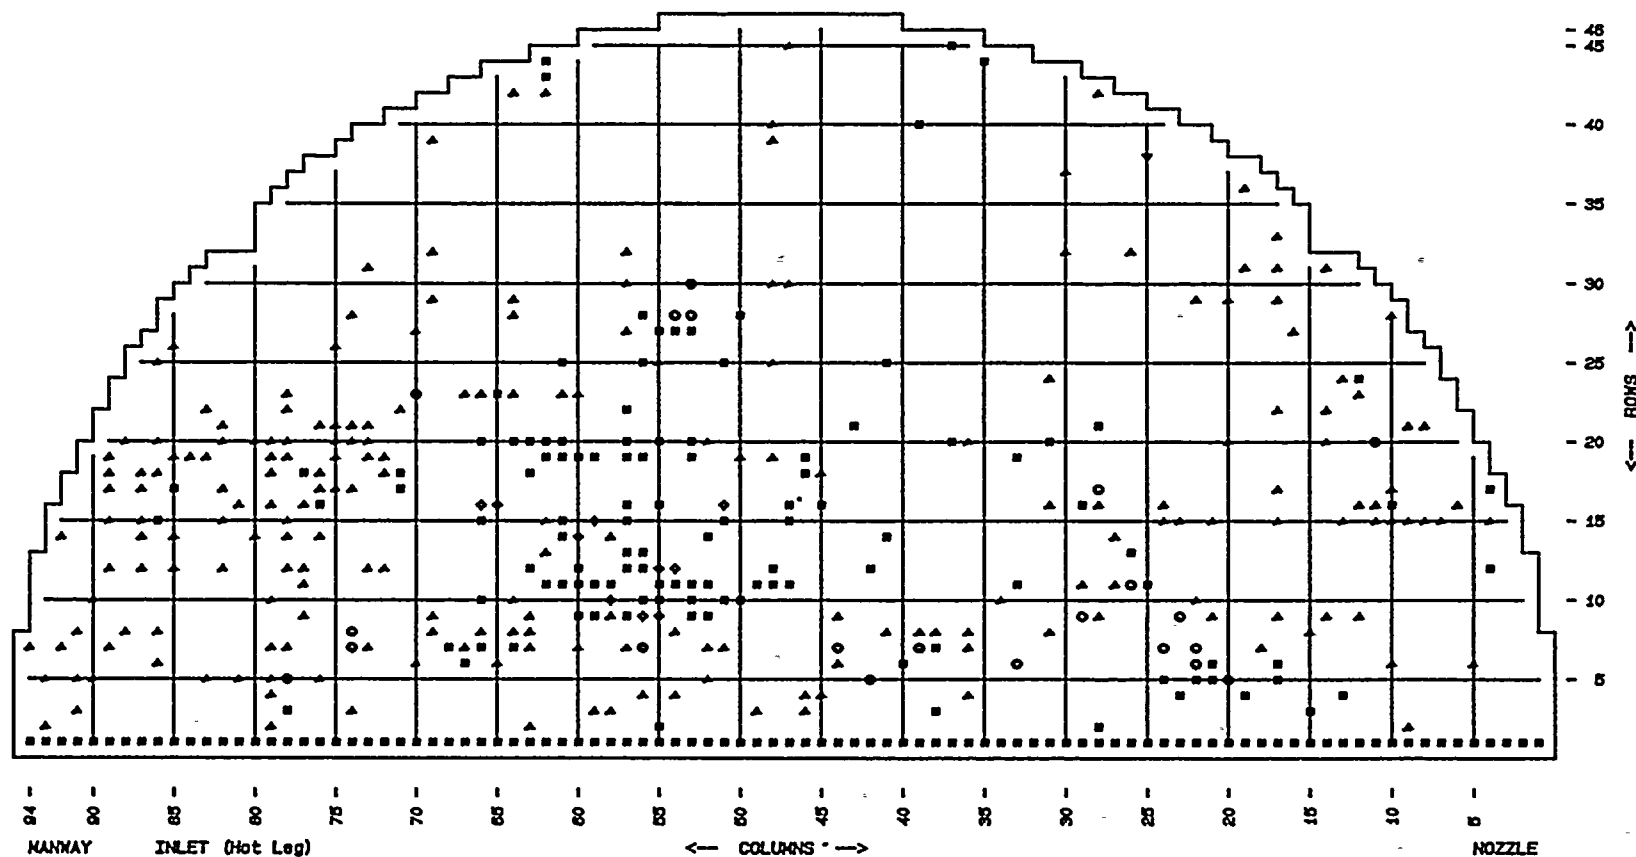
Figure 2

EC INSPECTION RESULTS - MARCH 1987

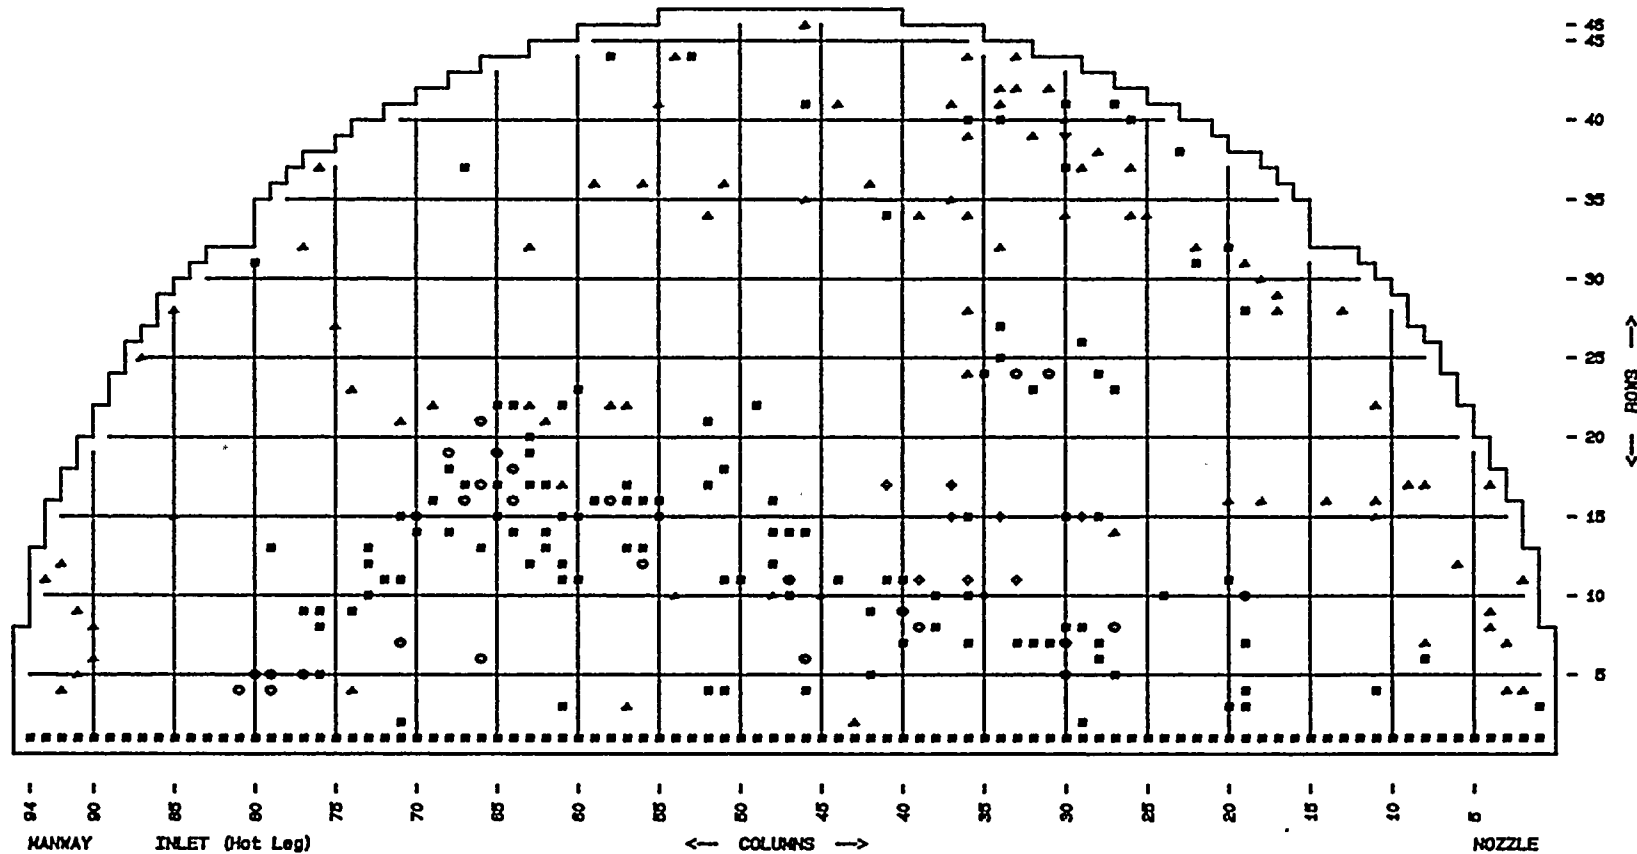
Figure 3

EC INSPECTION RESULTS - MARCH 1987

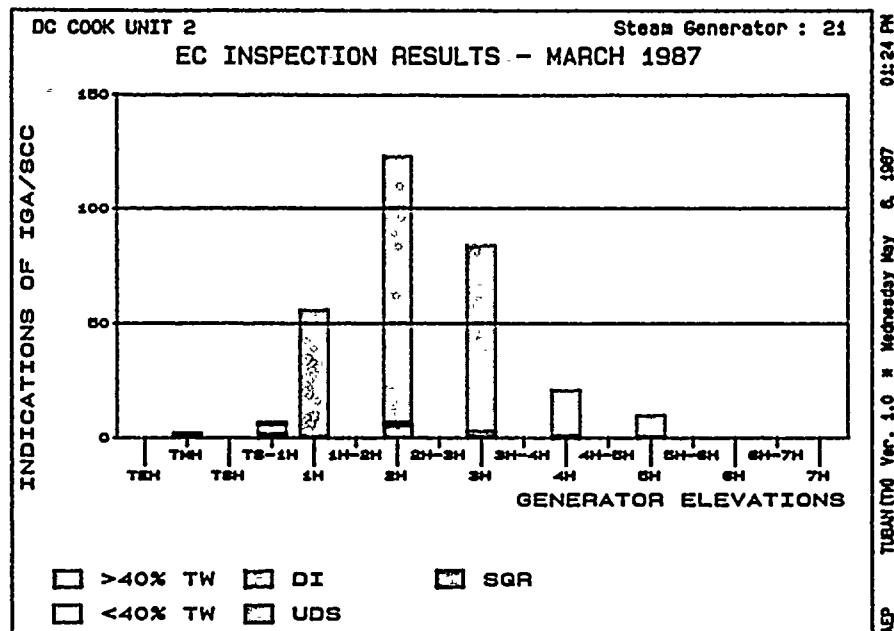
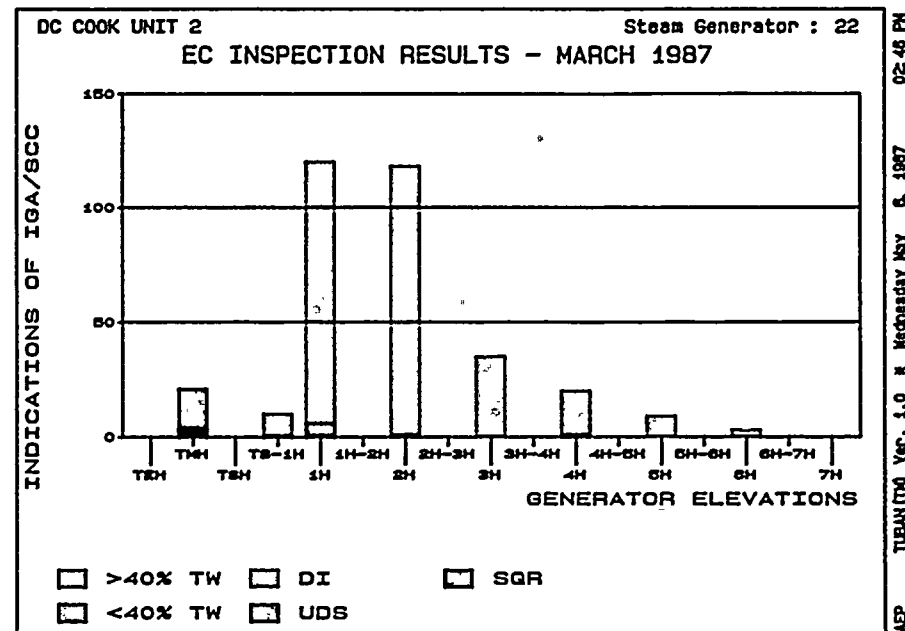
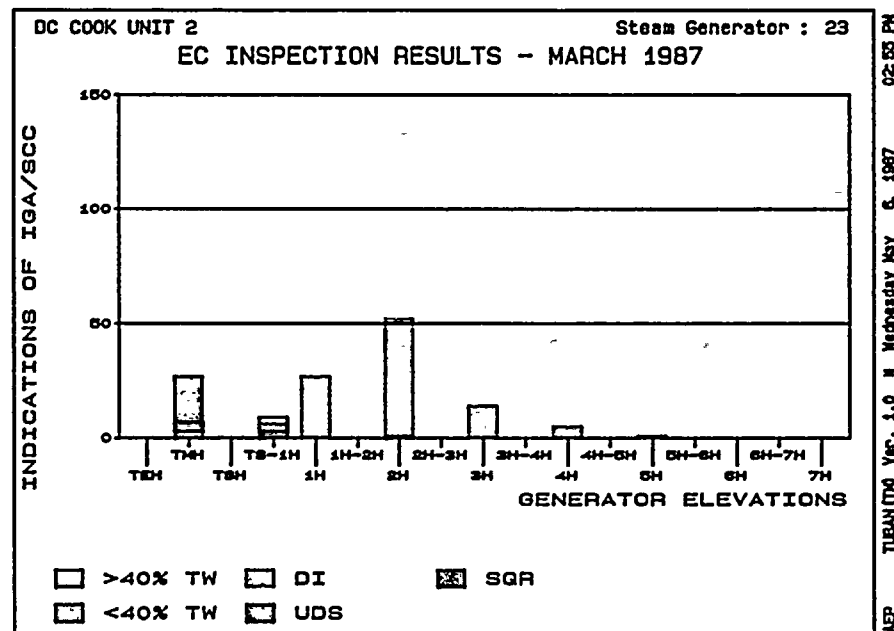
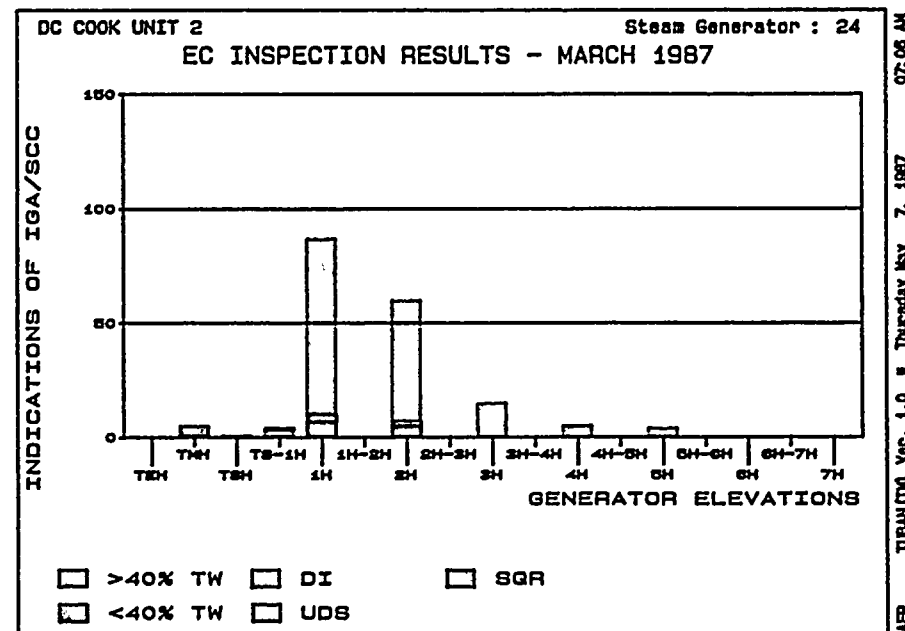
Figure 5 graphically depicts the data of Table 1-B for each steam generator. Figure 6 is a composite for all four steam generators, and gives a graphical comparison of total indications reported during the March 1987 inspection to the total indications left in service following the 1986 inspection. This provides an overview of tube degradation progression during the past operating period.

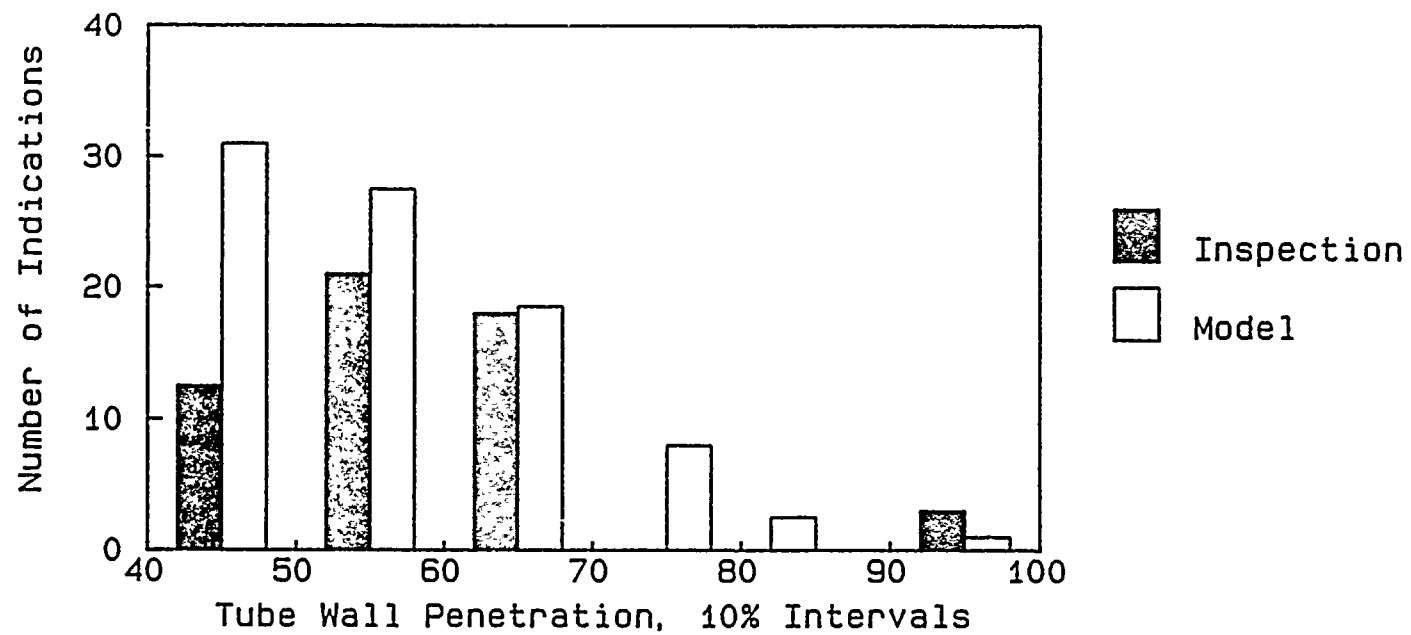
The end results of the above-described comparison are shown in Figure 7 for the tubesheet crevice region, Figure 8 for the tubesheet surface region, and Figures 9-A and 9-B for tube support plate intersections. In the tubesheet surface region and at tube support plate intersections, the model data was fit with a "best estimate" curve. In the tubesheet crevice region, the model data was fit with a more conservative "over-prediction" curve in recognition of the fact that crevice corrosion has been the limiting factor for continued operation.

Figure 7 Comparison of Model Prediction to Actual EC Inspection Results, Tubesheet Crevice Region

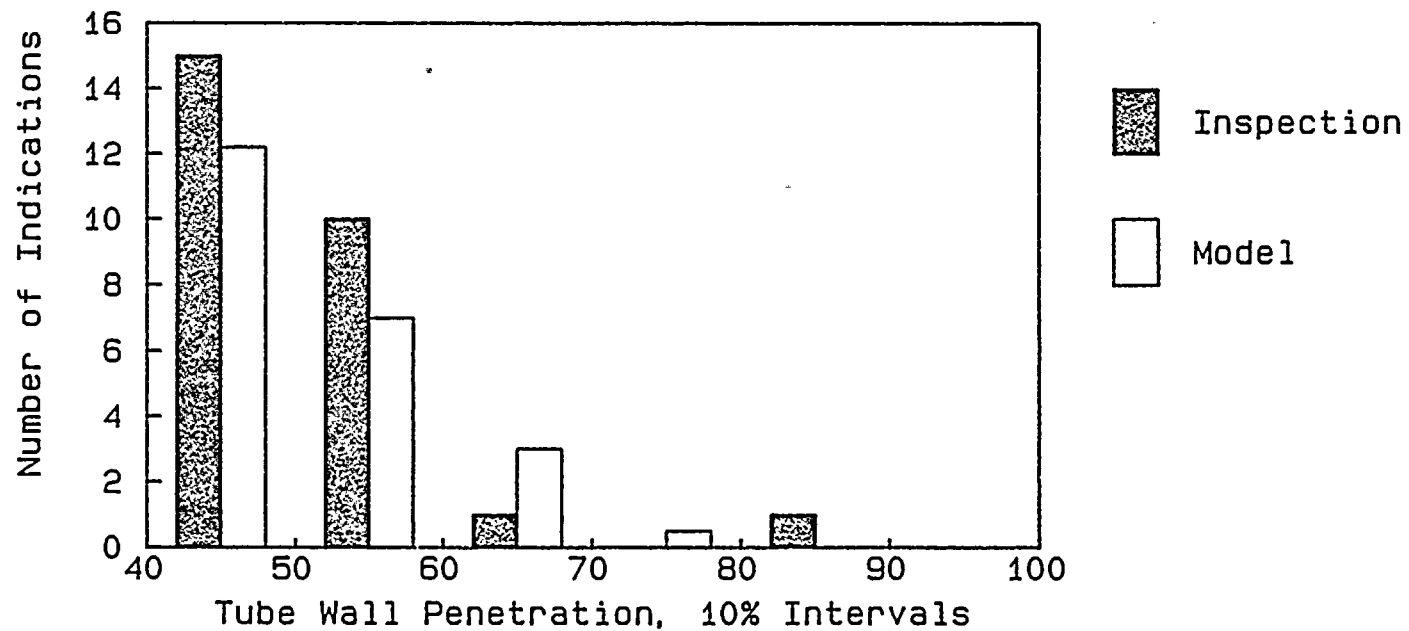
Figure 8 Comparison of Model Prediction to Actual EC Inspection Results, Tubesheet Surface Region

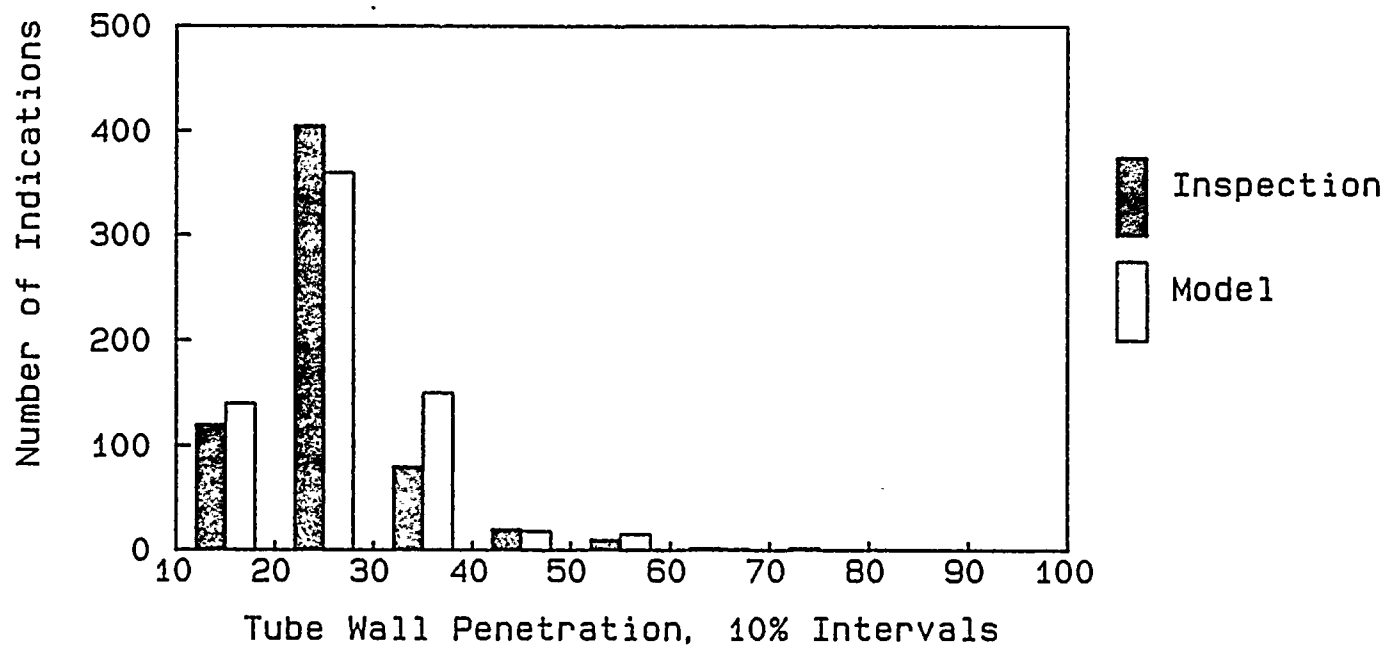
Figure 9-A Comparison of Model Prediction to Actual EC Inspection Results, Tube Support Plate Intersections Full Range, 0 to 100% TW

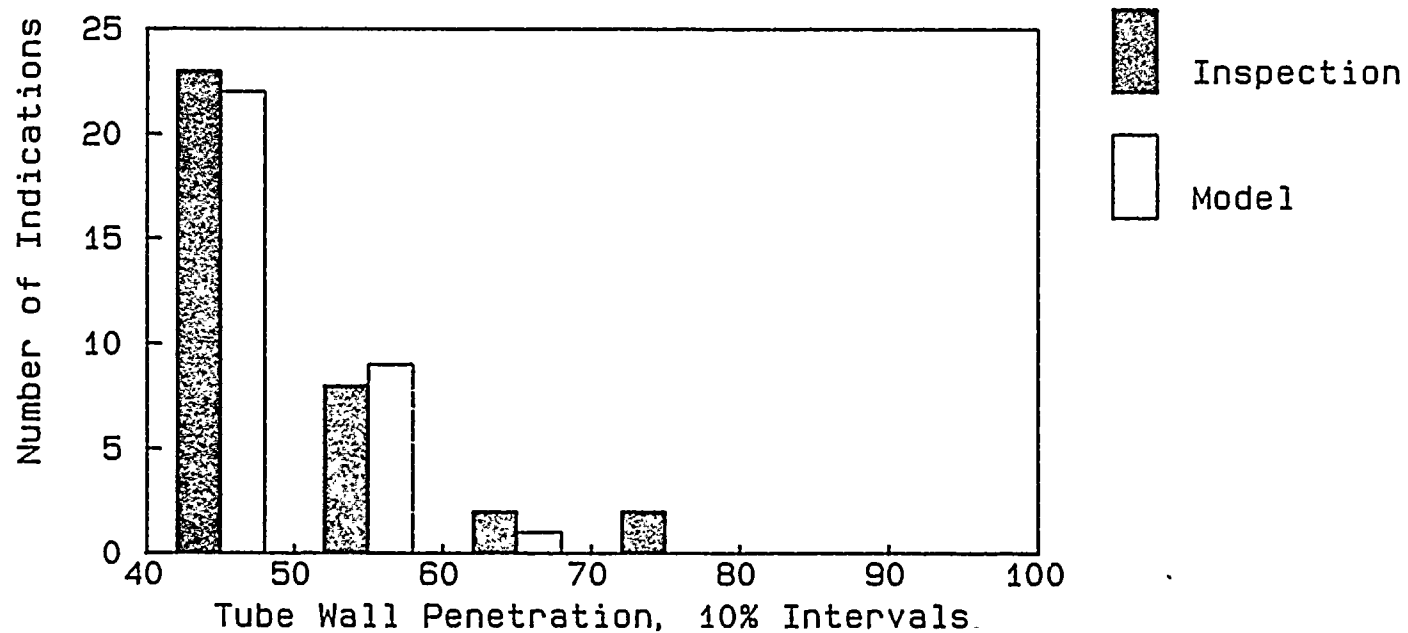
Figure 9-B Comparison of Model Prediction to Actual EC Inspection Results, Tube Support Plate Intersections Blowup of 40 to 100% TW Range

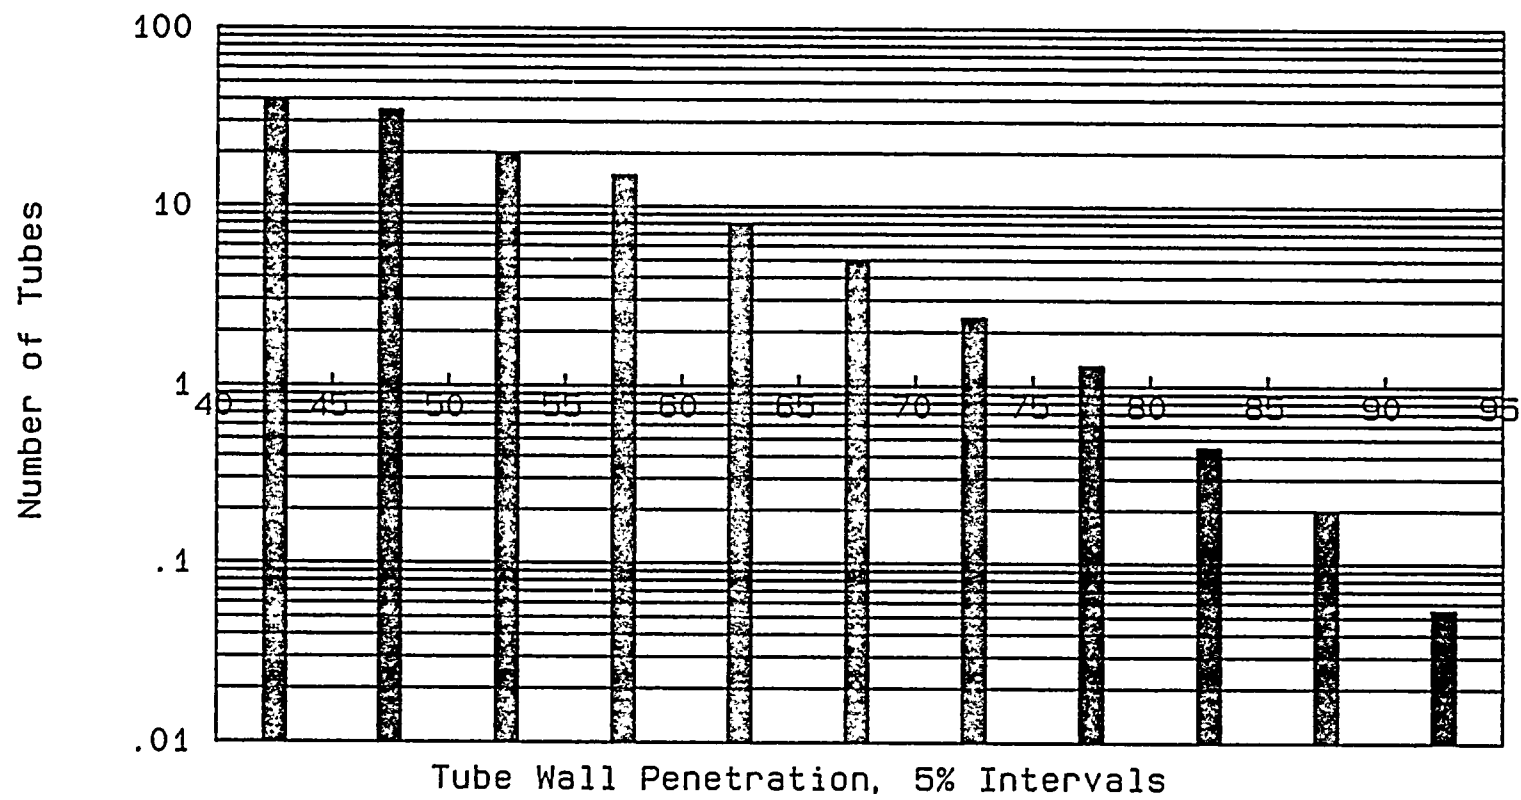
Figure 10 Predicted End-of-Interval Condition,
Tubesheet Crevice Region

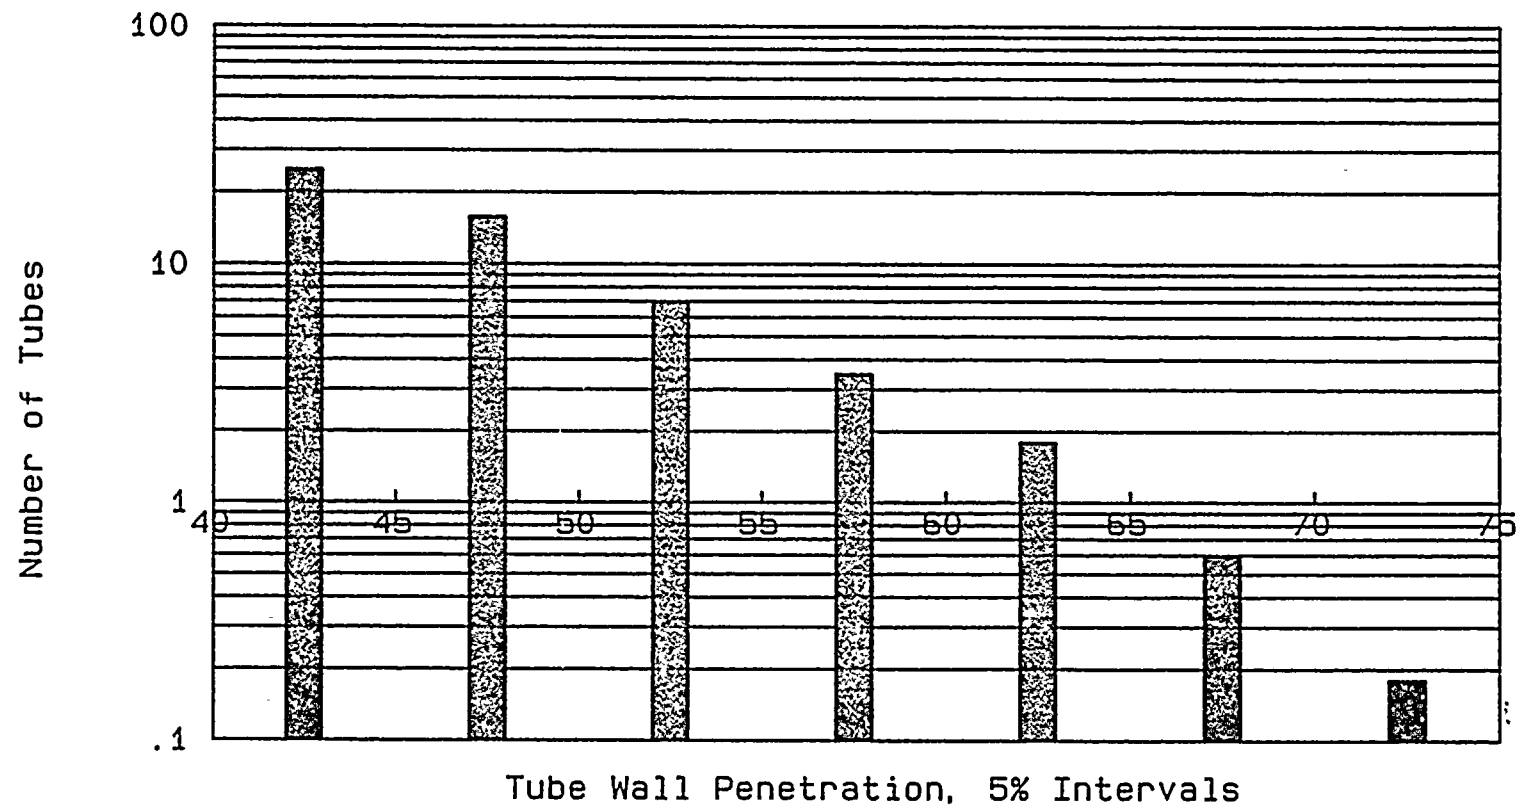
Figure 11 Predicted End-of-Interval Condition,
Tubesheet Surface Region

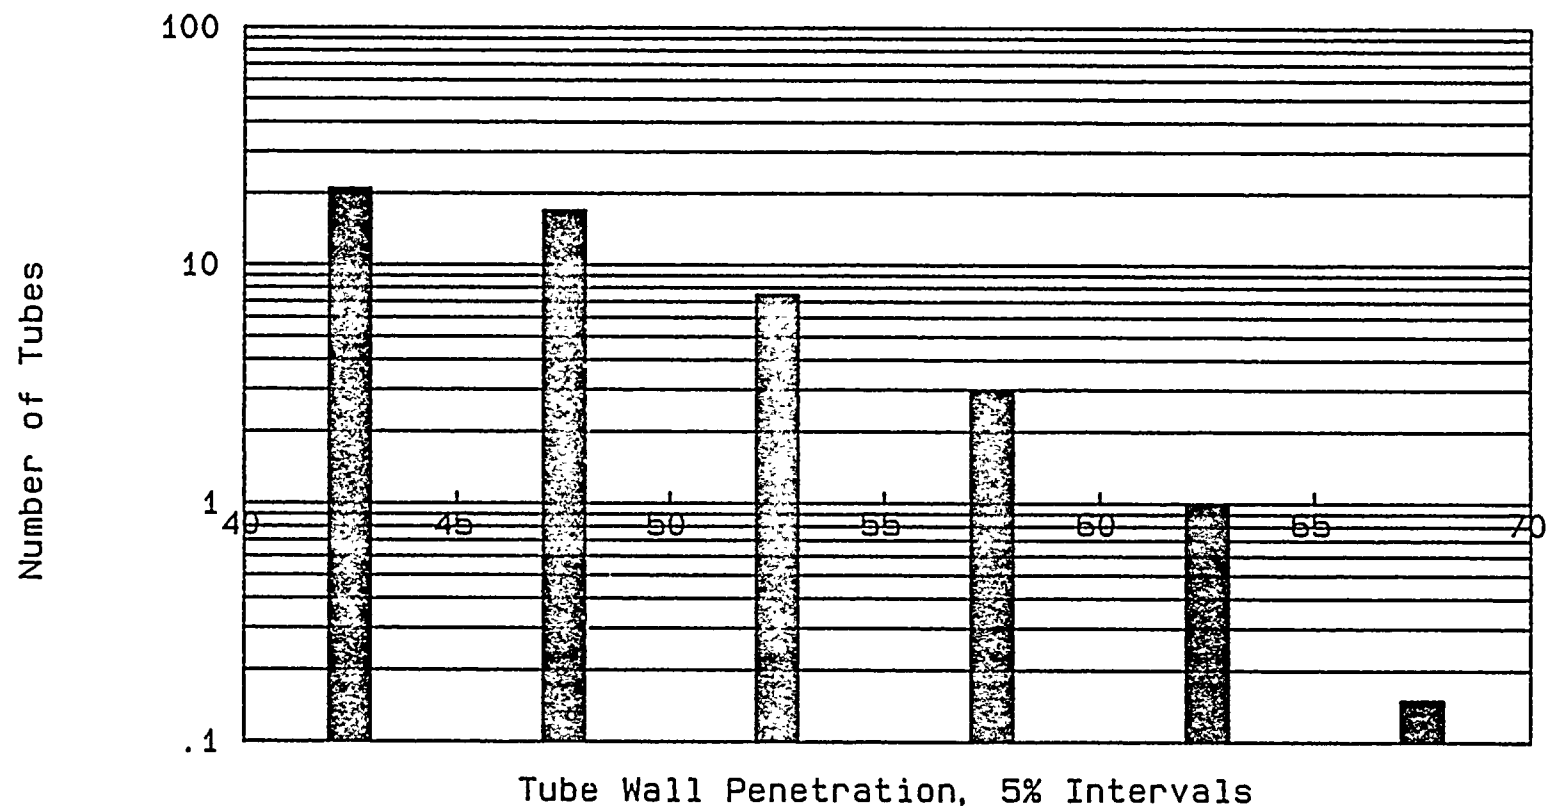
Consistent with the Section 4.1 discussion of reasonable operating interval lengths, an operating interval of 4.7 EFPMs was considered. To assess the reduction in potential for leakage, the probabilistic model described in Section 2.2.3 was applied in the same manner as used to assess growth rate. The analysis included new start-of-interval conditions resulting from the March 1987 inspection and plugging, and used the growth rate distribution derived from the 85-86 interval. The projected end-of-interval conditions for the tubesheet crevice region, tubesheet surface region, and tube support plate intersections are shown in Figures 10, 11, and 12. Since the end-of-interval projections show no appreciable number of tubes at extreme wall penetrations, such as might result in leakage, the 4.7 EFPM interval is considered appropriate.

Figure 12 Predicted End-of-Interval Condition,
Tube Support Plate Intersections
