SUBJECT: LER 87-013-00: on 870701 & 02, discovered ice buildup in ice condenser in ice condenser flow passages. Caused possibly by sublimation of ice or high humidity in containment air. Ice condenser defrosted. W/870729 ltr.

FACILITY NAME (1) D. C. Cook Nuclear Plant - Unit 1. DOCKET NUMBER (2) 0 5 0 0 0 3 1 5 PAGE (3) 1 OF 1 3

TITLE (4) ICE BUILDUP IN ICE CONDENSER FLOW PASSAGES DUE TO SUBLIMATION

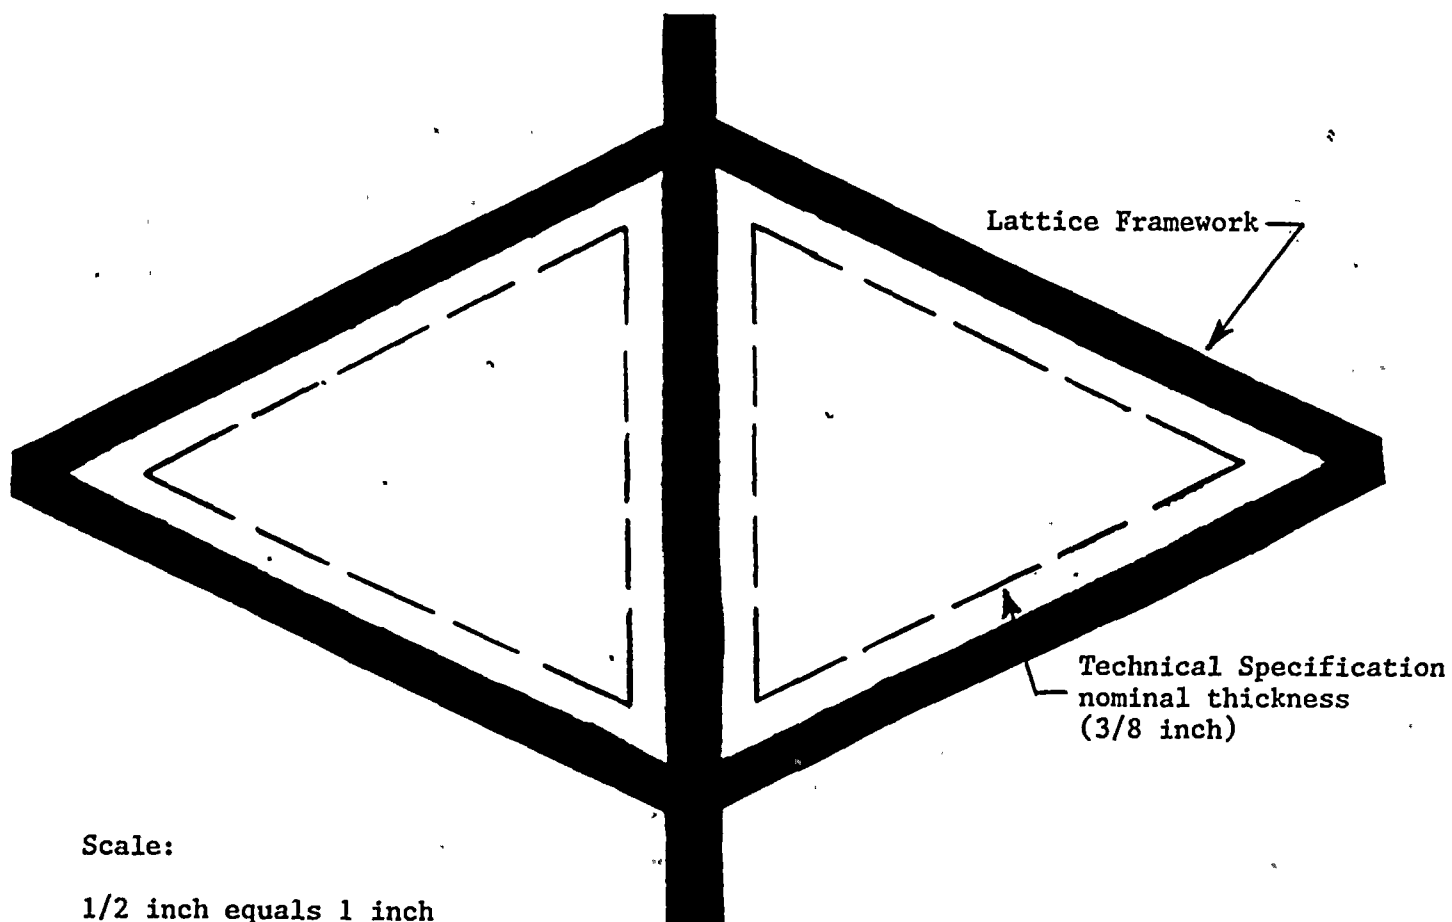
ATTACHMENT 2

Representative Diagram of Two Flow Passages

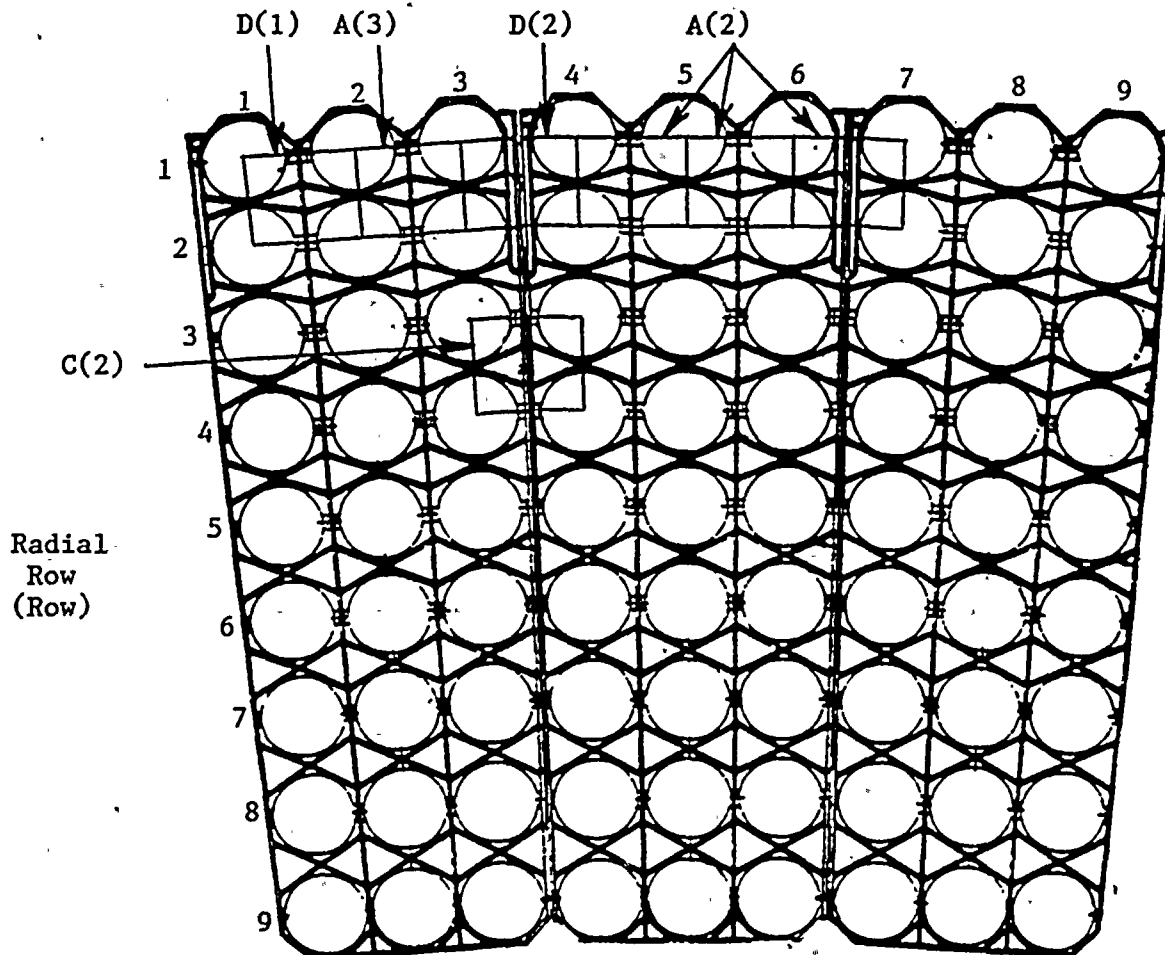
ATTACHMENT 3

The as-found visual inspection ice condenser (EIIS/COND) flow passages conducted on July 1 and 2, 1987, indicated frost and ice accumulation greater than 3/8 inch in two flow passages in Bay 1, four flow passages in Bay 4, two flow passages in Bay 13, two flow passages in Bay 18, two flow passages in Bay 19, four flow passages in Bay 22 and four flow passages in Bay 24. Subsequently, the inspection was expanded to include at least twenty additional flow passages in each bay. This inspection revealed an additional twelve flow passages in Bay 1, twenty-two flow passages in Bay 4, six flow passages in Bay 13, four flow passages in Bay 18, twenty-four flow passages in Bay 18, twenty-four flow passages in Bay 19, twenty-four flow passages in Bay 22, and twelve flow passages in Bay 24 with more than 3/8 inch frost and ice buildup for a total of 124 flow passages. There are a total of 3072 flow passages in the Ice Condenser. Attachments 1 through 9 graphically describe the geometry of the flow passages and the location of the ice/frost accumulation.

Bay 1 (of 24 total)

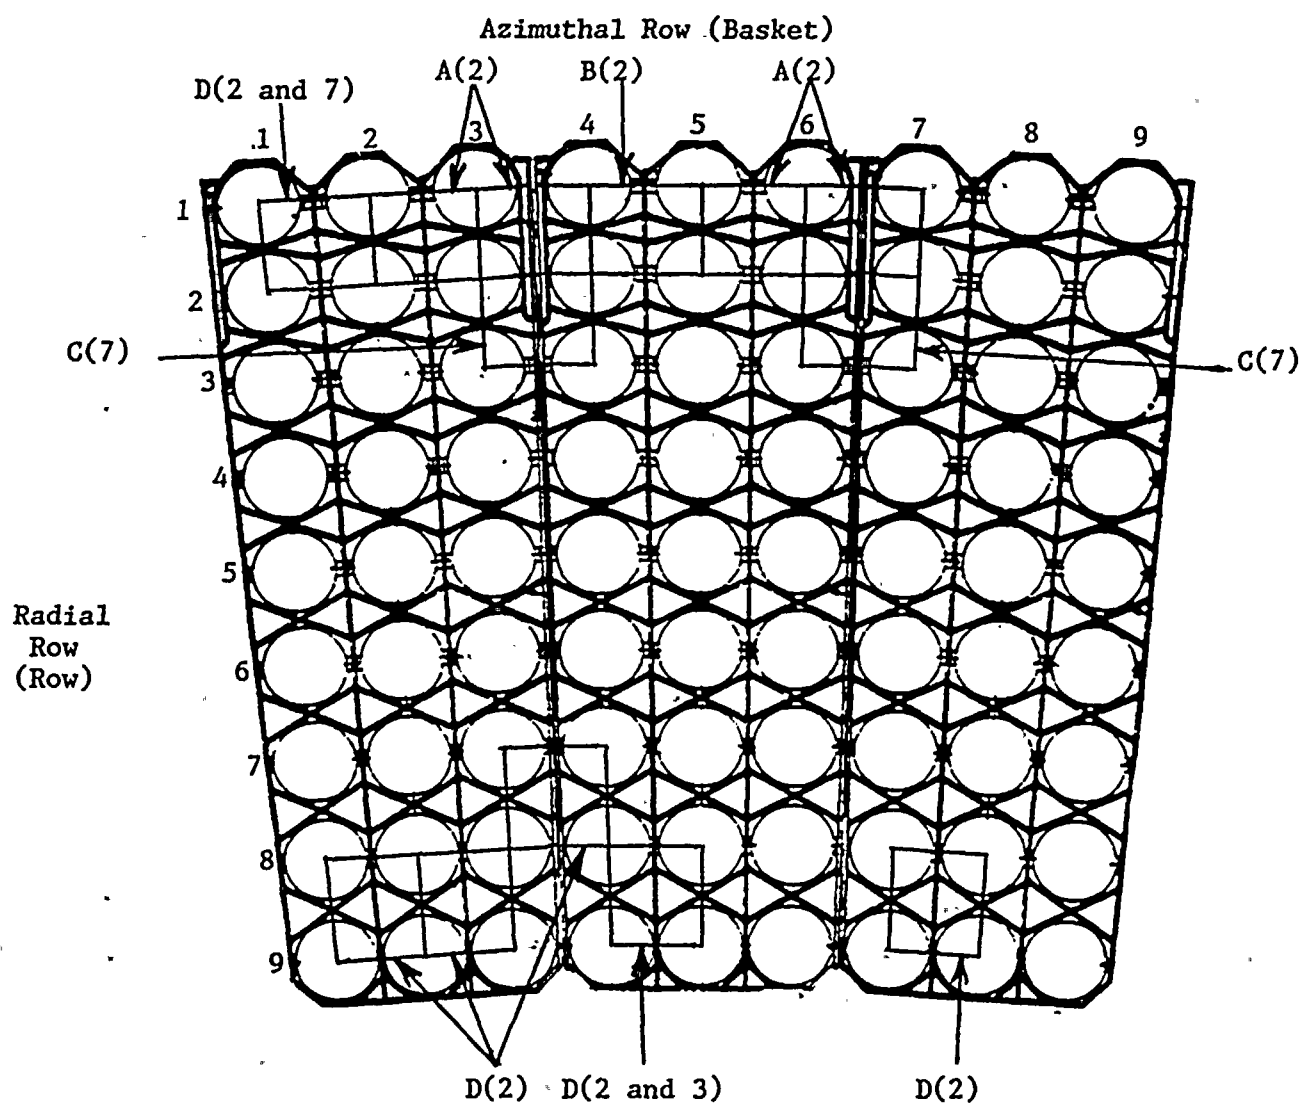
ATTACHMENT 4

Bay 4 (of 24 total)

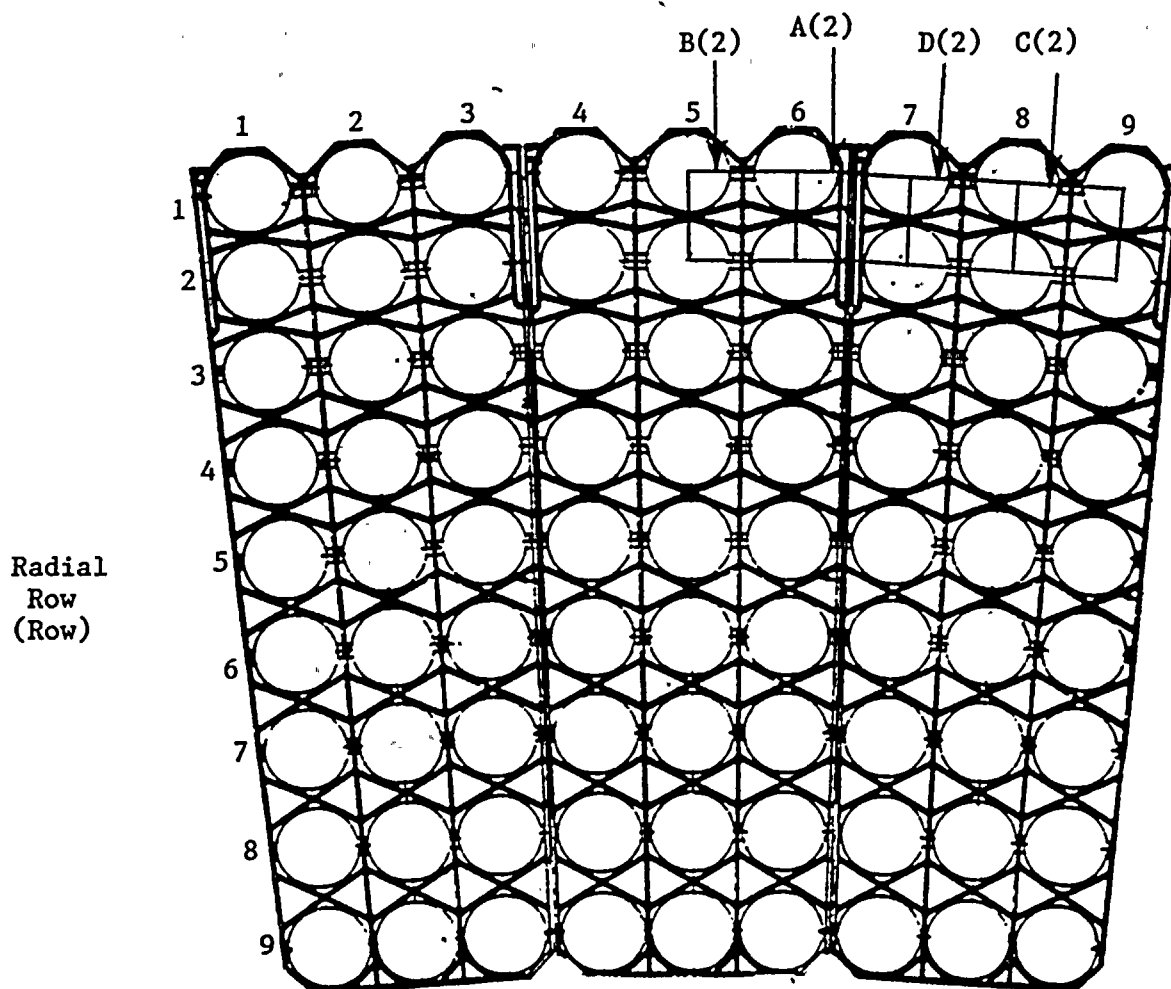
ATTACHMENT 5

Bay 13 (of 24 total)

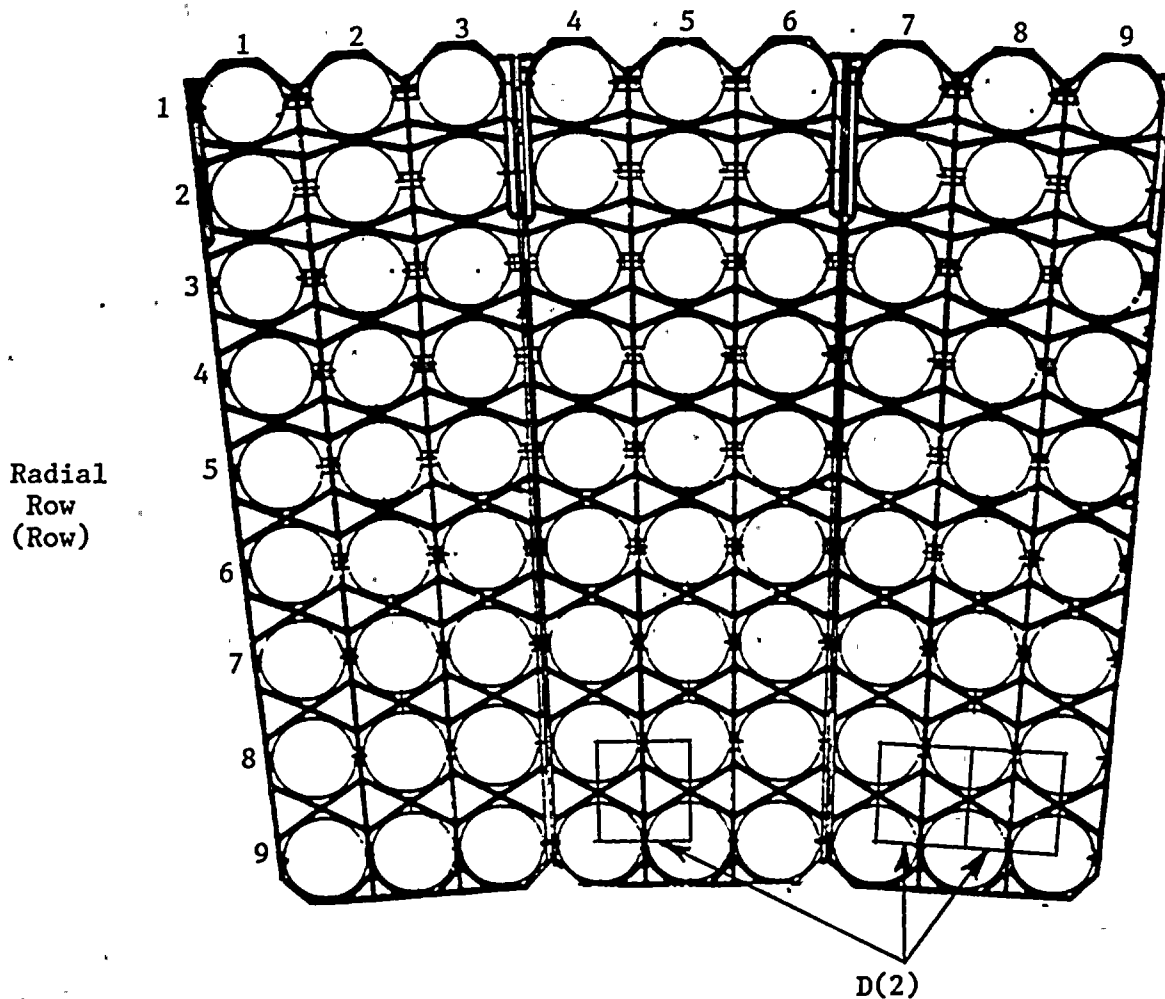
ATTACHMENT 6

Bay 18 (of 24 total)

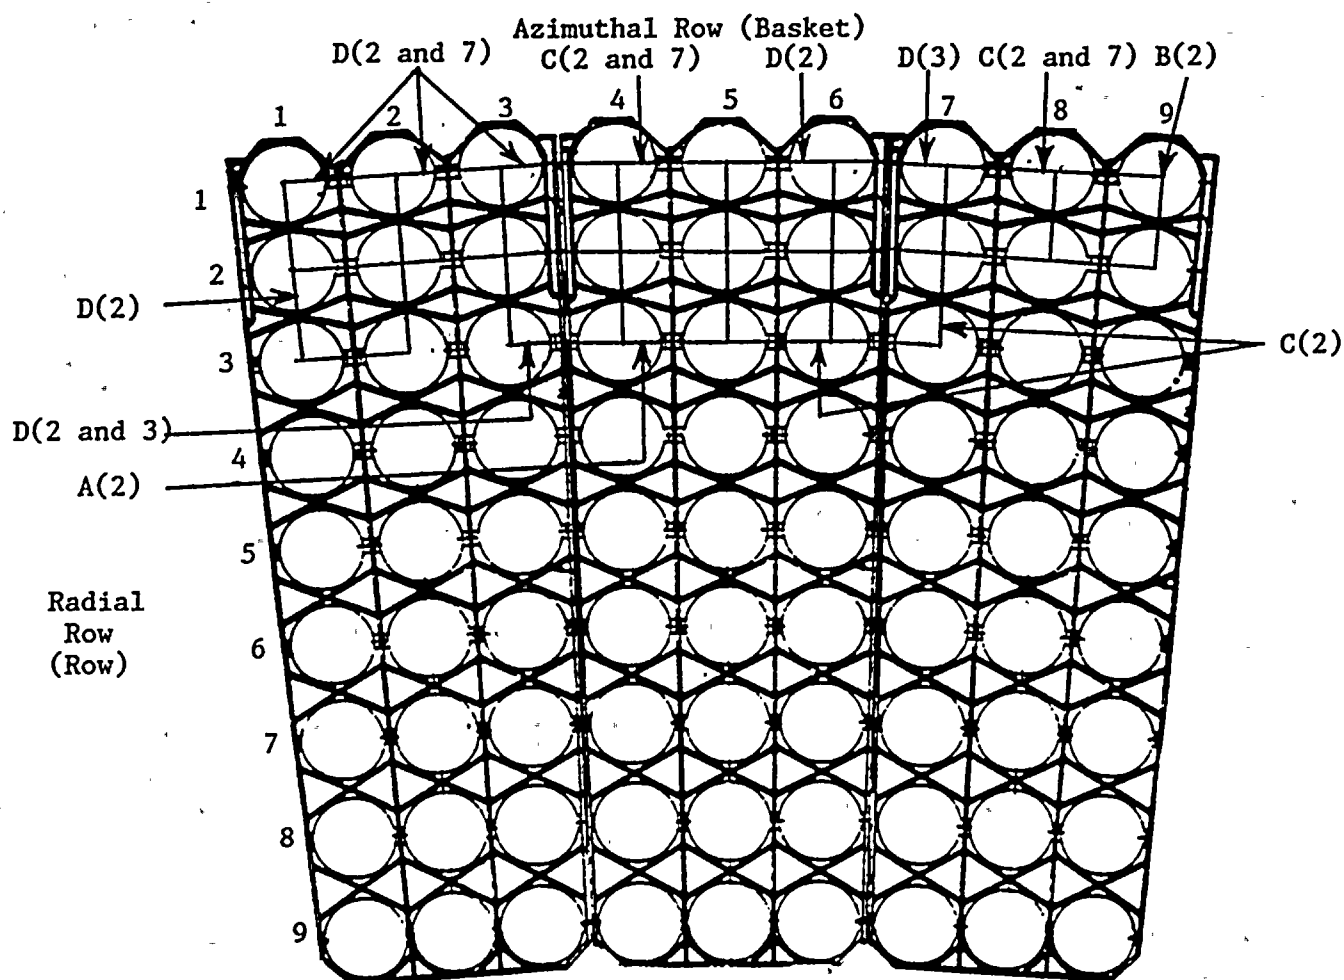
ATTACHMENT 7

Bay 19 (of 24 total)

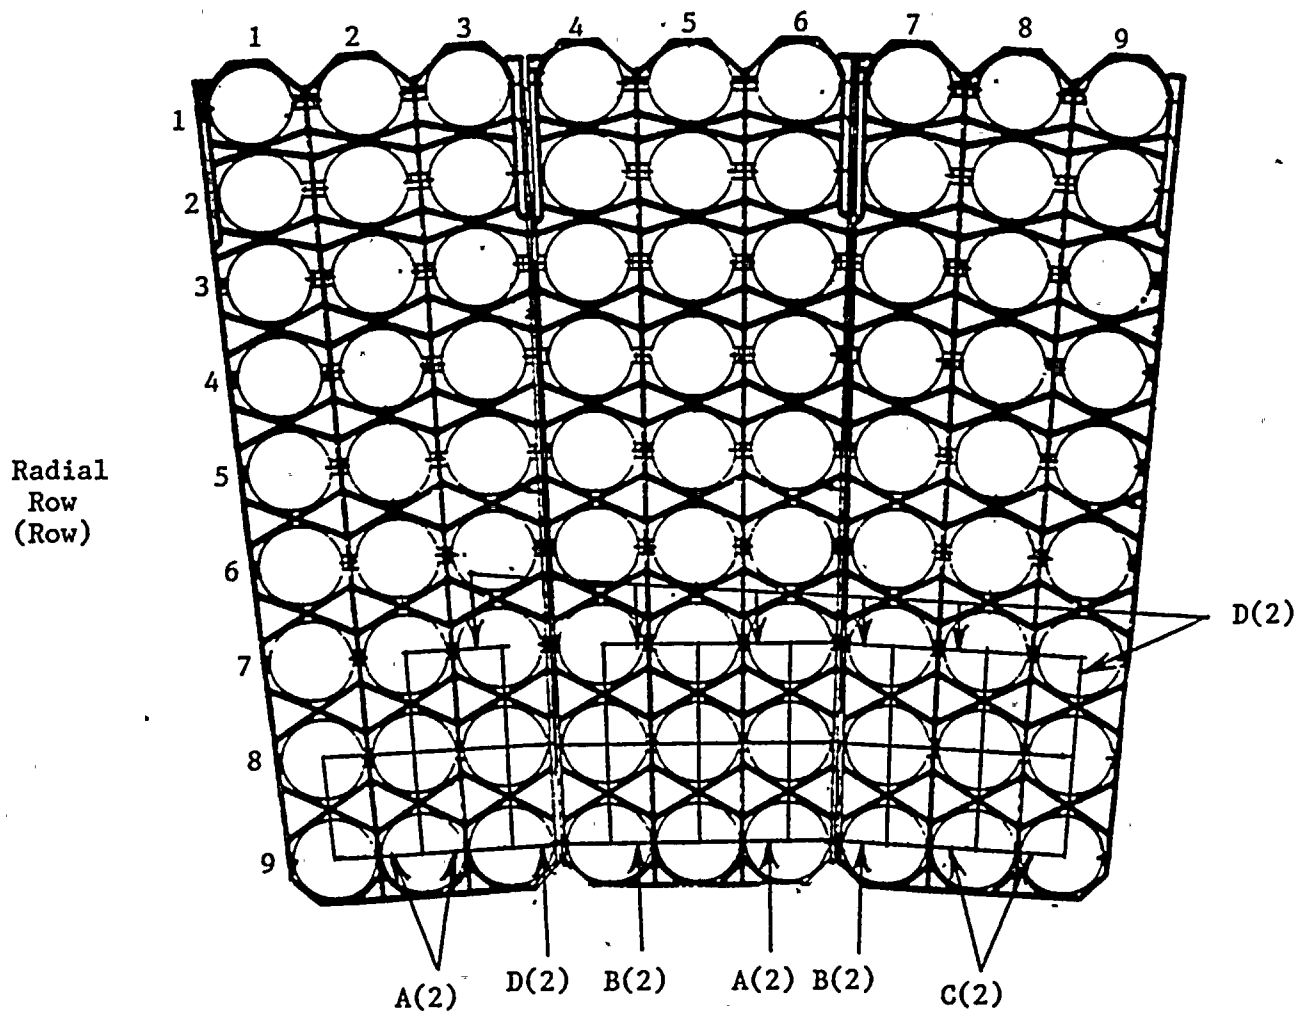
ATTACHMENT 6

Bay 22 (of 24 total)

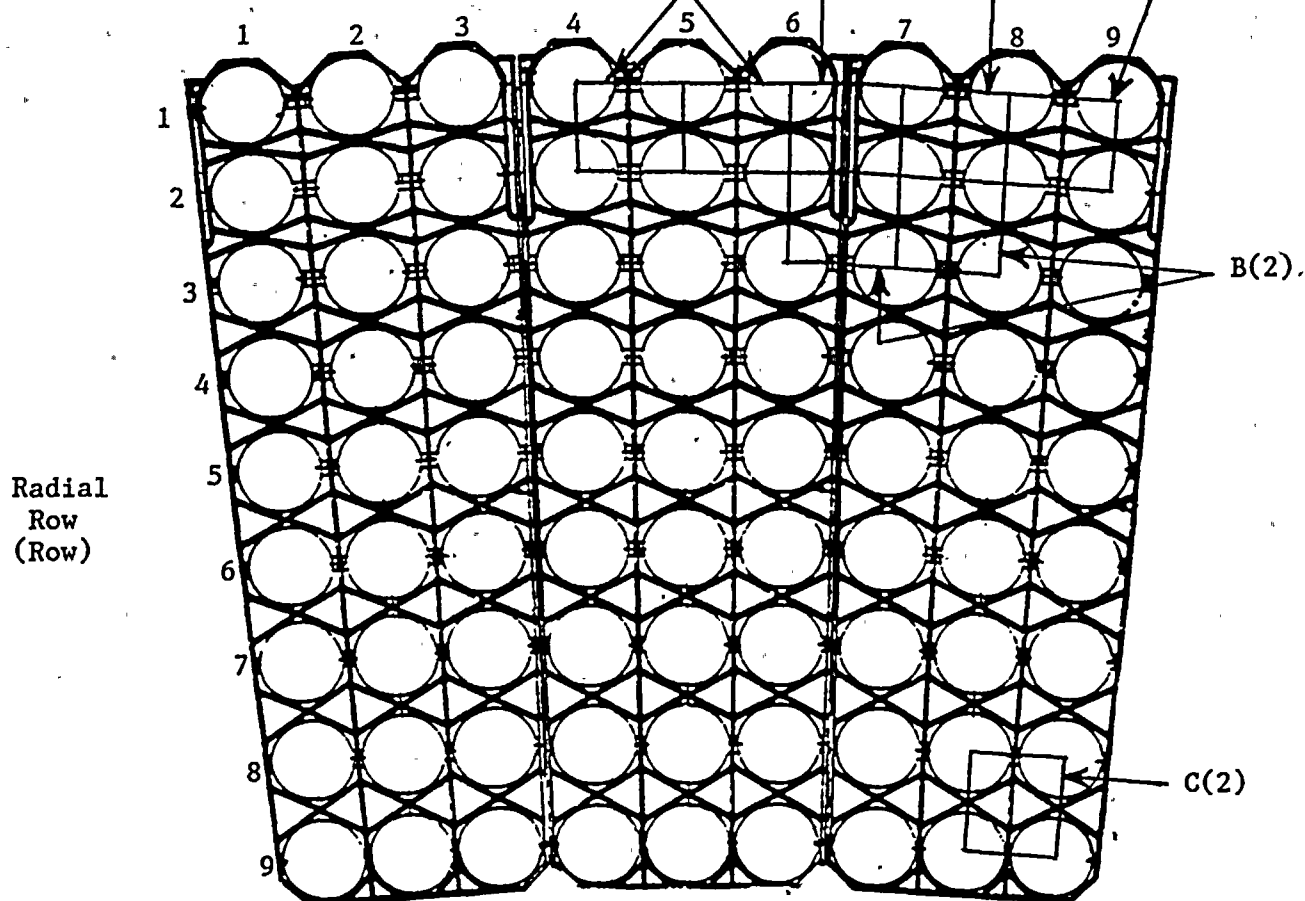
ATTACHMENT 9

Bay 24 (of 24 total)

A(2 and 7) A(7) C(2 and 7) D(2 and 7)
