SUBJECT: LER 87-010-00: on 870902, insps revealed frost & ice buildup on lattice frames of greater than 3/8 inch in 46 flow passages & 6 of 24 ice condenser bays. Caused by abnormal degradation. Ice condenser defrosted. W/870925 ltr.

LICENSEE EVENT REPORT (LER)

FACILITY NAME (1) D. C. Cook Nuclear Plant - Unit 2										DOCKET NUMBER (2) 0 5 0 0 0 3 1 6				PAGE (3) 1 OF 1 2										
TITLE (4) Ice Buildup in Ice Condenser Flow Passages Due to Sublimation																								
EVENT DATE (5)			LER NUMBER (6)				REPORT DATE (7)			OTHER FACILITIES INVOLVED (8)														
MONTH	DAY	YEAR	YEAR	SEQUENTIAL NUMBER	REVISION NUMBER	MONTH	DAY	YEAR	FACILITY NAMES				DOCKET NUMBER(S)											
0	9	0	2	8	7	8	7	0	1	0	0	0	9	2	5	8	7	0	5	0	0	0		
OPERATING MODE (9)		THIS REPORT IS SUBMITTED PURSUANT TO THE REQUIREMENTS OF 10 CFR §: (Check one or more of the following) (11)																						
5		20.402(b)				20.405(c)				50.73(a)(2)(iv)				73.71(b)										
POWER LEVEL (10)		20.405(a)(1)(i)				50.36(c)(1)				50.73(a)(2)(v)				73.71(c)										
0 0 0		20.405(a)(1)(ii)				50.36(c)(2)				50.73(a)(2)(vii)				<input checked="" type="checkbox"/> OTHER (Specify in Abstract below and in Text, NRC

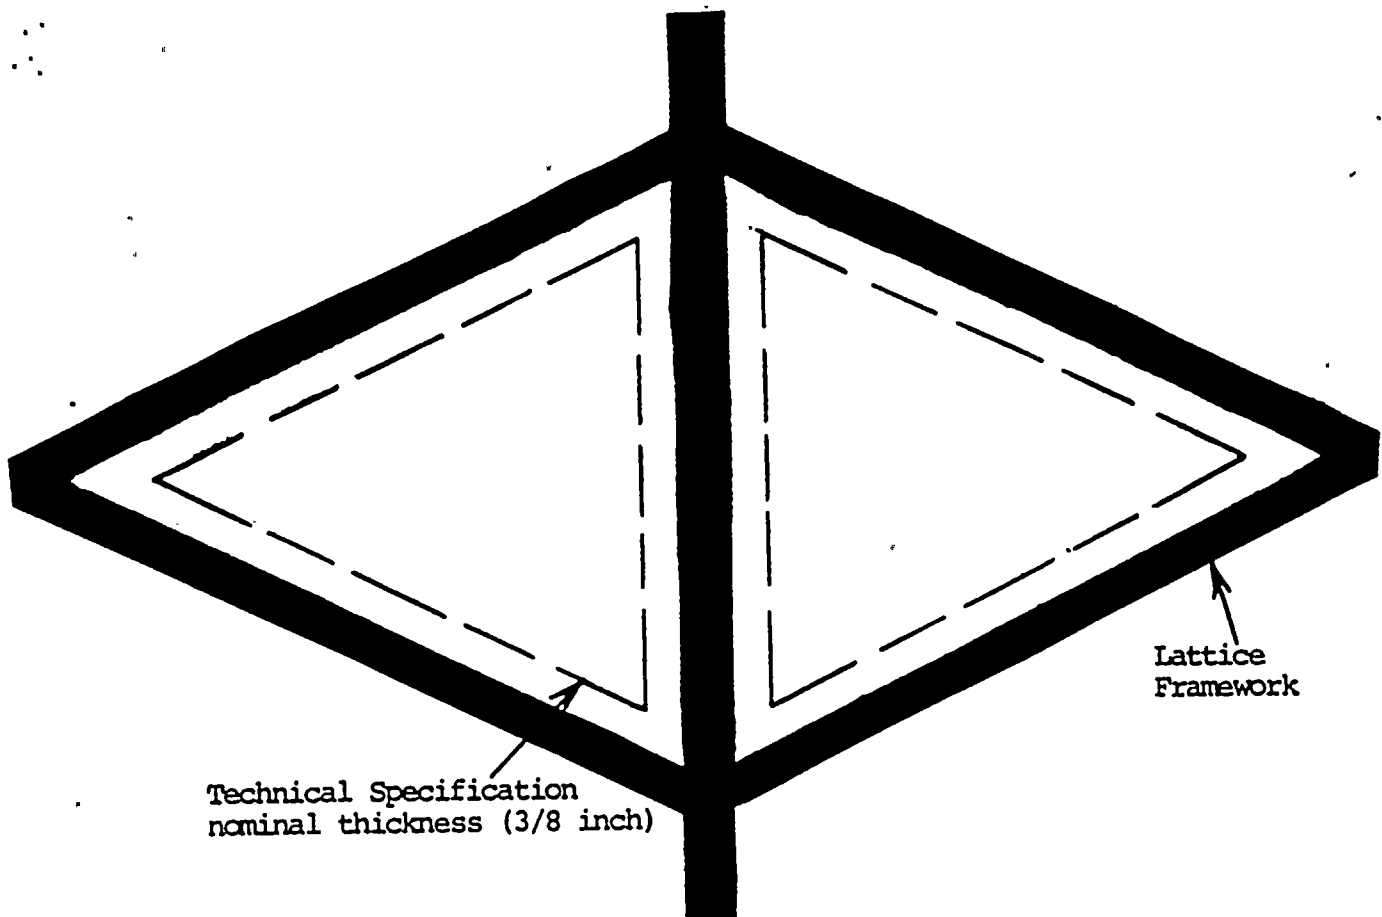
ATTACHMENT 2

Representative Diagram of Ice/Frost Build-up in Two Flow Passages

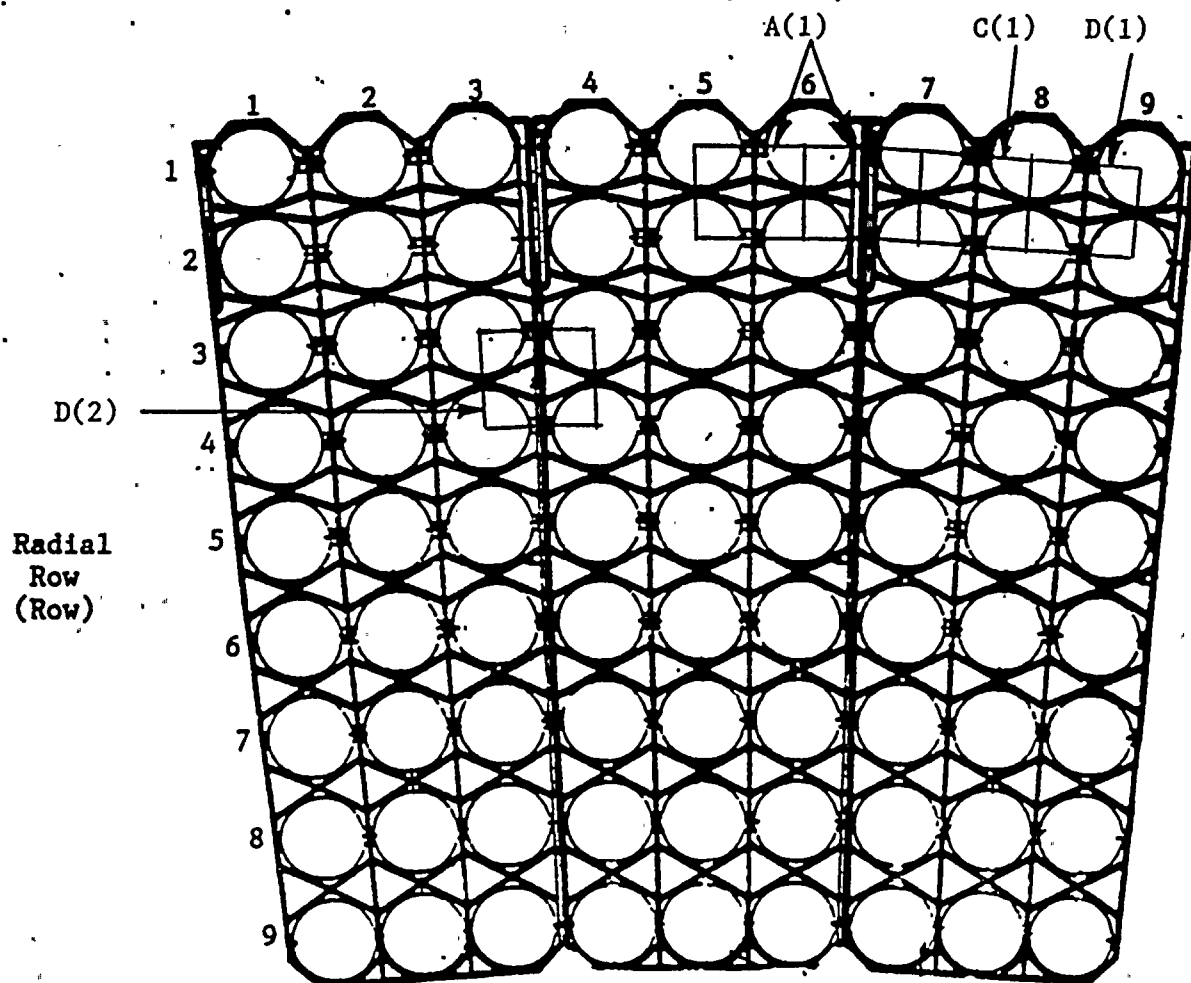
ATTACHMENT 3

Bay 3 (of 24 total)

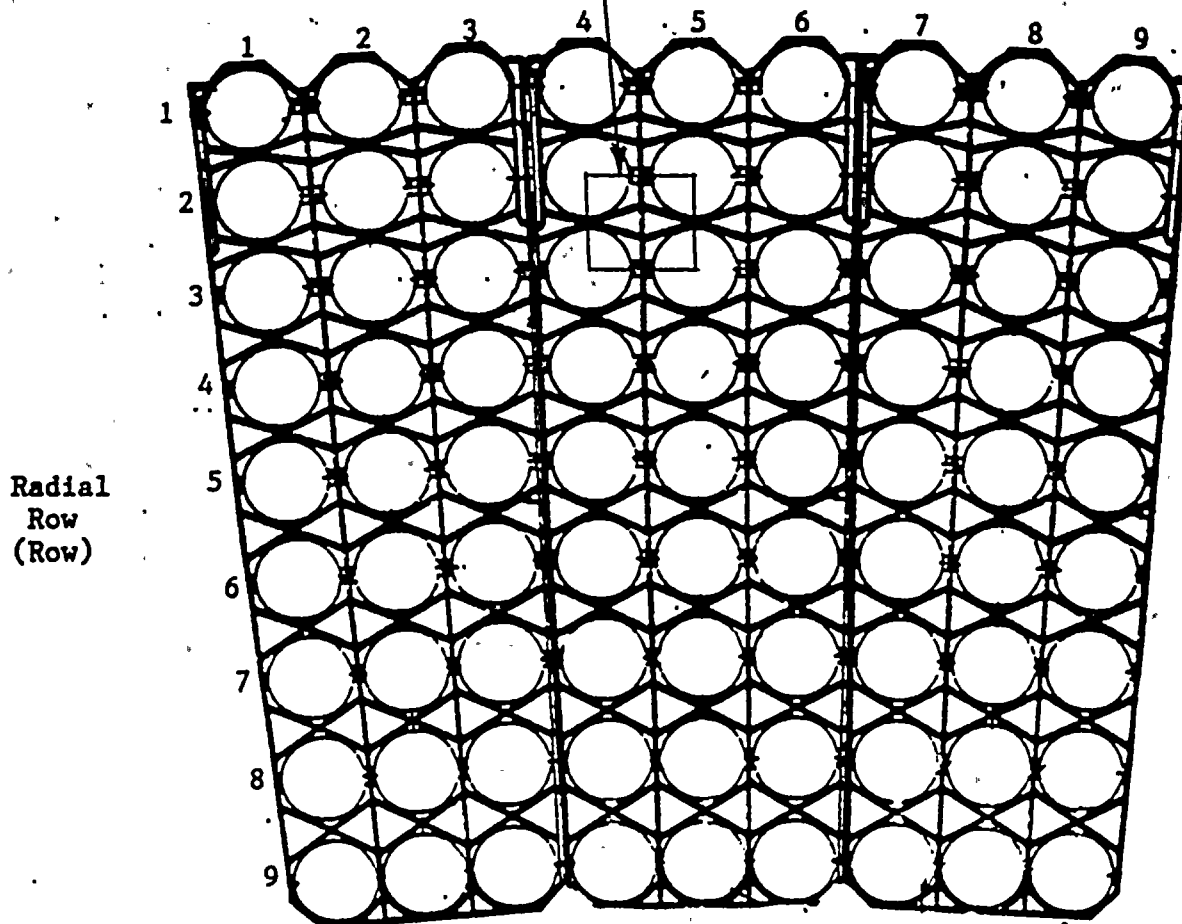
ATTACHMENT 4

Bay 4 (of 24 total)

C(1,2,3,4)

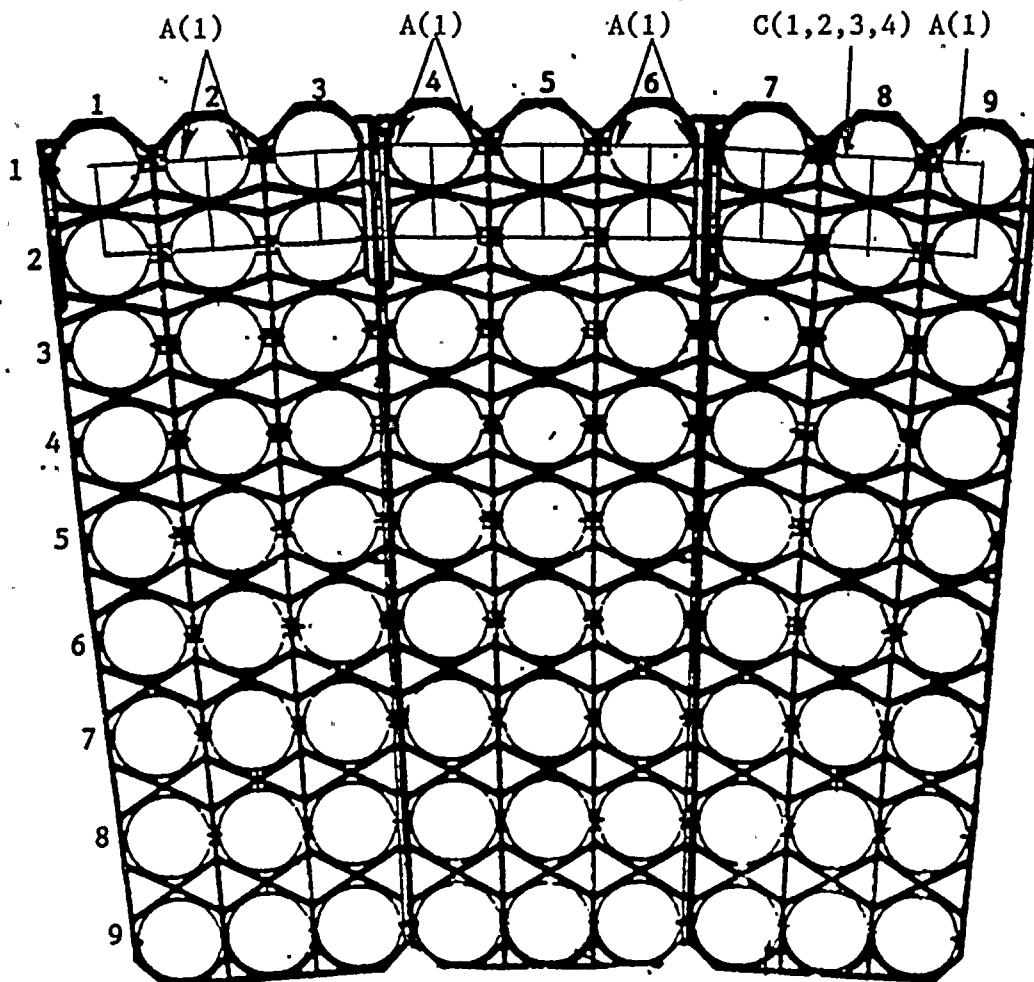
ATTACHMENT 5

Bay 8 (of 24 total)

C(1,2,3,4) A(1)

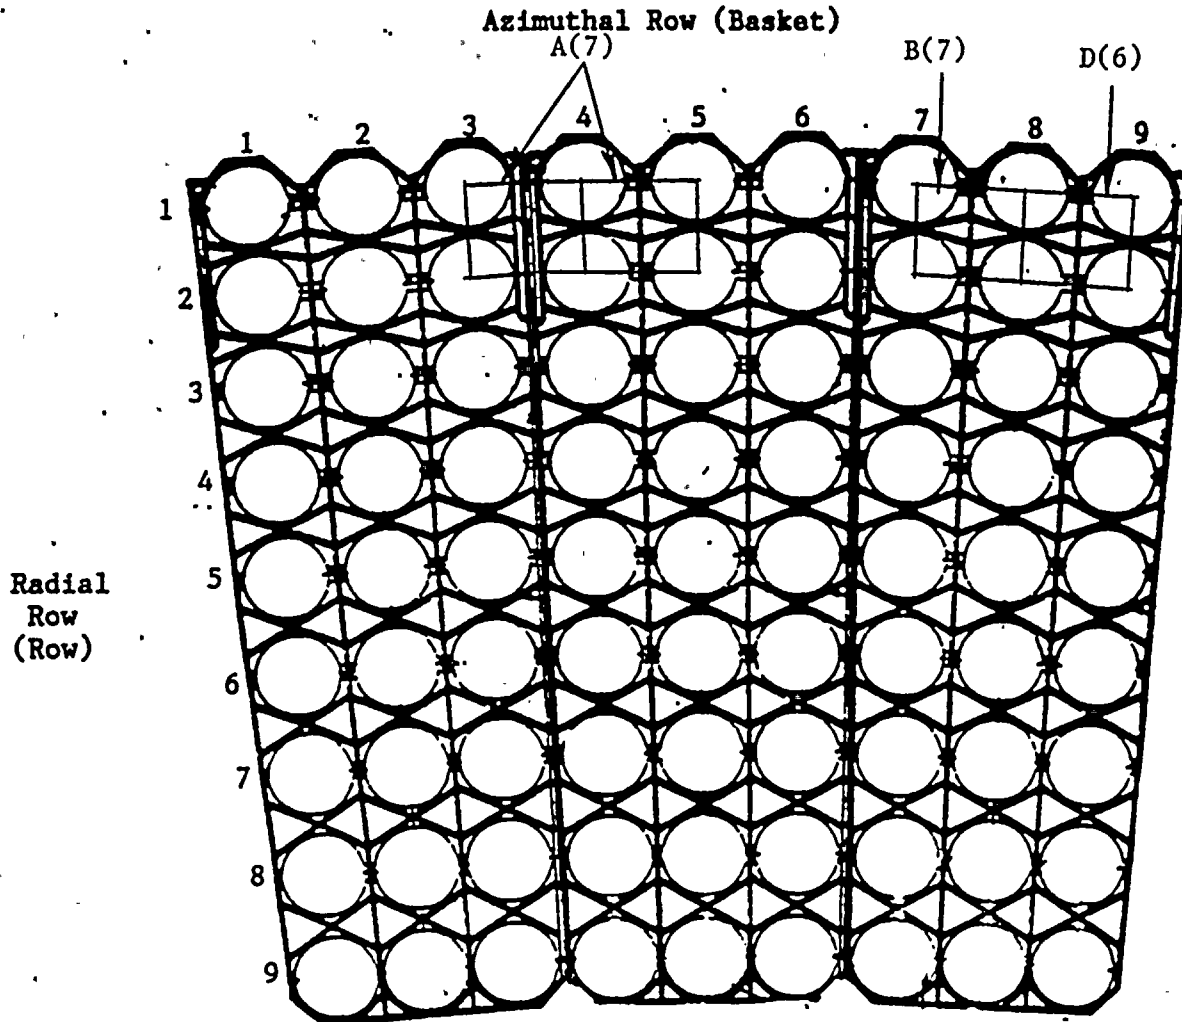
ATTACHMENT 6

Bay 11 (of 24 total)

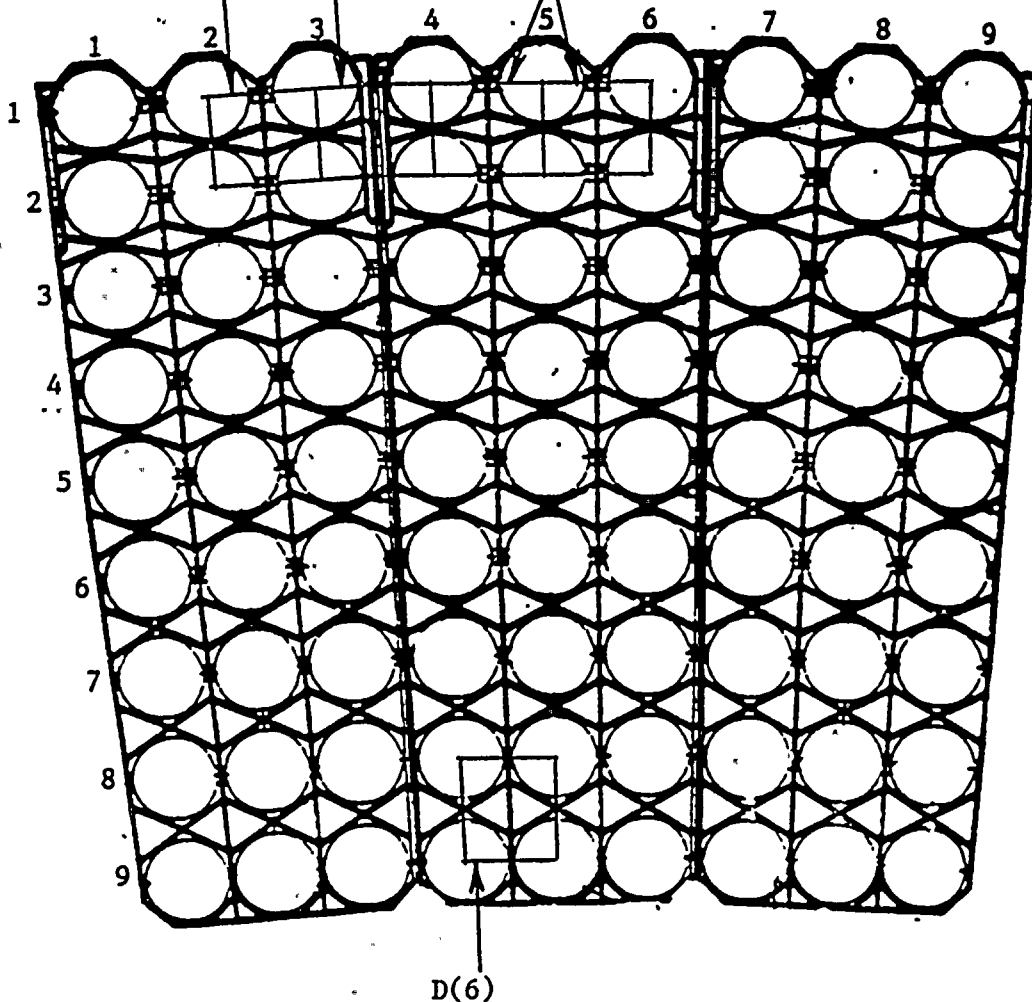
ATTACHMENT 7

Bay 13 (of 24 total)

C(1,2,3,4) A(1)

C(1,2,3,4)

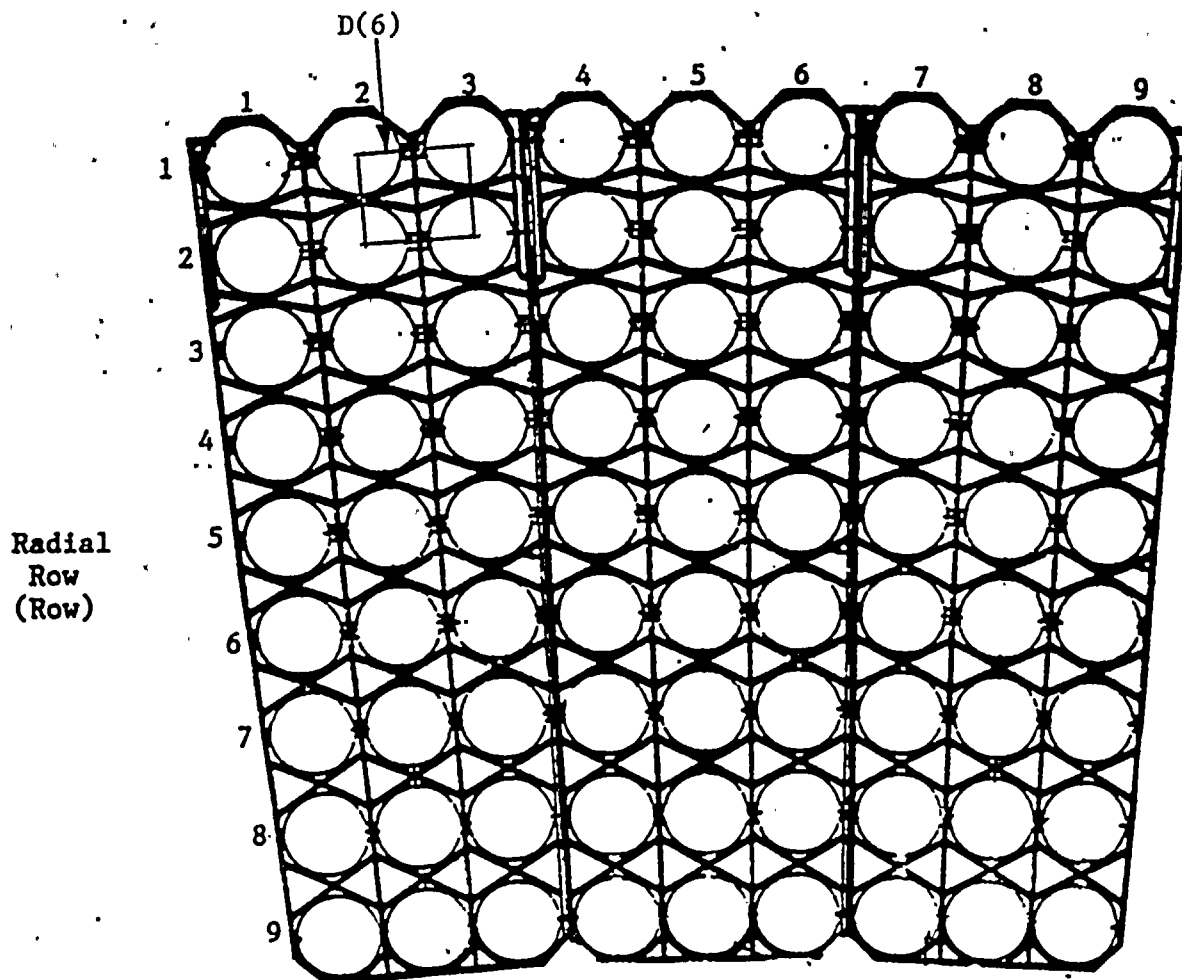
ATTACHMENT 8

Bay 17 (of 24 total)
