SUBJECT: LER 87-020-00: on 870917, determined that in event of fault of balance-of-plant cables, loss of control power on both independent trians of related panels could occur. Caused by deficient design. Design changes implemented. W/871019 ltr.

## LICENSEE EVENT REPORT (LER)

FACILITY NAME (1) D. C. Cook Nuclear Plant, Unit 1										DOCKET NUMBER (2) 0 5 0 0 0 3 1 5					PAGE (3) 1 OF 0 6								
TITLE (4) Lack of Isolation Between Balance of Plant and Essential Safety System Loads Due to Potential Design Deficiency																							
EVENT DATE (5)			LER NUMBER (6)				REPORT DATE (7)			OTHER FACILITIES INVOLVED (8)													
MONTH	DAY	YEAR	YEAR	SEQUENTIAL NUMBER	REVISION NUMBER	MONTH	DAY	YEAR	FACILITY NAMES				DOCKET NUMBER(S)										
0	9	1	7	8	7	0	2	0	D.C. Cook, Unit 2				0 5 0 0 0 3 1 6										
0	9	1	7	8	7	0	2	0	0	0	1	0	1	9	8	7	0	5	0	0	0	1	1
OPERATING MODE (9)		THIS REPORT IS SUBMITTED PURSUANT TO THE REQUIREMENTS OF 10 CFR §: (Check one or more of the following) (11)																					
5		20.402(b)				20.405(c)				50.73(a)(2)(iv)				73.71(b)									
POWER LEVEL (10)		0 0 0				20.405(a)(1)(i)				50.36(c)(1)				50.73(a)(2)(v)			73.71(c)

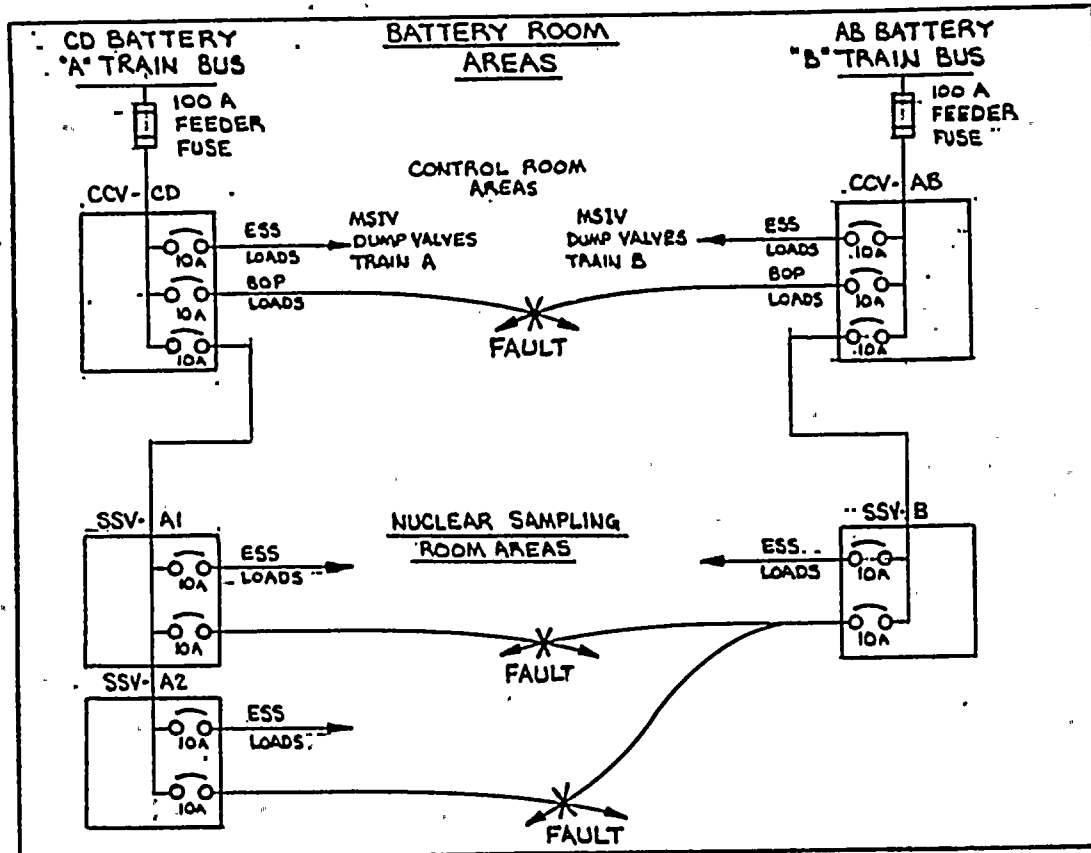
ATTACHMENT NO. 1  
DEMONSTRATION OF FAULT CONDITIONS

On September 17, 1987, at approximately 1730 hours, during a review of an internal Safety System Functional Inspection on our auxiliary feedwater system (EIIS/BA), it was determined that in the event of a fault in certain Balance Of Plant (BOP) cables (EIIS/CBL), which would involve distribution panels from both independent trains (see Attachment 1), a loss of control power on both independent trains of related Essential Safety System (ESS) distribution panels could occur.

The following distribution panels (EIIS/BL) utilize electrical circuit breakers (EIIS/BKR) manufactured by the Heinemann Electric Company (Series 0441).

Unit 1:	Train A 1-CCV-CD	1-SSV-A1, 1-SSV-A2
	Train B 1-CCV-AB	1-SSV-B
Unit 2	Train A 2-CCV-CD	2-SSV-A1, 2-SSV-A2
	Train B 2-CCV-AB,	2-SSV-B

The breakers are used for 250 VDC service. It was discovered that the interrupting capability of the Heinemann breakers, as used for D. C. Cook, is not specified by the manufacturer at 250 VDC. Furthermore, with the specified lower voltage (125 VDC) interrupting curves (trip current vs. time), a comparison of the breakers with their upstream fuses (Gould-Shawmut Trionic, or Bussman FRN) (EIIS/FU) indicates a lack of coordination for fault currents above approximately 1500 amps. Investigation concluded that this condition has existed since the initial startup of the units.

The cause of this event was a potential deficient design which could have caused insufficient breaker interrupting capability in conjunction with a lack of isolation between BOP and ESS loads.
