SUBJECT: Forwards executive summary of investigation, results of
 investigation & conclusions re integrity of containment
 operating deck hatches.

Donald C. Cook Nuclear Plant Units 1 and 2
Docket Nos. 50-315 and 50-316
License Nos. DPR-58 and DPR-74
INVESTIGATION OF INTEGRITY OF CONTAINMENT OPERATING DECK
HATCHES EXECUTIVE SUMMARY

D. C. COOK NUCLEAR PLANT - UNIT #1
CONTAINMENT INVESTIGATION - REACTOR COOLANT PUMP & CRDM HATCHES
EXECUTIVE SUMMARY

D. C. COOK NUCLEAR PLANT - UNIT #2
CONTAINMENT INVESTIGATION REACTOR COOLANT PUMP HATCHES
EXECUTIVE SUMMARY

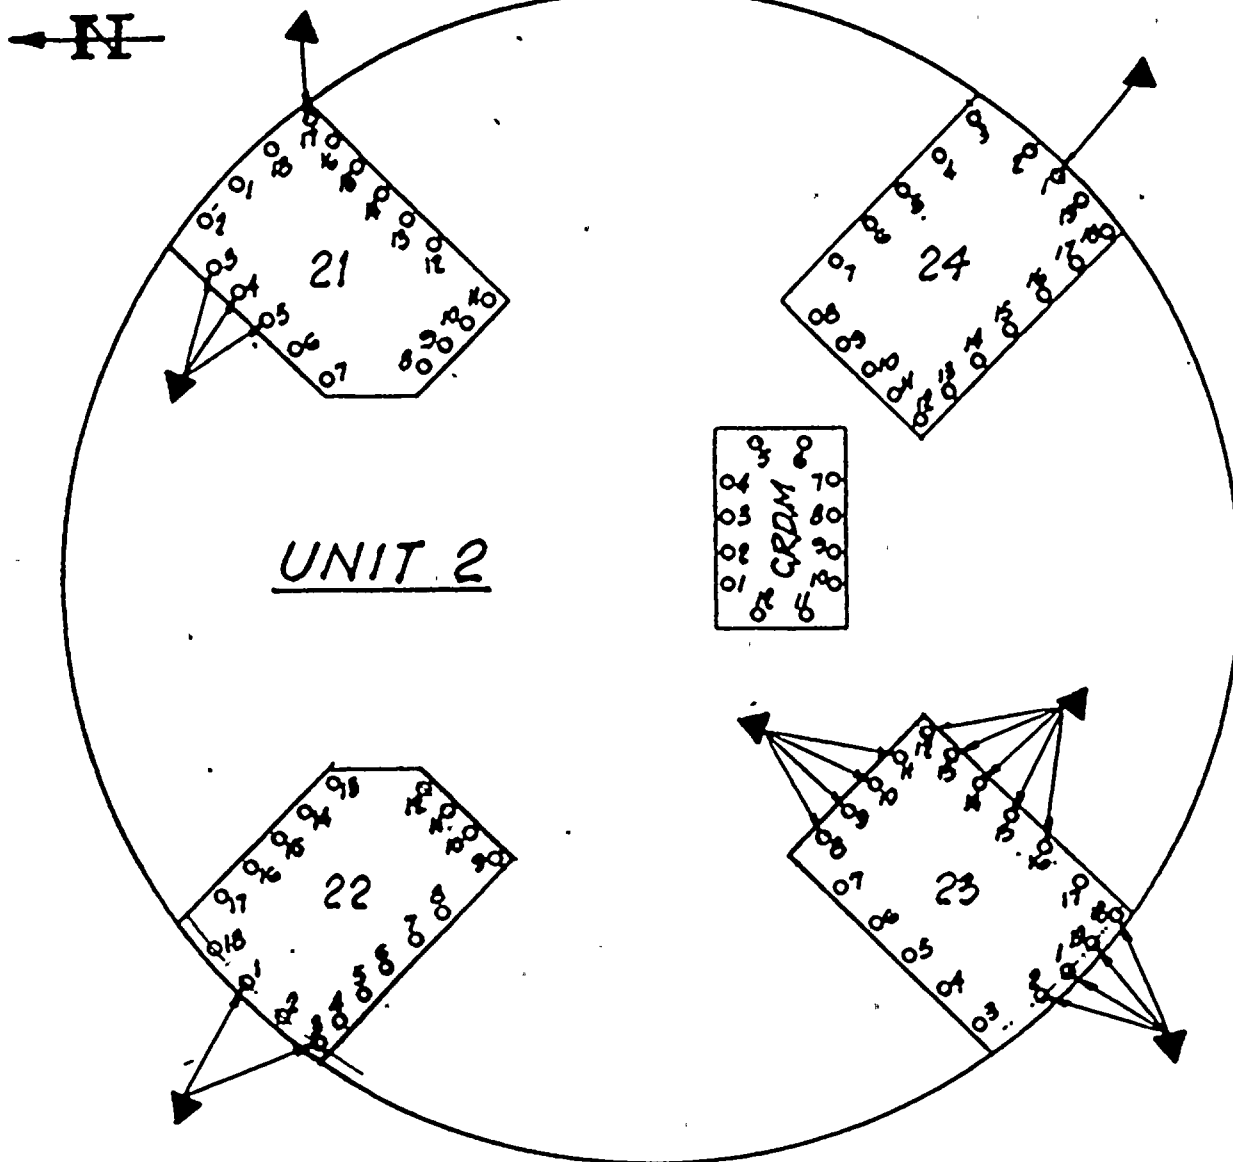
FIGURE NO. 7

Hatch #21

3 bolts cut off and rewelded - bolts #3, #4 & #5.

1 stud with no embedded anchor bolt in concrete below - bolt #17.

Hatch #22

1 bolt cut off and rewelded - bolt #1.

1 stud with no embedded anchor bolt in concrete below - bolt #3.

Hatch #23

12 bolts cut off and rewelded - bolts #1, #2, #8 thru #16, and #19.

1 stud with no embedded anchor bolt in concrete below #18.

Hatch #24

The bolt layout and the locations of the suspect bolts are shown in Figure No. 7.

AEP modified the as-found configuration of every suspect Unit #2 anchor bolt to a configuration as close to the original design as was possible. With the exception of bolt #17 on Hatch #21, bolt #3 on Hatch #22 and bolt #18 on Hatch #23, all of the Unit #2 RCP hatch anchor bolts that were cut and rewelded have been modified in accordance with Figures No. 8 thru 22. The rewelded studs have been removed. The embedded anchor bolts have been freed of any connection to the seal channel. The top of the embedded anchor bolts have been threaded and extension nuts have been installed on those threads. ASTM A193 studs have been installed in the other end of the extension nuts to fit into the hatch cover bolt pockets. These bolt pockets were modified to accept the location of the modified anchor bolts.

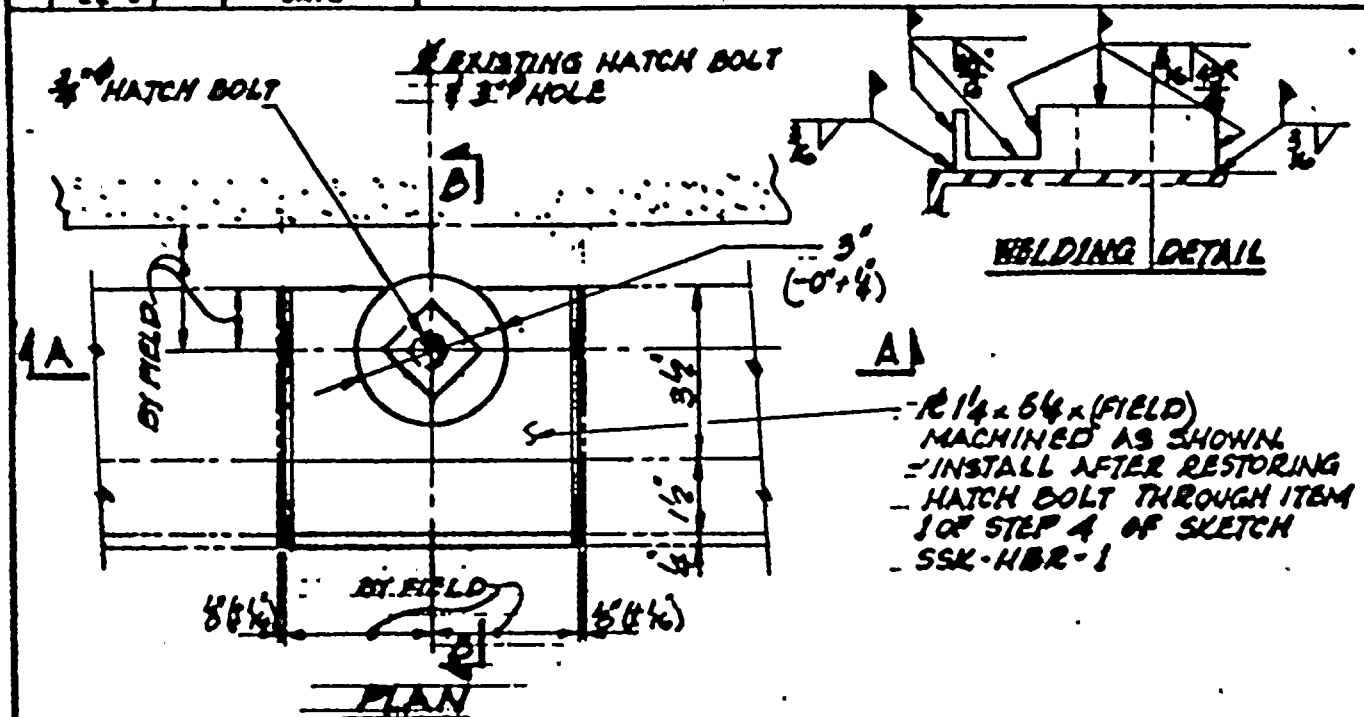
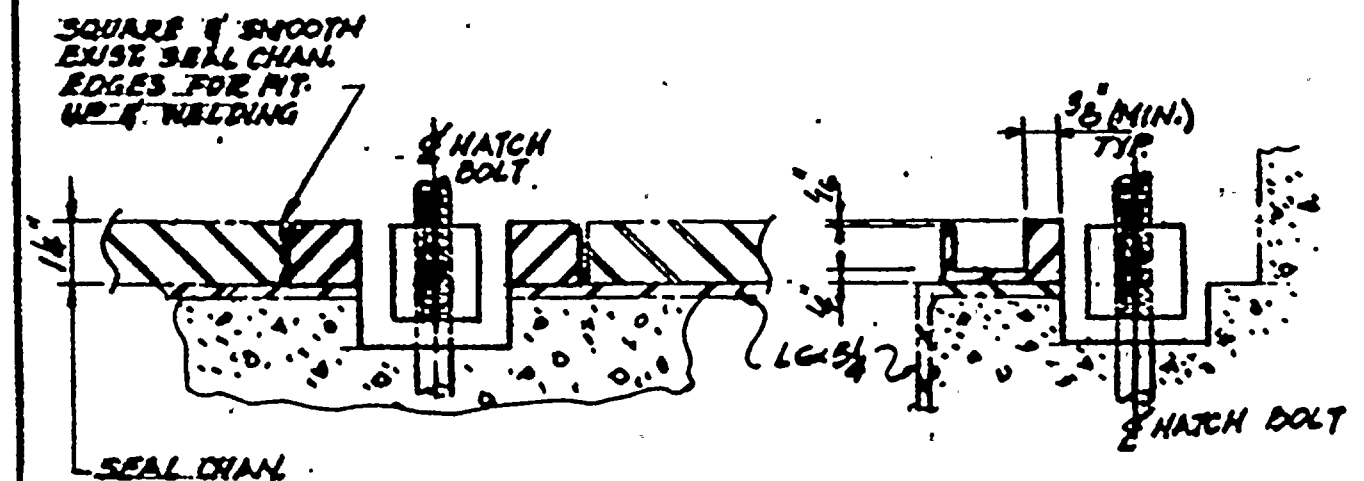
DR. *D.S.* AMERICAN ELEC. POWER SERVICE CORP.
CH. *ML/JAR* *gh* UNIT #2 RCP HATCH COVER #23
DATE 9-22-87 SEAL CHANNEL RESTORATION @ BOLT #9

Bolt #9 in hatch #23 and a section of the seal channel it was attached to were cut out and a lengthwise slice was made through the specimen to examine the weld. This bolt was selected because from previous analyses we knew that bolt #9 was one of the lesser loaded bolts in the hatch. Cutting out this bolt posed less risk in the restoration of the hatch. The slice was sent to Westinghouse Electric Corporation's General Technology Systems Division (metallurgical laboratory) for testing to establish an analytical baseline. The results of the metallurgical analysis showed that:

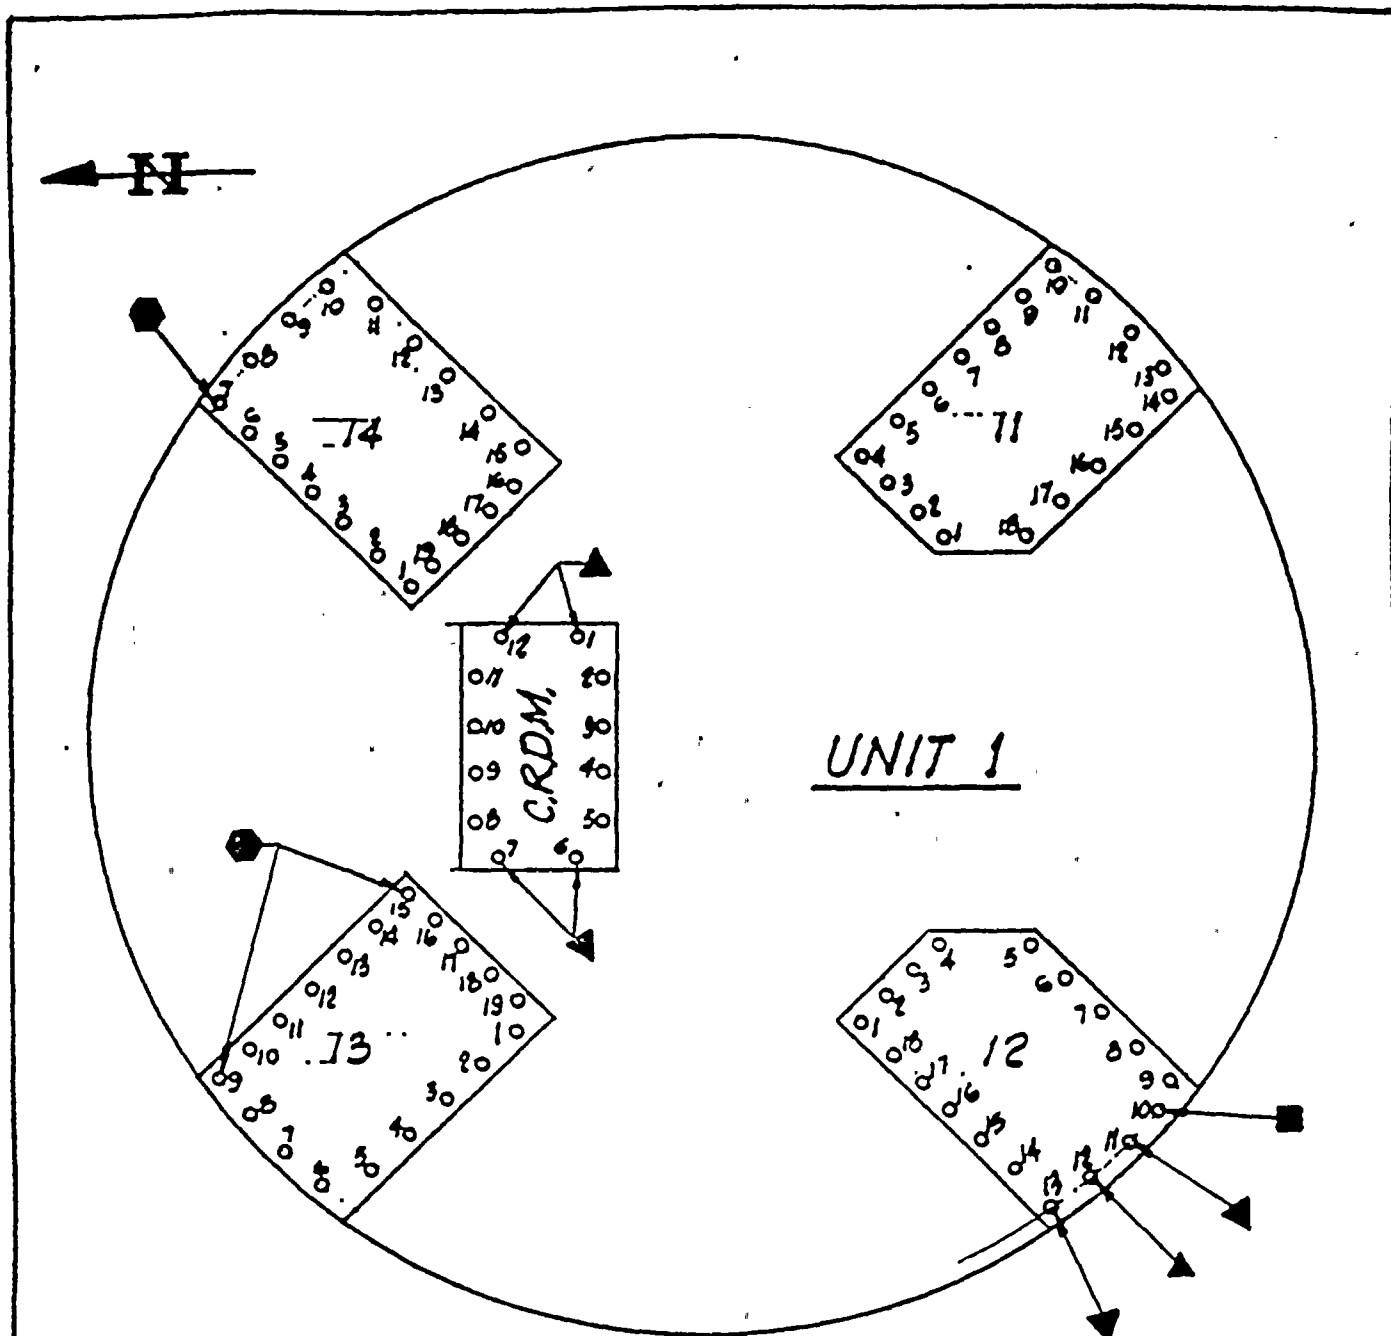
UNIT #1 AS-FOUND CONDITION
- RCP & CRDM HATCH
ANCHOR BOLTS

Hatch #12

4 bolts cut off and rewelded - bolt #10, #11, #12, and #13. Note that bolt #10 broke in the weld while being torqued.

Hatch #13

2 bolts missing - bolts #9 and #15. This had been documented and analyzed previously.

Hatch #14

1 bolt missing - bolt #7. This had been documented and analyzed previously.

CRDM Hatch

4 bolts cut off and rewelded - bolts #1, #6, #7 and #12.

The bolt layout and the locations of the suspect bolts are shown in Figure No. 25.

Based on the experience gained in restoring the bolts cut off and rewelded in Unit #2, AEP has decided to restore all the Unit #1 bolts that were cut off and rewelded or missing in a way similar to that which was done on Unit #2. This work is planned for the next scheduled Unit #1 outage in 1989. (Figures No. 12 through 15, 17, 19 and 21 show the type of restoration planned for the Unit #1 bolts.)
