SUBJECT: LER 88-002-00: on 880326, ice buildup in ice condenser flow passages due to sublimation.

## LICENSEE EVENT REPORT (LER)

FACILITY NAME (1)  
D. C. Cook Nuclear Plant - Unit 1

Ice Buildup in Ice Condenser Flow Passages Due to Sublimation

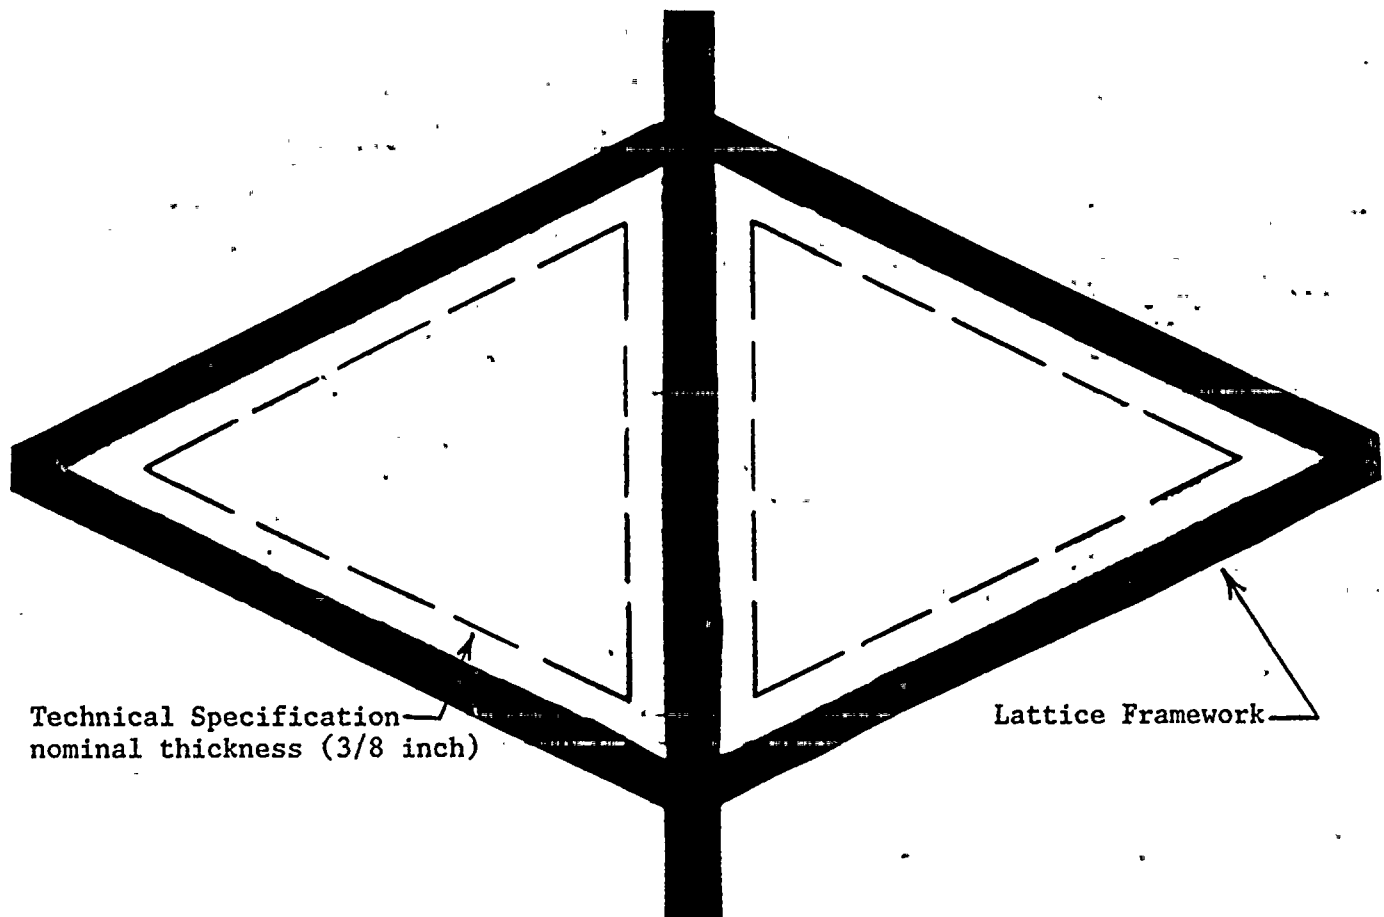
## ATTACHMENT 2

### Representative Diagram of Ice/Frost Buildup in Two Flow Passages

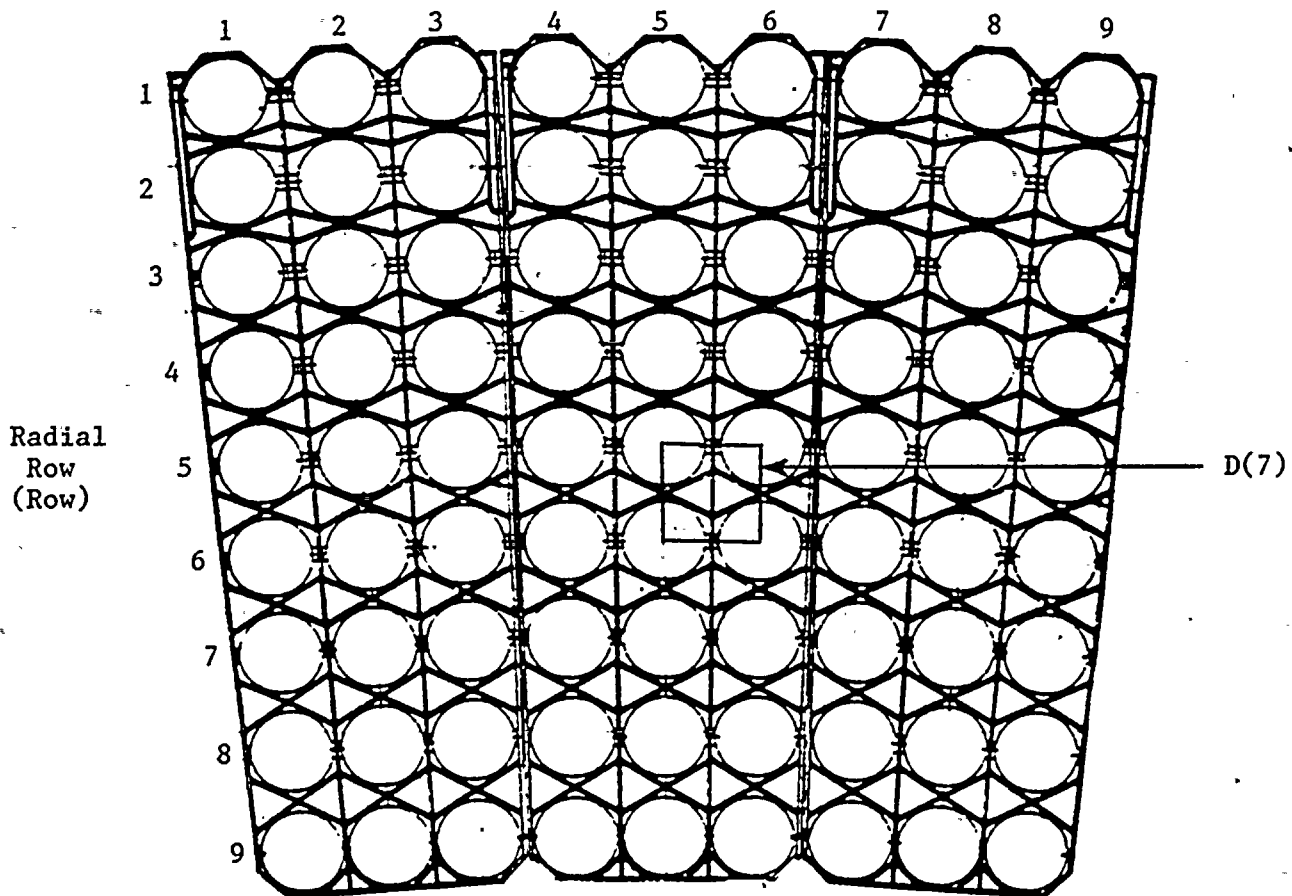
Bay 5 (of 24 total)

The as-found visual inspection ice condenser (EIIS/COND) flow passages conducted on March 26, 1988, indicating frost and ice accumulation greater than 3/8 inch in two flow passages in Bay 5, four flow passages in Bay 17, two flow passages in Bay 19 and four flow passages in Bay 24. Subsequently, the inspection was expanded to include at least twenty additional flow passages in each of these bays. This inspection revealed no additional frost or ice buildup in any of the additional flow passages inspected. A total of 12 flow passages were affected. There are a total of 3072 flow passages in the Ice Condenser. Attachments 1 through 6 graphically describe the geometry of the flow passages and the location of the ice/frost accumulation. The flow passages were declared inoperable at 1530 hours on March 26, 1988.

The corrective action was to manually clean the flow passages to remove the accessible frost and ice buildup. The AHU with the clogged drain line was turned off and the drain line has been cleaned. Operations performs tours of the ice condenser at least three times per week. The tour includes a check for proper operation of the air handling units and initiation of required corrective actions for malfunctioning units. To address future indications of AHU overflow, administrative controls will be developed and put in place by October 1, 1988, to evaluate any effect(s) of AHU overflow on flow passages and to implement appropriate corrective actions.
