SUBJECT: LER 88-005-00: on 880426, insp revealed ice buildup in ice
 condenser flow passages. Caused by sublimation of ice or high
 humidity in containment air. Flow passages were manually
 cleaned & impact of buildup studied. W/880519 ltr.

LICENSEE EVENT REPORT (LER)

FACILITY NAME (1) D. C. Cook Nuclear Plant - Unit 2										DOCKET NUMBER (2) 0 5 0 0 0 3 1 6					PAGE (3) 1 OF 0 7								
TITLE (4) Ice Buildup in Ice Condenser Flow Passages Due to Sublimation																							
EVENT DATE (5)			LER NUMBER (6)				REPORT DATE (7)			OTHER FACILITIES INVOLVED (8)													
MONTH	DAY	YEAR	YEAR	SEQUENTIAL NUMBER	REVISION NUMBER	MONTH	DAY	YEAR	FACILITY NAMES				DOCKET NUMBER(S)										
0	4	2	6	8	8	8	8	0	0	5	0	0	0	5	1	9	8	8	0	5	0	0	0
OPERATING MODE (9)		5		THIS REPORT IS SUBMITTED PURSUANT TO THE REQUIREMENTS OF 10 CFR §: (Check one or more of the following) (11)																			
POWER LEVEL (10)		0 0 0		20.402(b)				20.406(e)				50.73(a)(2)(iv)				73.71(b)

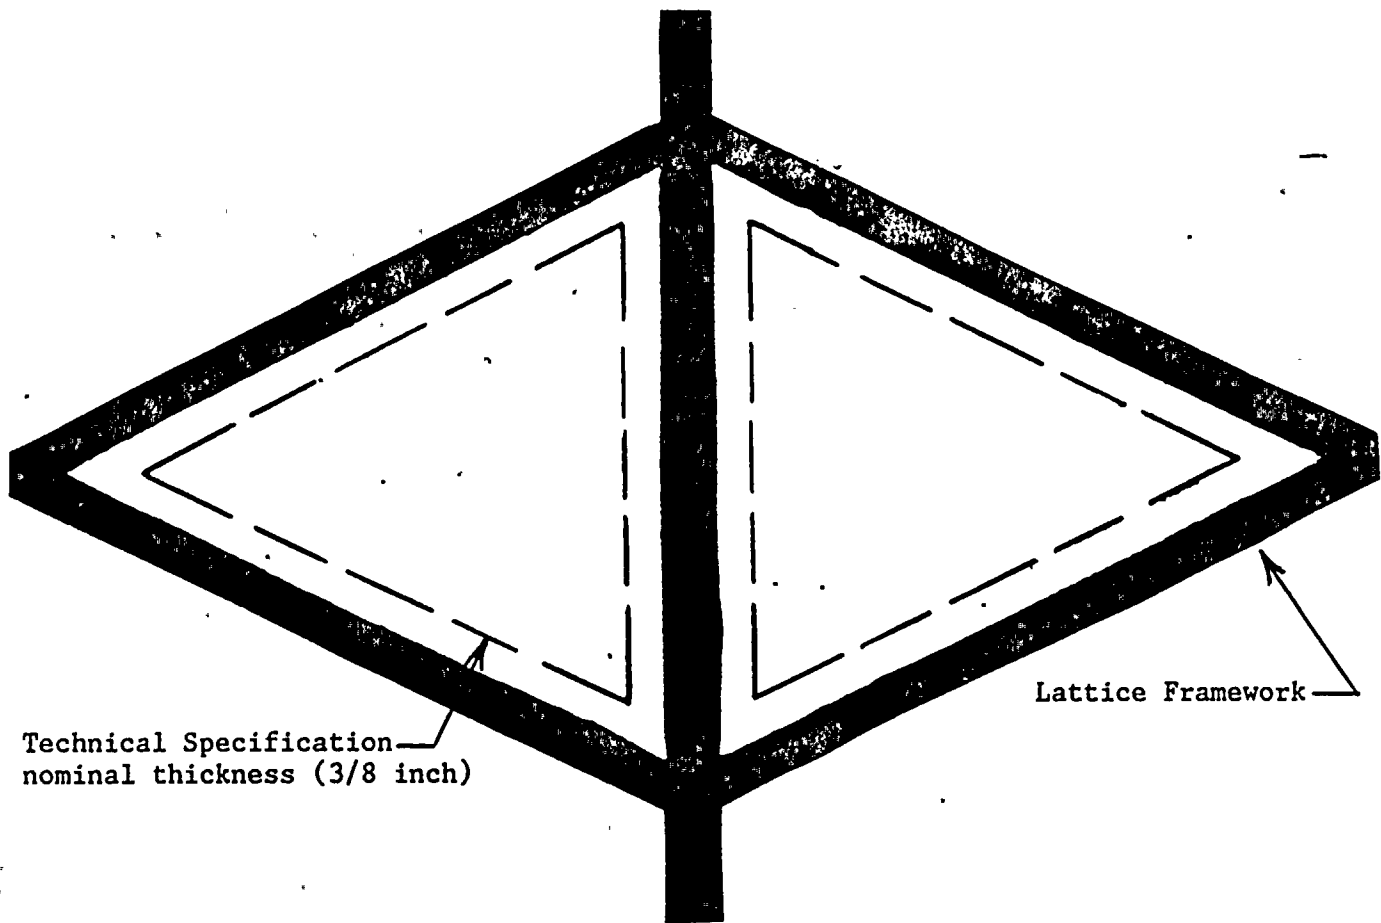
ATTACHMENT 2

The as-found visual inspection ice condenser (EIIS/COND) flow passages conducted on April 26, 1988, indicating frost and ice accumulation greater than 3/8 inch in two flow passages in Bay 4. Subsequently, the inspection was expanded to include at least twenty additional flow passages in that bay. This inspection revealed an additional two flow passages with more than 3/8 inch frost and ice buildup. A total of 4 flow passages were affected. There are a total of 3072 flow passages in the Ice Condenser. Attachments 1 through 6 graphically describe the geometry of the flow passages and the location of the ice/frost accumulation.

Representative Diagram of Ice/Frost Buildup in Two Flow Passages

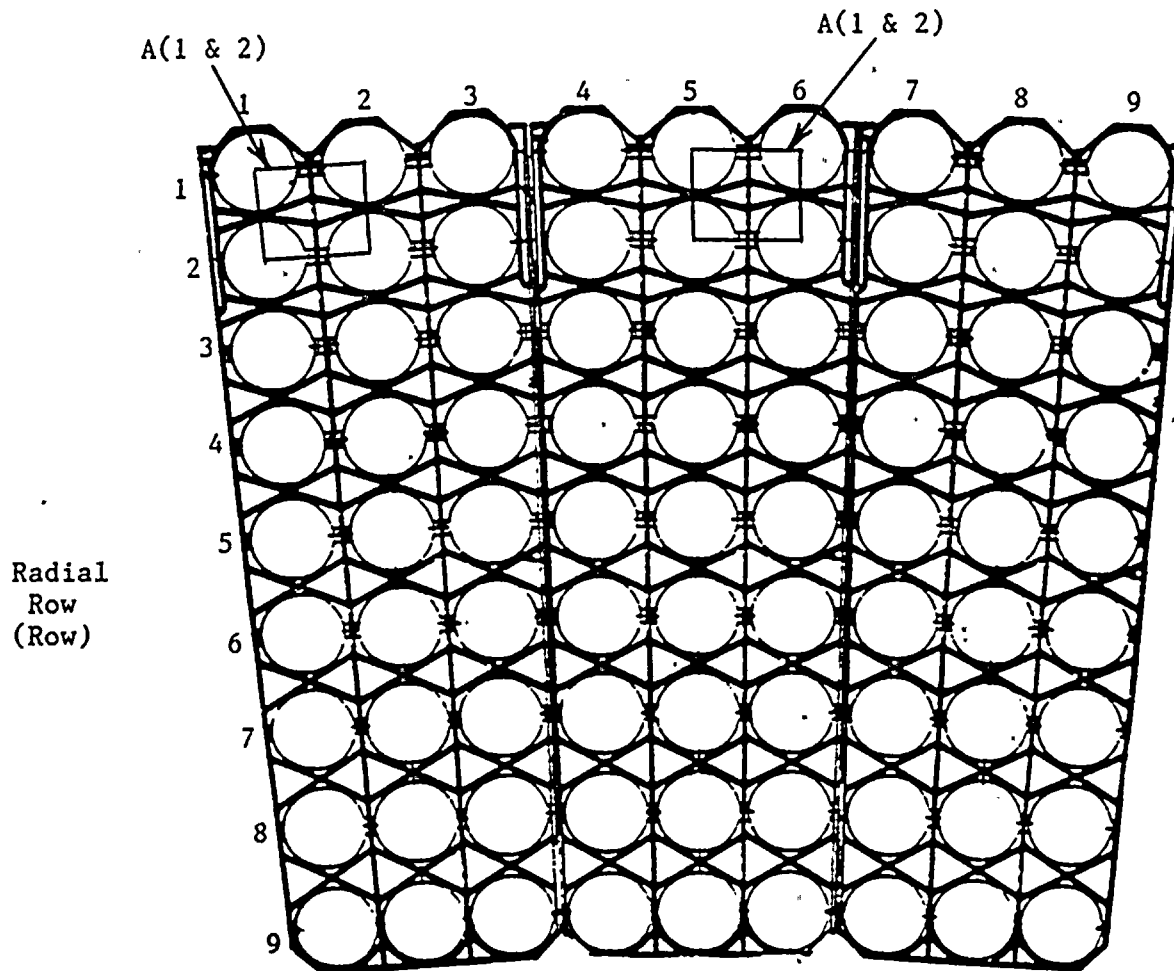
ATTACHMENT 3

Category	Description*
A	Maximum Flow Passage Ice/Frost Blockage greater than 75 percent.
B	Maximum Flow Passage Ice/Frost Blockage between 50 and 75 percent.
C	Maximum Flow Passage Ice/Frost Blockage between 25 and 50 percent.
D	Maximum Flow Passage Ice/Frost Blockage less than 25 percent (but greater than 3/8" buildup).

* NOTE: These are generalized categories which reflect the maximum ice/frost blockage found in a particular flow passage and in general was limited to one or two lattice frameworks in the flow passage. This does not indicate that the flow passage was blocked it's entire length. Lattice Framework is located at the positions of cruciforms in the ice basket. Cruciforms are installed every six feet within the 48 foot ice basket (for convention the "top" lattice framework is referred to as number 1, etc.). The specific lattice frameworks affected are indicated on the individual Bay drawings (Attachment 3).

Bay 4 (of 24 total)

NOTE: The Lattice Frameworks affected are indicated in parenthesis after the category description number (see ATTACHMENT 1).

The corrective action was to manually clean the flow passages to remove the accessible frost and ice buildup.
