SUBJECT: LER 88-004-00:on 880606,use of improperly aligned test
 recorder results in nuclear instrumentation channel error.
 W/8 ltr.

LICENSEE EVENT REPORT (LER)

FACILITY NAME (1) D. C. COOK NUCLEAR PLANT - UNIT 1										DOCKET NUMBER (2) 0 5 0 0 0 3 1 5										PAGE (3) 1 OF 0 5	
TITLE (4) USE OF IMPROPERLY ALIGNED TEST RECORDER RESULTS IN NUCLEAR INSTRUMENTATION CHANNEL BEING OUT OF SPECIFICATION

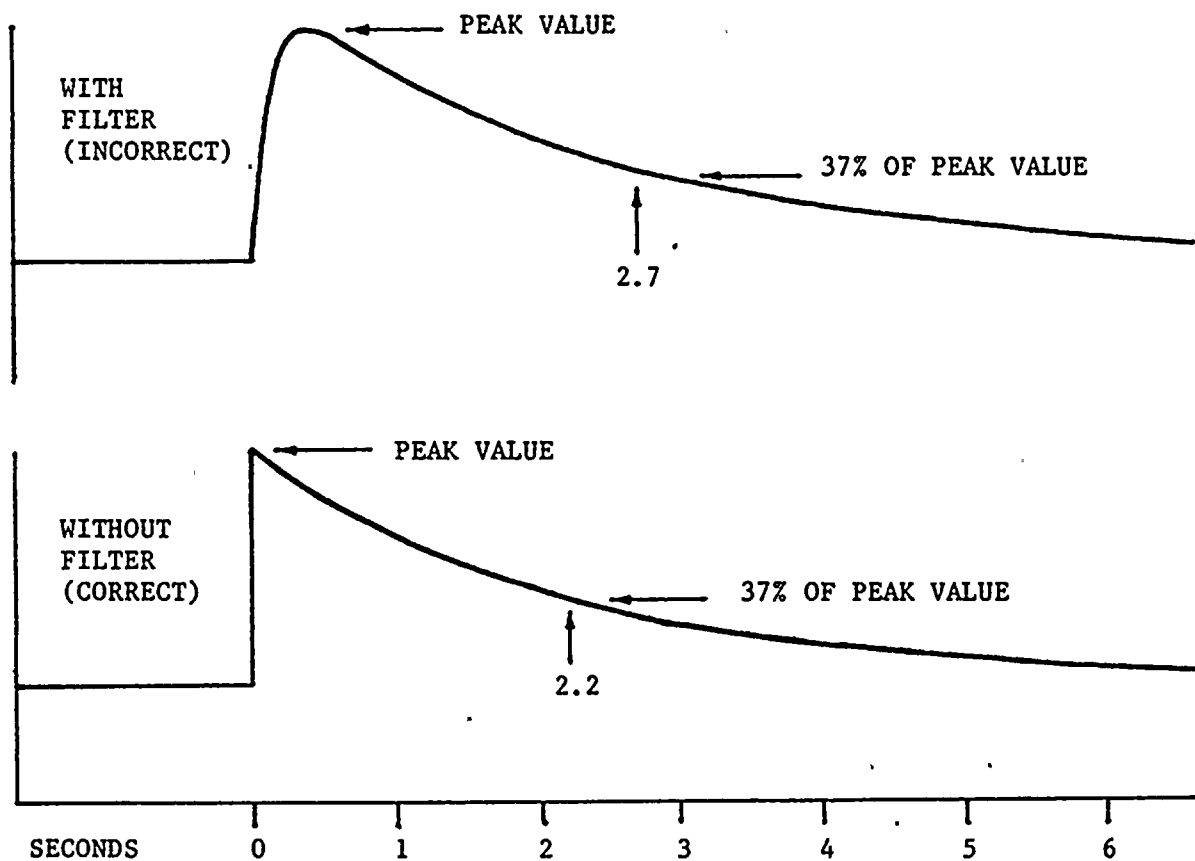
During the routine supervisory review of the test data, the supervisor observed that the shape of the recorder trace was different than expected (see attached graphs) and initiated an investigation. The test equipment used was a Western Graphtec, Model 3101 two channel strip chart recorder. The recorder is equipped with an input filter that can be switched in or out of service. The input filter is used to dampen rapid fluctuations or noise during certain applications. The investigation revealed that during the calibration of Power Range Channel N-41, the input filter was in the IN position, which is incorrect for this application. The input filter being in the circuit affected the recorder output graph which is used to determine the response of the instrument circuit.

The input filter switch is located inside the recorder and is an integral part of a module that is plugged into the recorder. Its position is not readily apparent. The input filter switch is normally kept in the OFF position. Lack of identification on the test recorder that the input filter was switched into the circuit as an off normal condition was the primary cause of the event.

The Technical Specification Table 2.2-1 Allowable Value for the rate module time constant is equal to or greater than 2 seconds. The as left value following the erroneous adjustment of Power Range Channel N-41 was 1.7 seconds, making the channel technically inoperable.

EFFECT OF FILTER ON RECORDED OUTPUT
OF RATE MODULE TIME CONSTANT
ADJUSTED AT 2.2 SECONDS

The test equipment misconfiguration was corrected and the rate module time constant recalibrated on June 7, 1988.

To control the recorder filter switch position, a "Limited Use" tag will be affixed to the recorder during times that the filter is on.
