AEP:NRC:0980Q

Donald C. Cook Nuclear Plant Unit 2
Docket No. 50-316
License No. DPR-74
UNIT 2 RCS LOOP WELD INSPECTION PROGRAM

UNIT 2 RCS LOOP WELD INSPECTION PROGRAM

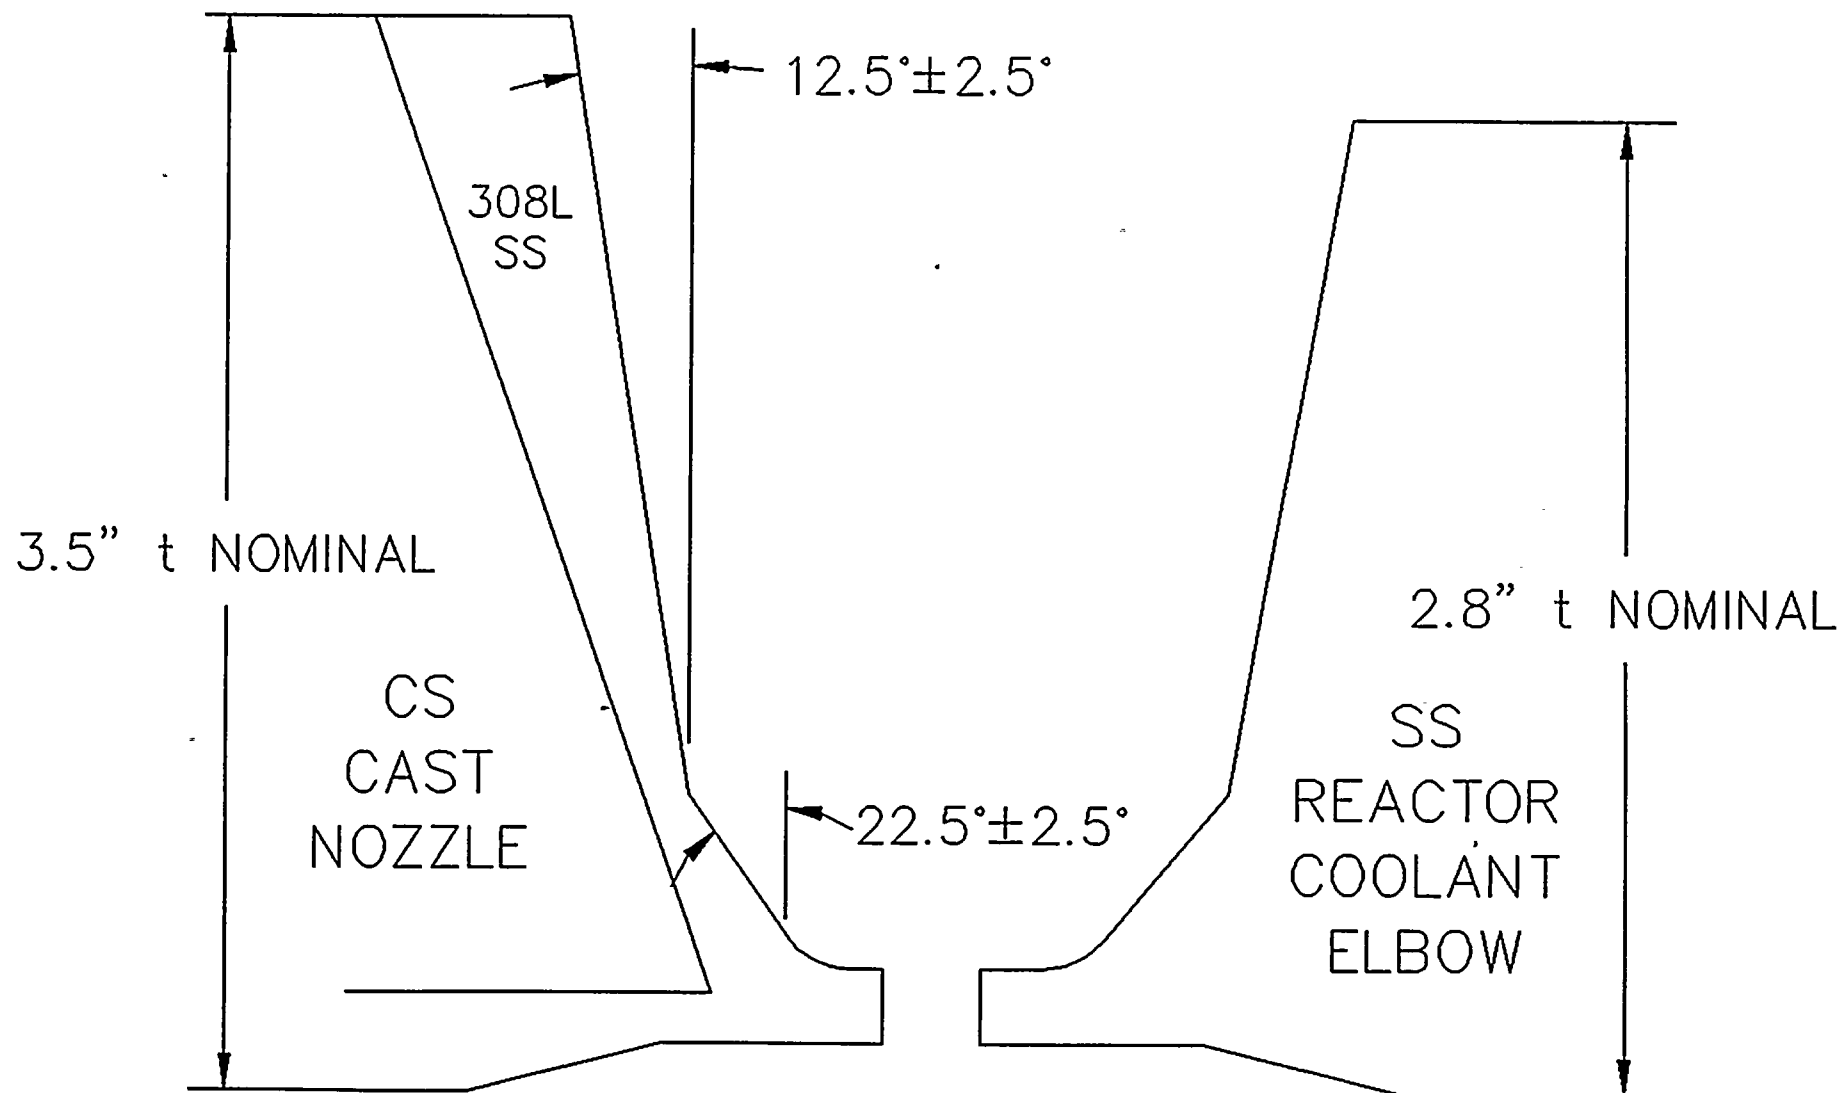
FIGURE 1

The steam generator nozzle to reactor coolant elbow weld joint is a compound bevel, single-U groove weld oriented in the 6G position (Figure 1). The nozzle is cast carbon steel (SA-216 Grade WCC) on which 308L stainless steel buttering is applied with a flux-cored arc welding process over an initial underlay of 309L. The root passes of the nozzle to elbow weld are 308 stainless steel manual gas tungsten arc welds, and the fill is 308 deposited with an automatic gas tungsten arc welding machine. The difficulty encountered was in obtaining complete fusion along the 308L buttering interface when welding progressed above the change in joint bevel. Sporadic weld pool behavior and poor wetting were observed when the gas tungsten arc weld was made over the flux core deposited buttering. Visually observable cracking occurred on the nozzle side of the joint due to poor fusion at the nozzle caused by the tight joint access, poor wetting, and the force of gravity. The poor fusion at the nozzle created a notch at the interface between the weld metal and nozzle buttering from which a crack was propagating as a result of shrinkage stresses in the deposited layer.

In addition to in-process informational radiographs and final code acceptance radiographs, all Unit 2 steam generator nozzle to reactor coolant elbow welds have been radiographed at an angle to the weld joint. These radiographs were oriented along the 12.5° joint prep angle shown in Figure 1. This was done to provide maximum detectability of any planar indications on the nozzle side of the joint.

The surface cracking was relieved by welding technique changes. To reduce shrinkage stresses in the joint, bead width was reduced by eliminating torch oscillation and depositing stringer beads. Bead sequencing was changed to start each layer at the nozzle side of the joint first and progress towards the elbow side. These welding technique changes relieved the surface cracking by reducing shrinkage stresses in the weld joint. Although shrinkage stresses were reduced, the tight joint access continued to cause lack of fusion defects after the cracking problem was solved. The lack of fusion defects were embedded in the weld, occurred in the middle 1/3 of the thickness of the weld joint, and were detectable by radiography. Lack of fusion detected by radiography is a linear indication per ASME Section III, and is required to be repaired.

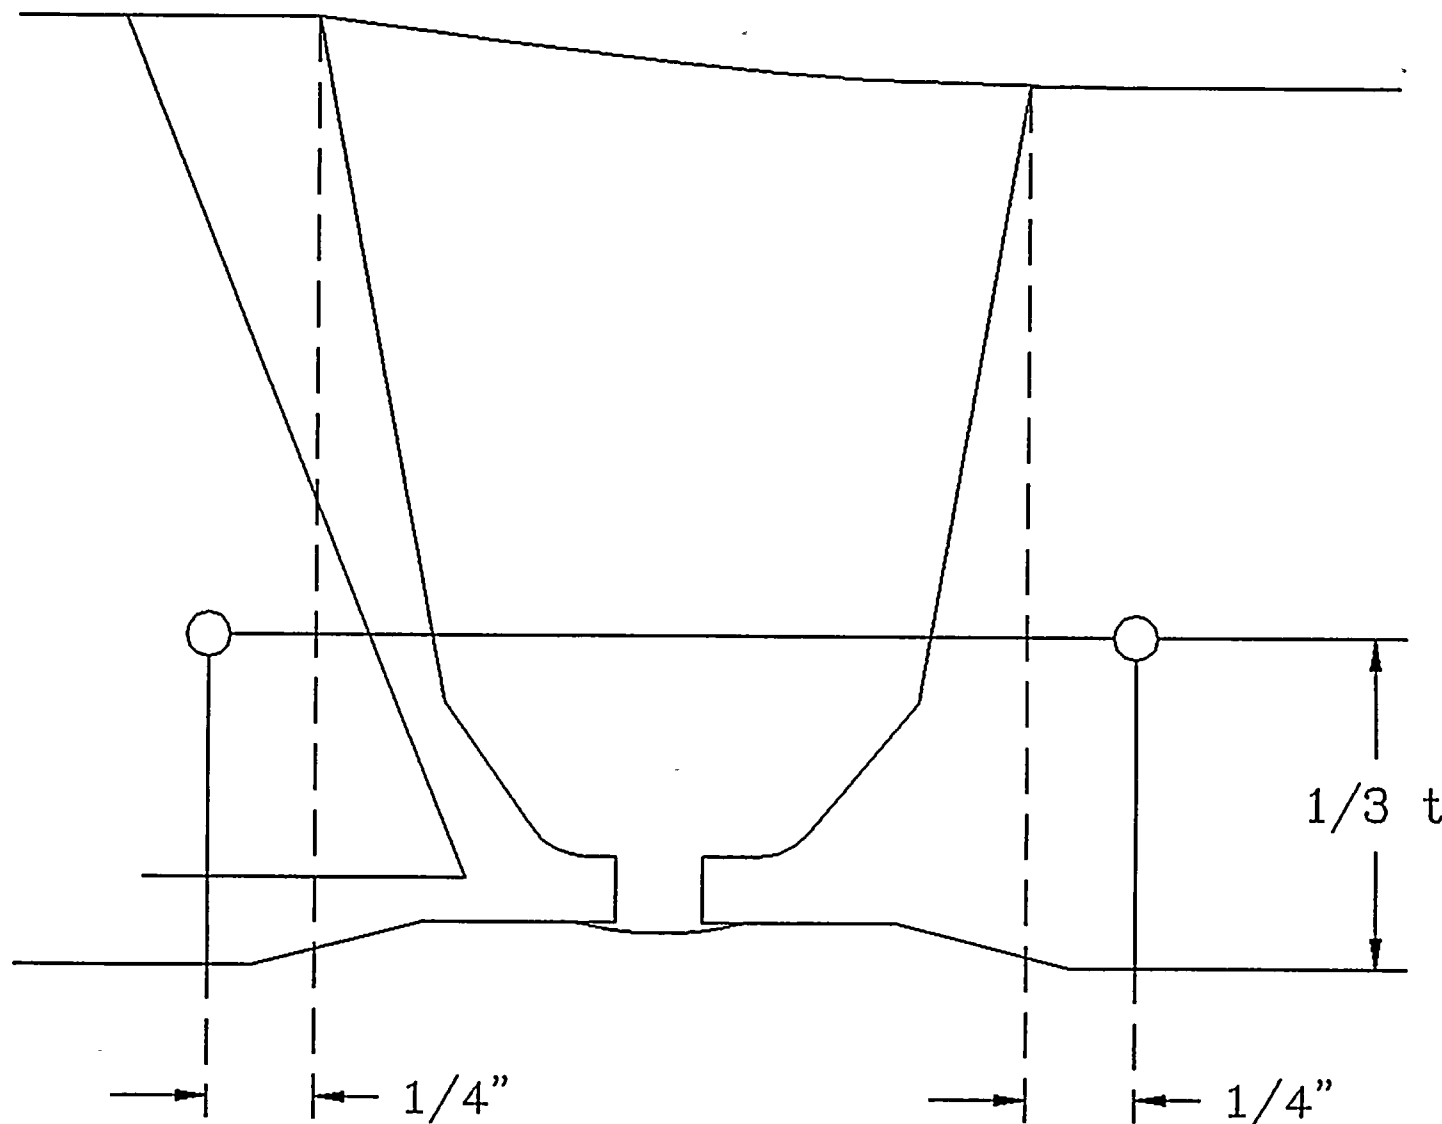
FIGURE 4

Figure 4 shows the code required ultrasonic examination volume for preservice and inservice examinations of the steam generator nozzle to reactor coolant elbow welds. As discussed previously, all indications on these welds occurred in the middle 1/3 of the thickness, outside of the code required examination volume. As an additional level of assurance, we will perform essentially full volume ultrasonic examination of these welds during the Unit 2 preservice and inservice inspections. This expanded ultrasonic examination volume will cover the area of interest for inservice monitoring of the integrity of these welds.

In addition to the Section XI ultrasonic examination being performed on the nozzle to elbow welds, we are going to perform a second Section XI ultrasonic examination of all welds after hydrostatic and pre-operational testing. This subjects the welds to one pressure/temperature cycle, and the subsequent ultrasonic examination will serve as the official Section XI preservice baseline.

The inservice inspection program for the first 10 years following installation of the nozzle to elbow welds (second 10-year interval) will be front loaded to the maximum extent permitted by ASME Section XI code. Four steam generator nozzle to reactor coolant elbow welds will be examined during the first period of the interval (at the next scheduled refueling outage), two during the second period, and two during the third period.
