SUBJECT: LER 89-001-00:on 890116, wrong control switch operated due to  
 personnel error resulted in reactor trip.

## LICENSEE EVENT REPORT (LER)

FACILITY NAME (1) D. C. Cook Nuclear Plant - Unit One										DOCKET NUMBER (2) 0   5   0   0   0   3   1   5   1					PAGE (3) 1 OF 0   6										
TITLE (4) Wrong Control Switch Operated Due to Personnel Error Resulted in Reactor Trip																									
EVENT DATE (5)			LER NUMBER (6)				REPORT DATE (7)			OTHER FACILITIES INVOLVED (8)															
MONTH	DAY	YEAR	YEAR	SEQUENTIAL NUMBER	REVISION NUMBER	MONTH	DAY	YEAR	FACILITY NAMES				DOCKET NUMBER(S)												
0	1	1	6	8	9	8	9	0	0	1	0	0	0	2	1	5	8	9	0	5	0	0	0	0	0
OPERATING MODE (9)		THIS REPORT IS SUBMITTED PURSUANT TO THE REQUIREMENTS OF 10 CFR §: (Check one or more of the following) (11)																							
POWER LEVEL (10)		20.402(b) <input checked="" type="checkbox"/> 20.405(c) <input checked="" type="checkbox"/> 50.73(a)(2)(iv) <input type="checkbox"/> 73.71(b) <input type="checkbox"/>																							
0   7   1		20.405(a)(1)(i) <input type="checkbox"/> 50.36(c)(1) <input type="checkbox"/> 50.73(a)(2)(v) <input type="checkbox"/> 73.71(c) <input type="checkbox"/>

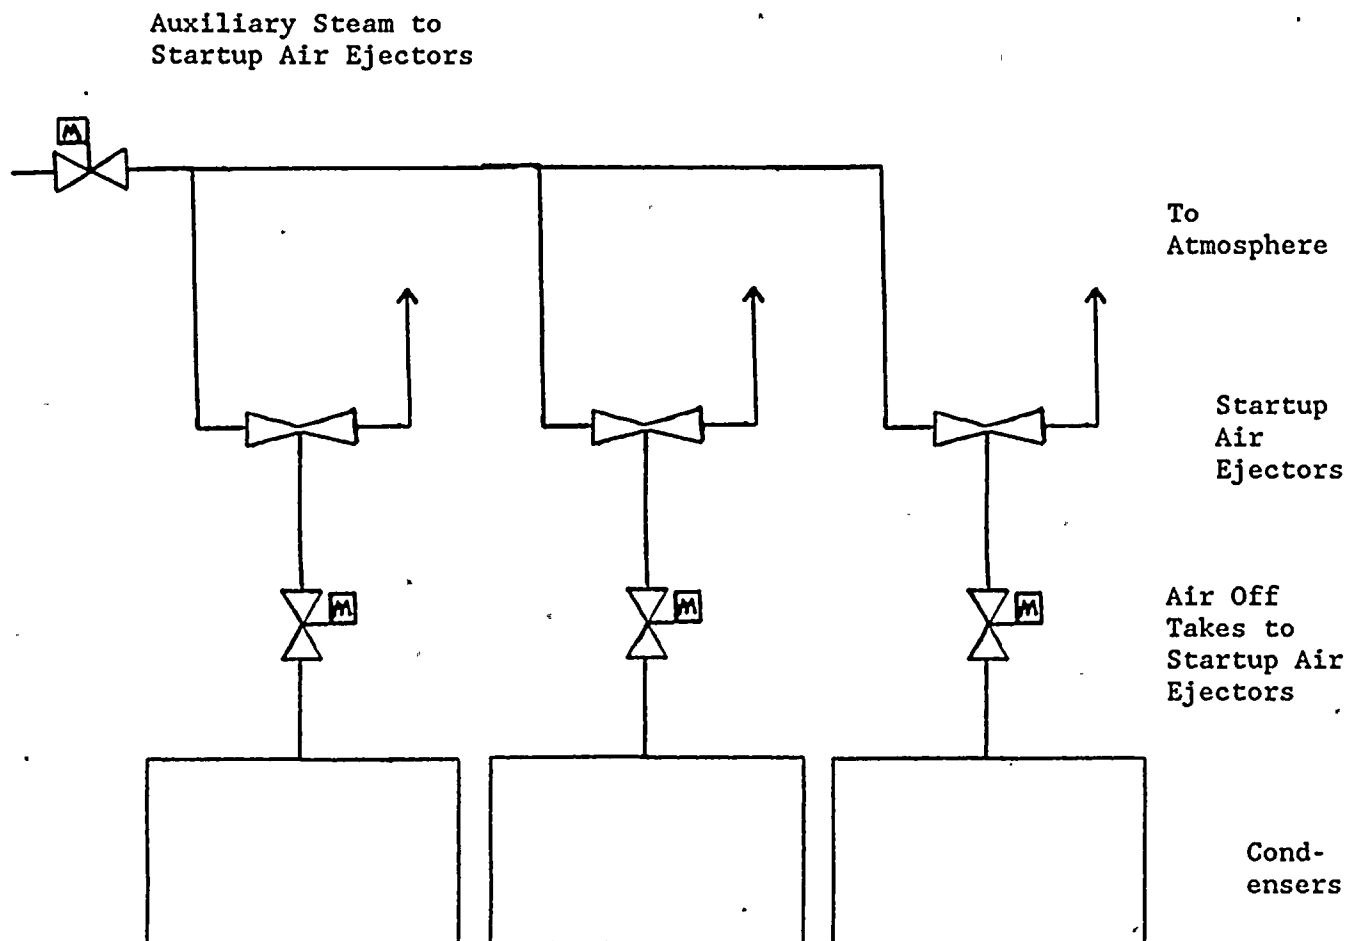
## DIAGRAM OF STARTUP AIR EJECTOR ARRANGEMENT

On 01/16/89 the Plant Heating Boiler (PHB) (EIIS/SA-BLR) was being operated for testing purposes after maintenance. To accommodate load testing, the Unit Supervisor (Senior Licensed Operator) gave instructions to one of the Reactor Operators (RO) (Licensed Operator) for aligning the 150 psig auxiliary steam header (EIIS/SA) to the PHB. The RO was also given instructions to open the 150 psig motor operated auxiliary steam supply valve (EIIS/SA-ISV) to the start-up air ejectors (EIIS/SG-EJR) if the PHB testing required more load. The Unit Supervisor stressed that the motor operated condenser air off-takes (EIIS/SG-ISV) to the start-up air ejectors were not to be operated. (See simplified drawing, page 6 of 6.)

The Control Room was later notified that more load was needed on the PHB. The RO established communication with the boiler room and relayed that he was going to open the steam supply valve to the start-up air ejectors. The RO then mistakenly operated the control switch for the condenser air off-takes to the start-up air ejectors, resulting in an open signal. In order to increase the steam flow slowly, the RO pulled on the control switch to stop the valve travel. When the switch would not pull out, the RO began to realize his error. Within a few seconds from going to open on the switch, the main condenser low vacuum alarm (EIIS/SG-PA) setpoint of 24.3" Hg was reached. The RO attempted to close the air off-takes, but the valves must travel full open before they will close. The Unit Supervisor opened the steam supply to the start-up air ejectors in an attempt to stop the vacuum decrease, but the low condenser vacuum turbine trip (EIIS/TA-94) setpoint of 21.7" Hg was reached and the turbine (EIIS/TA-TRB) tripped, which caused a reactor (EIIS/AC-RCT) trip as designed.

The root cause of the event was personnel error by failure to perform self checking prior to operating what was thought to be the control switch for steam to the start-up air ejectors.

The RO properly identified the correct switch a few minutes prior to the event, but apparently just quickly read the label prior to actually operating the incorrect control switch. If the label on the incorrect switch had included the words "AIR TO", possibly the RO would have caught his mistake.

NOTE: The three condenser air off take motor operated valves are operated from one control switch in the Control Room. The control scheme for the air off takes is such that, once given a signal to open, they must travel full open before it is possible to close them.

1. A case study on this event, with emphasis on the need for effective self checking will be developed for the licensed operator requalification program and replacement class.
2. The labeling for the start-up air ejector steam and air valves will be reviewed and changed for human factor concerns.
3. Appropriate administrative action was taken with the involved RO.
