SUBJECT: LER 89-002-00:on 890116,non-svc induced deformation of ECCS
 suction line seismic restraint.

LICENSEE EVENT REPORT (LER)

FACILITY NAME (1) D. C. Cook Nuclear Plant - Unit 2										DOCKET NUMBER (2) 0 5 0 0 0 3 1 6				PAGE (3) 1 OF 0 5		
TITLE (4) Non-Service Induced Deformation of Emergency Core Cooling System Suction Line Seismic Restraint																
EVENT DATE (5)			LER NUMBER (6)				REPORT DATE (7)			OTHER FACILITIES INVOLVED (8)						
MONTH	DAY	YEAR	YEAR	SEQUENTIAL NUMBER	REVISION NUMBER	MONTH	DAY	YEAR	FACILITY NAMES				DOCKET NUMBER(S)			
0 1	1 6	8 9	8 9	0 0 2	0 0	0 2	1 5	8 9					0 5 0 0 0			
OPERATING MODE (9) 6		THIS REPORT IS SUBMITTED PURSUANT TO THE REQUIREMENTS OF 10 CFR §: (Check one or more of the following) (11)														
POWER LEVEL (10) 0 0 0		20.402(b)				20.405(c)				60.73(a)(2)(iv)				73.71(b)

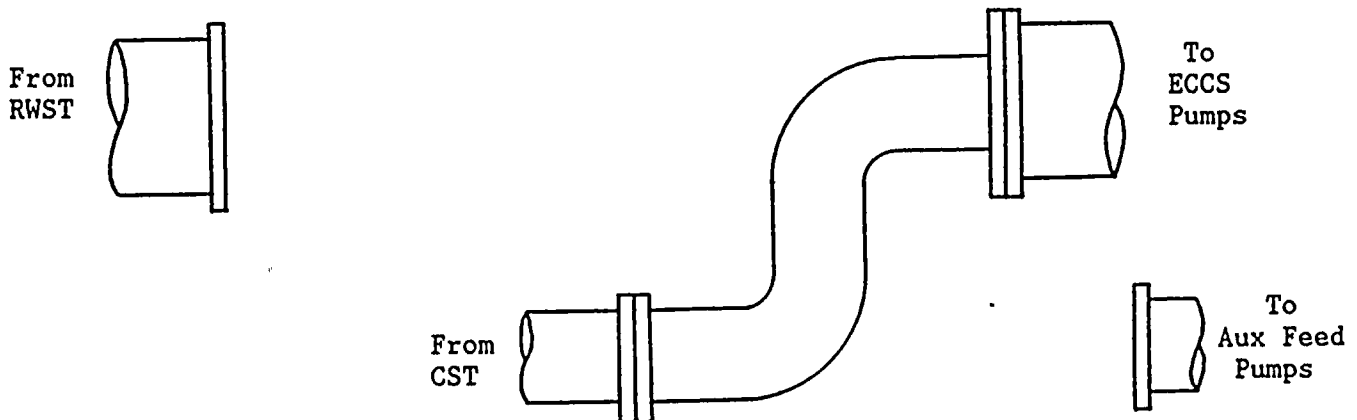
PIPING CONFIGURATION USED FOR FLUSHING AND TESTING

A review of modifications made to the system identified one potential cause for the deformation of 2GSI-L102. In order to facilitate flushing and other startup activities prior to initial unit startup a modification was made to the system, (changing this section of piping to a spool piece) to allow this portion of piping to be removed and replaced with a "jumper" spool piece. The modification, performed in 1976, was completed with one minor change to the original design; ie, the subject restraint was moved to prevent interference with newly installed flanges. No other problems were noted. A Quality Control inspection report from August 1977 noted no problems with the restraint. The startup activities removed the modified pipe section and replaced it with a spool piece connecting the ECCS pump suction to the Condensate Storage Tank (CST) (see ATTACHMENT 1). Upon completion of the startup activities, the piping was restored. It is believed that the deformation of the restraint occurred during this evolution; however, no documentation of such deformation could be located. The corresponding restraint for Unit 1 was examined. There was no similar modification performed on Unit 1 and no deformation of the restraint was seen.

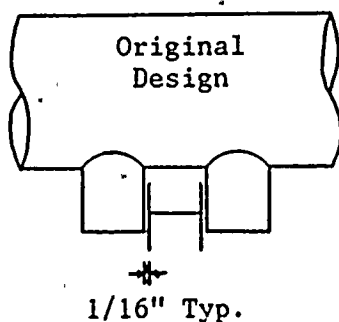
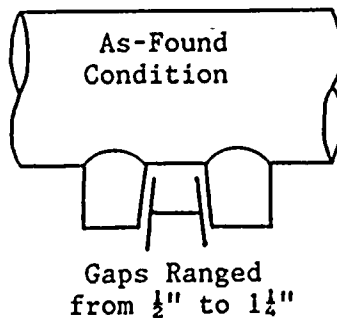
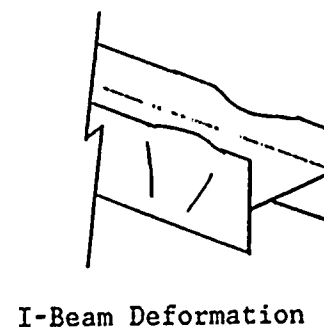
SUPPORT 2-GSI-L102 DETAIL

The deformation of the restraint was identified as deformation of the I-beam attached to the wall, along with deformation of two stanchions attached to the suction pipe (see ATTACHMENT 1). The deformation caused significant increases in the gap between the I-beam and the stanchions. Examination of the ECCS piping itself revealed no damage. The original seismic design required a one-sixteenth inch gap on each side. The gaps found from the deformation ranged from one-half to one and one-quarter inches. The design of the restraint is for seismic considerations and by definition is exempt from ISI visual examination per ASME Section XI. The restraint carries no load during normal plant operation in any plane. The purpose of the restraint is to limit horizontal movement of the suction line during a seismic event.

The investigation concluded that it is highly unlikely that the deformation of 2GSI-L102 was service induced as there have been no recorded unusual operating conditions, including a Design Basis Earthquake, which could have resulted in such significant deformation. The location of the restraint, on the suction side of the ECCS pumps, supports the likelihood that this type of deformation did not occur during service.

Due to the extent of the deformation of 2GSI-L102, it was not possible to return the restraint to its original design configuration. A revised design was developed to reinforce the restraint and reestablish the gap clearances specified by the original seismic design. A modification was initiated along with an ASME Section XI repair plan to repair the restraint. Repairs have been completed and the restraint visually inspected for final acceptance.
