SUBJECT: LER 89-017-00:on 891019,loss of turbine driven auxiliary  
 feed pump flow retention.

Operating License DPR-74  
Docket No. 50-316

TITLE (4)  
Loss of Turbine Driven Auxiliary Feed Pump Flow Retention

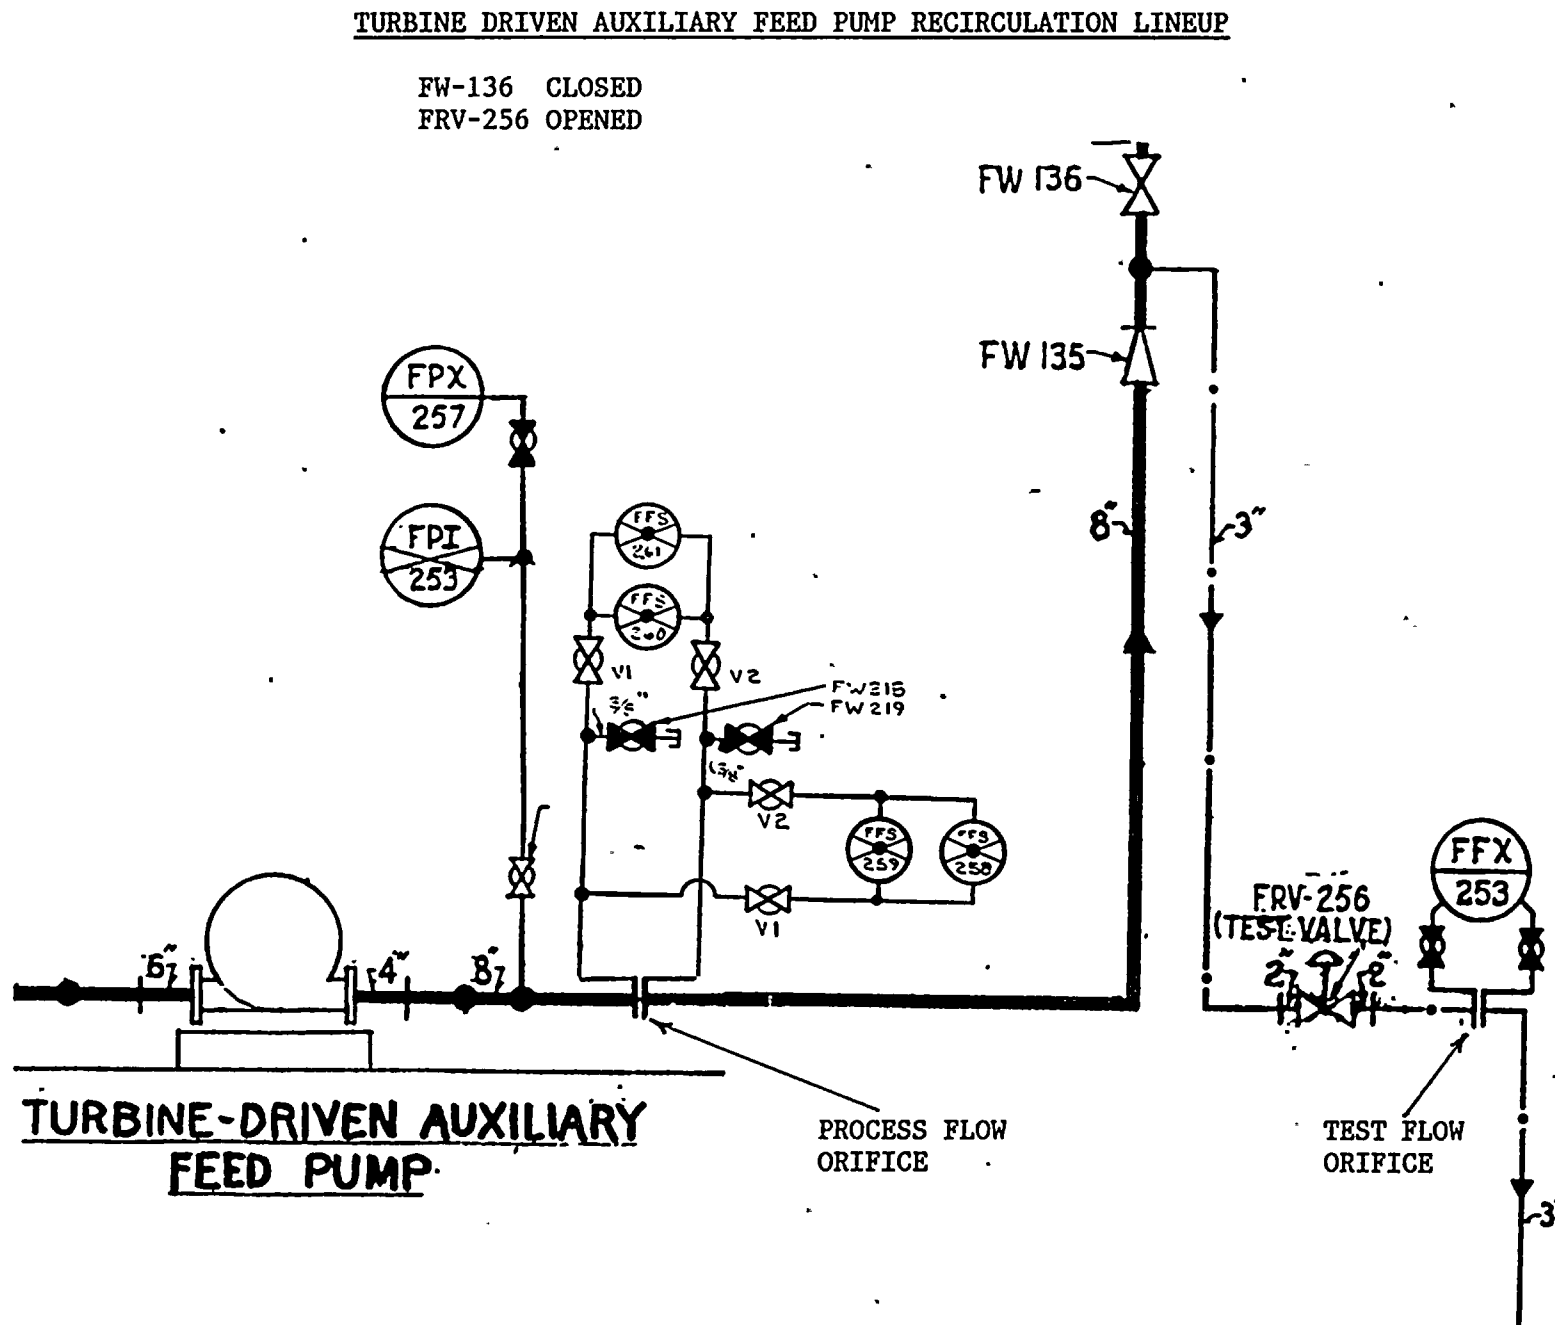
On October 19, 1989 at 0900 hours, an NRC Inspector conducting an IST Audit discovered an instrument discrepancy between the Turbine Driven Auxiliary Feedpump (TDAFP) (EIIS/BA-P) test line flow indication (FFX-253) and the in-series process flow indicating switches (FFS-258 and FFS-260) (EIIS/BA-FS). Attached is a drawing describing the configuration of these instruments. Instrumentation at the process flow switches indicated a flow of 550 GPM while test instrumentation indicated a flow of 700 GPM. The process flow switch actuates a flow retention signal when the TDAFP flow reaches 975 GPM. This flow retention function prevents pump runout during a feedwater line break. With the process instrumentation reading 78 percent of actual flow, the flow retention function would have actuated at a TDAFP approximate flow of approximately 1225 GPM. Therefore, flow retention would not have actuated before pump runout occurred. The process flow indication had not been used for testing since 1978. The test orifice had been used exclusively.
