SUBJECT: Responds to NRC Bulletin 88-02, "Rapidly Propagating Fatigue  
 Cracks in Steam Generator Tubes."

Donald C. Cook Nuclear Plant Units 1 and 2  
Docket Nos. 50-315 and 50-316  
License Nos. DPR-58 and DPR-74  
RESPONSE TO NRC BULLETIN 88-02, RAPIDLY PROPAGATING  
FATIGUE CRACKS IN STEAM GENERATOR TUBES

Attachment 1 to AEP:NRC:1056

NRC Bulletin 88-02  
Rapidly Propagating Cracks in  
Steam Generator Tubes

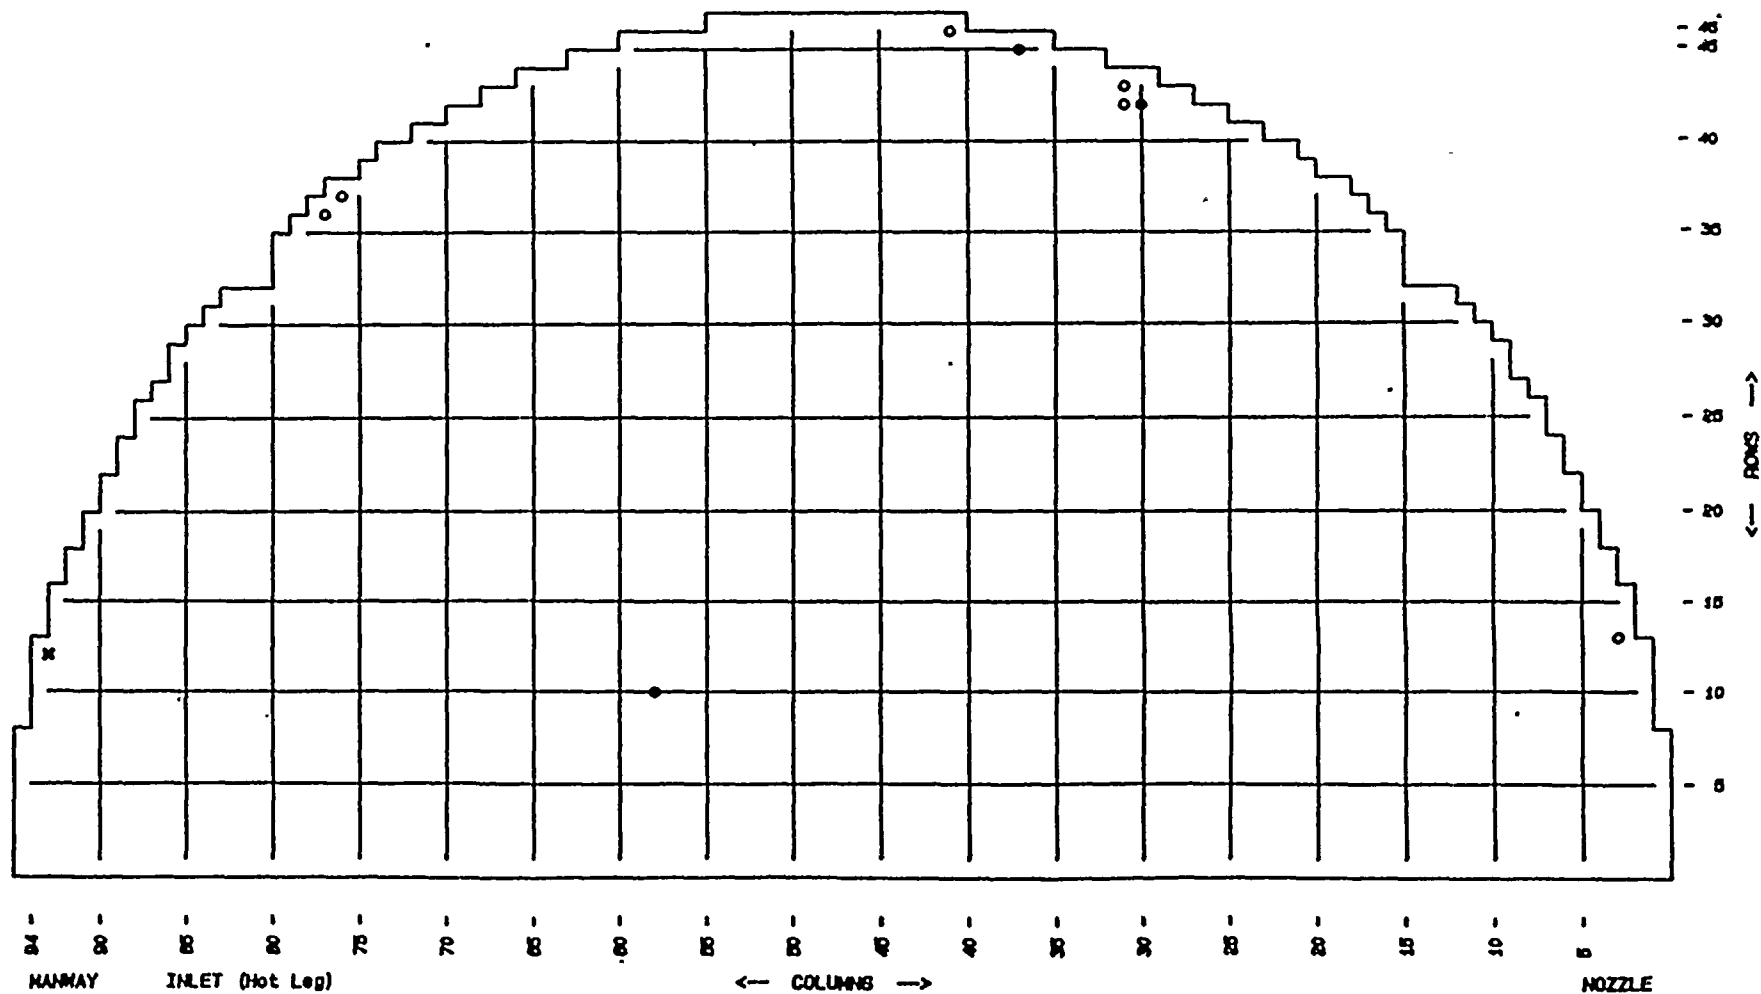
# UPPERMOST TUBE SUPPORT PLATE DENTS (RESPONSE TO NRCB 88-02)

X - DENTS - COLD LEG TOP TSP (1)

O - DENTS - HOT LEG TOP TSP (9)

TOTAL TUBES ASSIGNED: 10

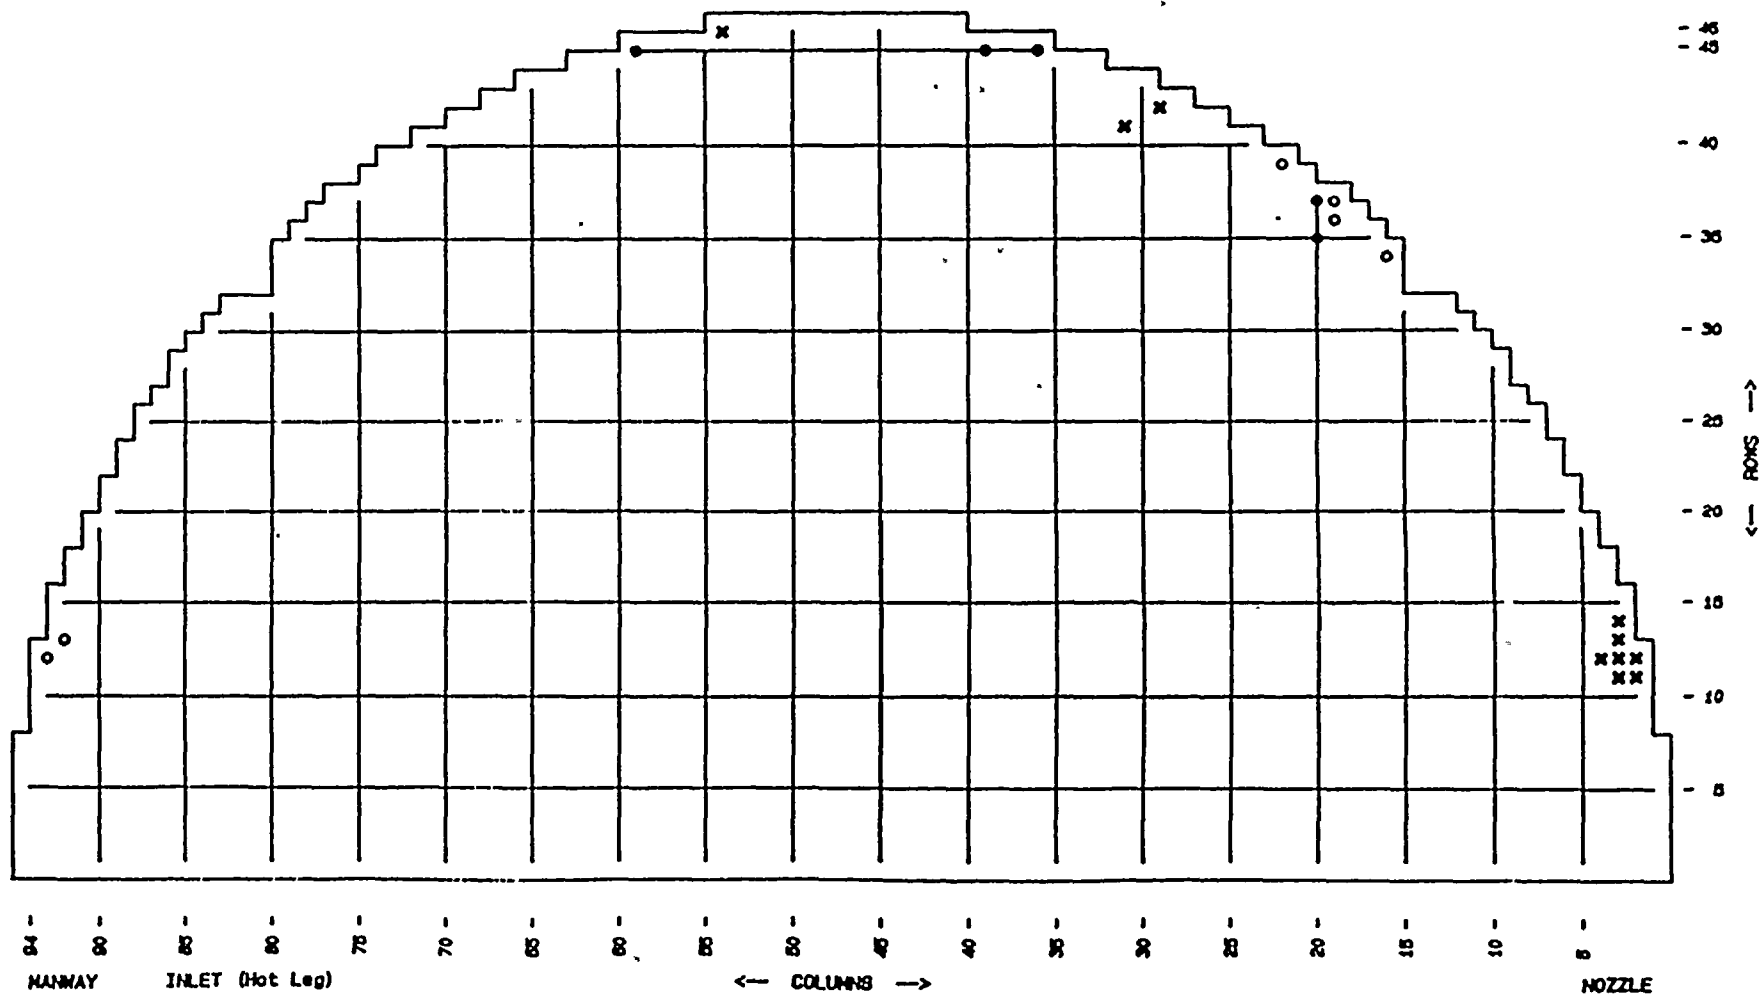
UPPERMOST TUBE SUPPORT PLATE DENTS (RESPONSE TO NRCB 88-02)

X - DENTS - COLD LEG TOP TSP (10)

O - DENTS - HOT LEG TOP TSP (11)

**TOTAL TUBES ASSIGNED: 21**

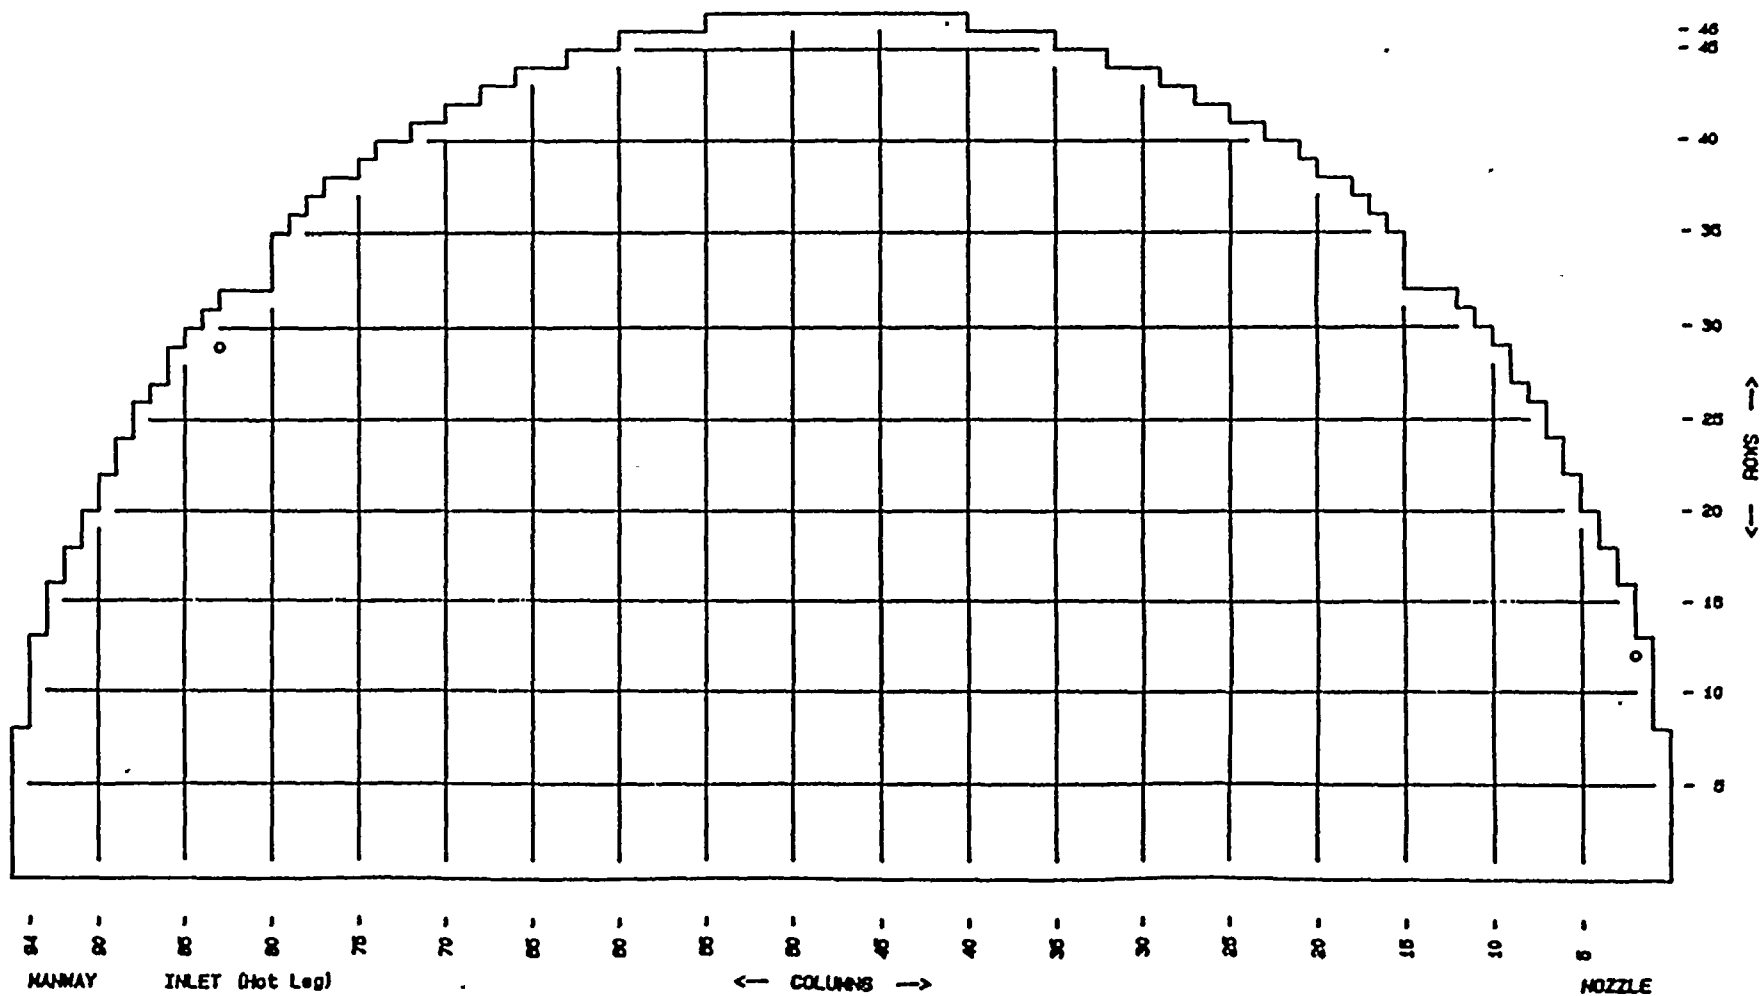
# UPPERMOST TUBE SUPPORT PLATE DENTS (RESPONSE TO NRCB-8802)

X = DENTS - COLD LEG TOP TSP (0)

O = DENTS - HOT LEG TOP TSP (2)

TOTAL TUBES ASSIGNED: 2

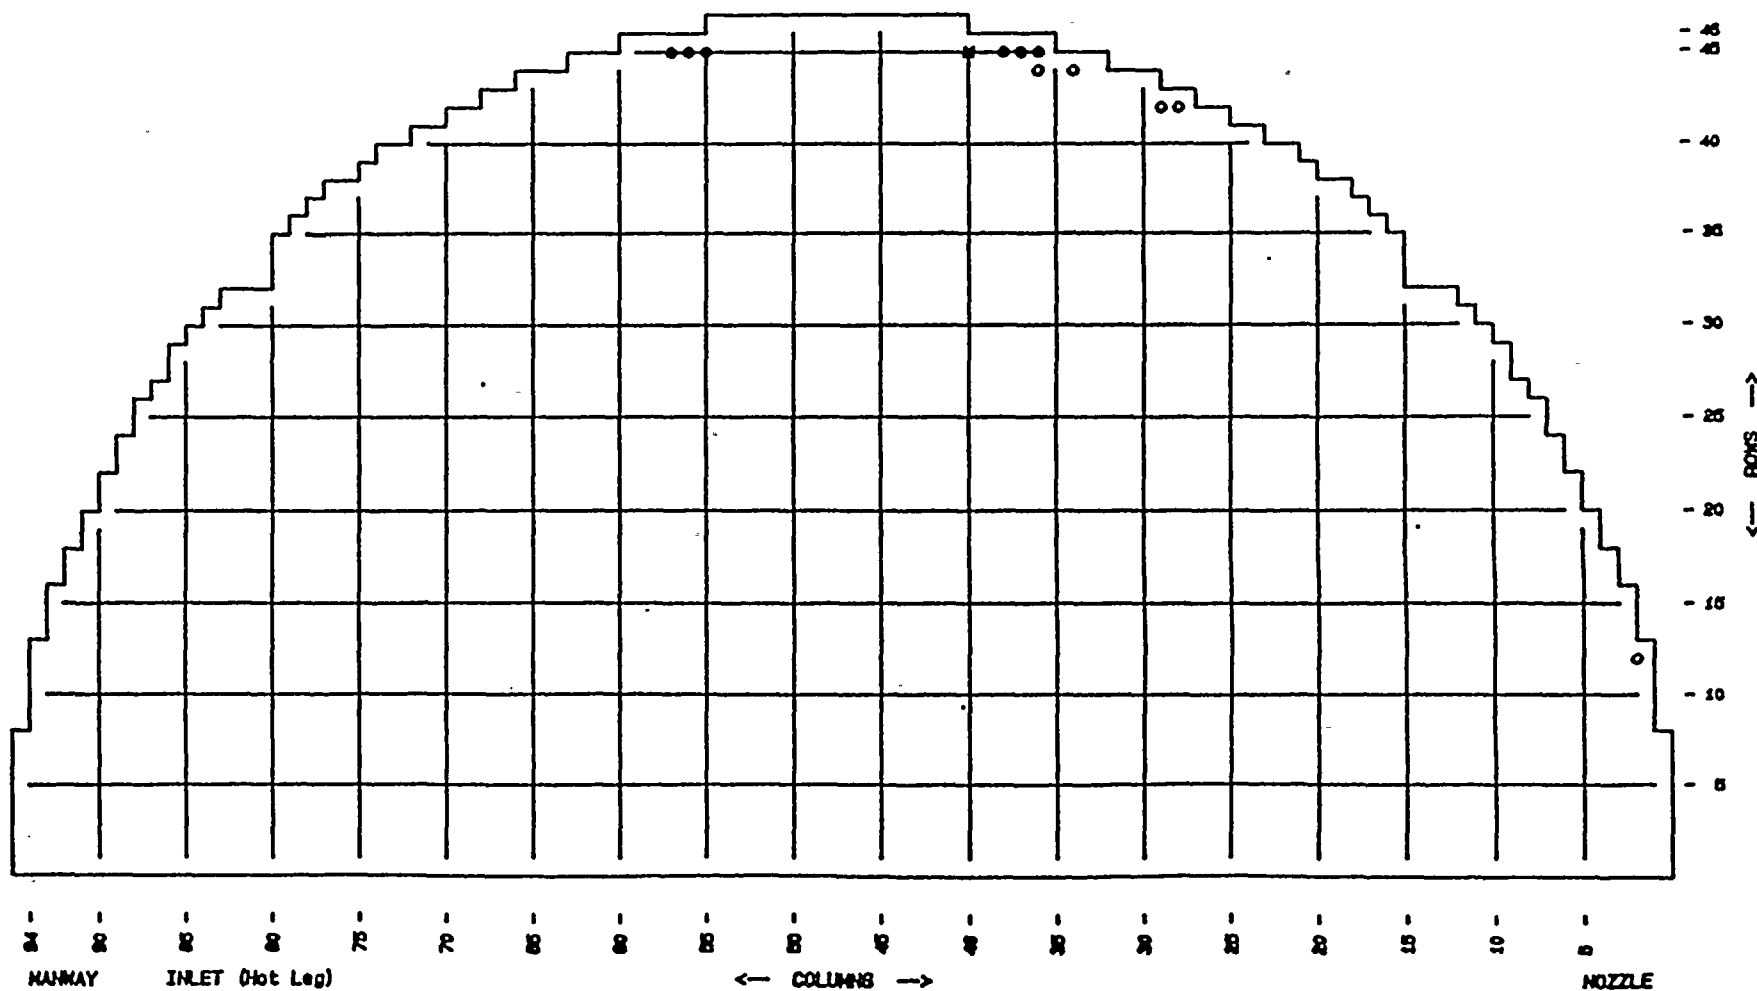
# UPPERMOST TUBE SUPPORT PLATE DENTS (RESPONSE TO NRCB 88-02)

X - DENTS - COLD LEG TOP TSP (1)

O - DENTS - HOT LEG TOP TSP (11)

TOTAL TUBES ASSIGNED: 12

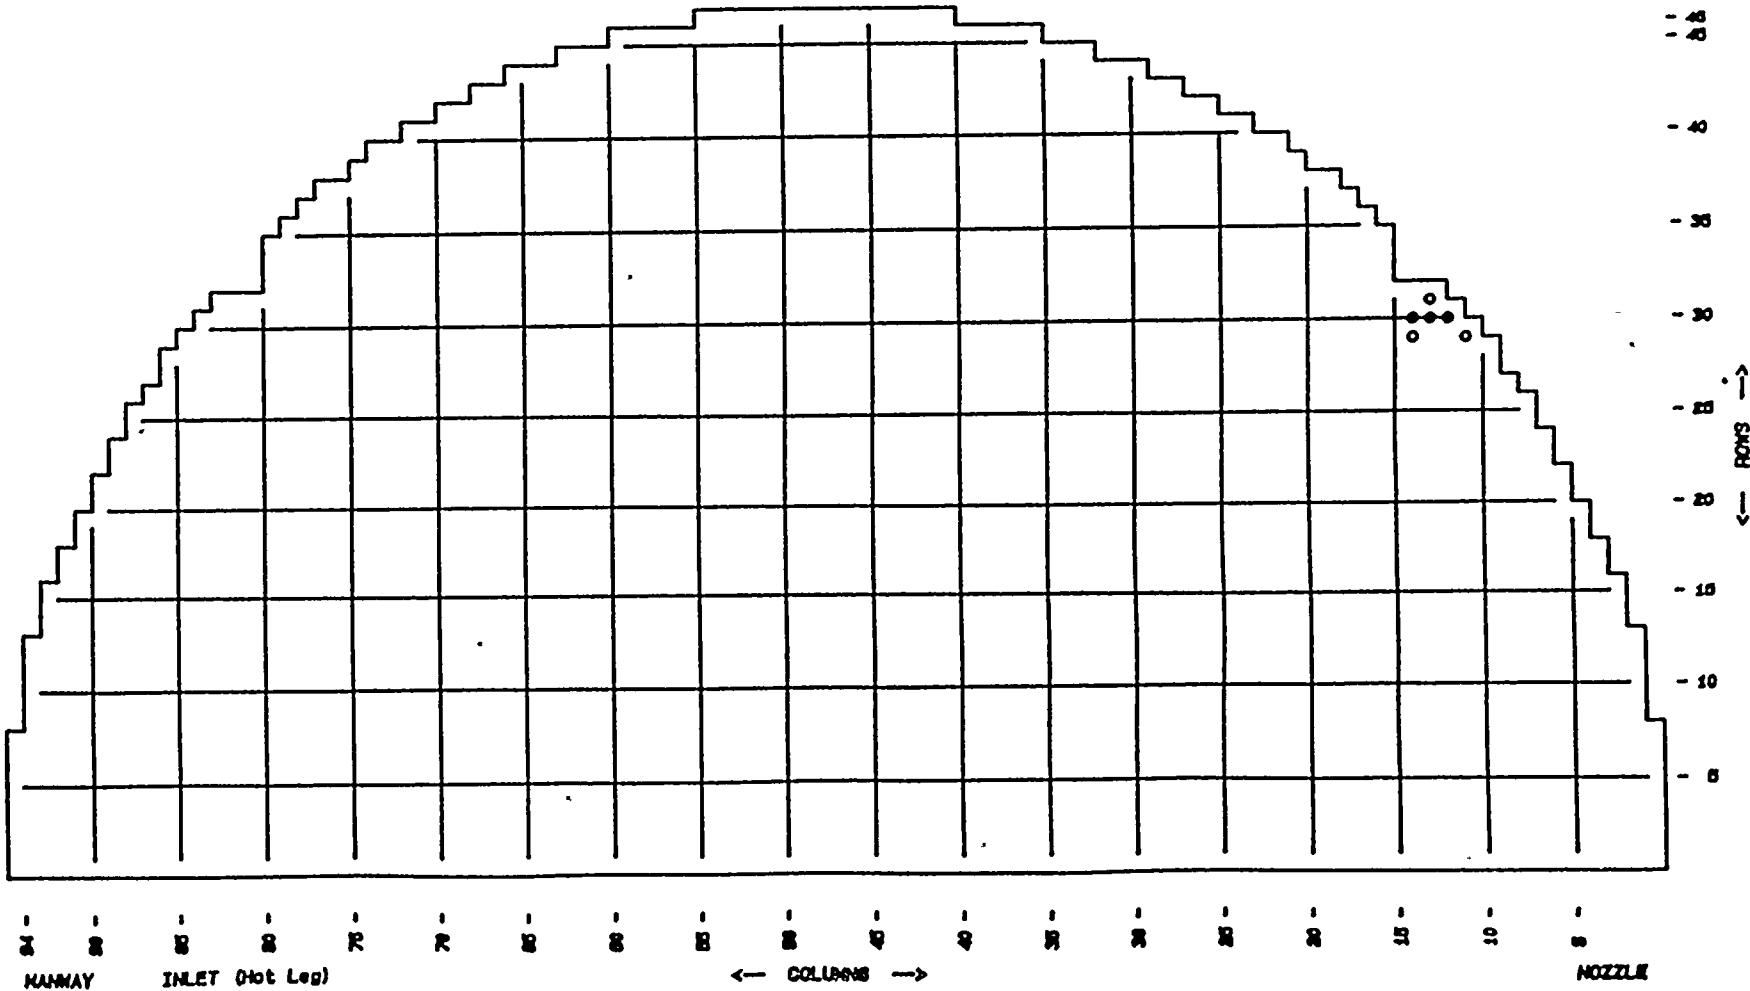
UPPERMOST TUBE SUPPORT PLATE DENTS (RESPONSE TO NRCB 88-02)

X - DENTS - COLD LEG TOP TSP (0)

O - DENTS - HOT LEG TOP TOP (B)

**TOTAL TUBES ASSIGNED: 8**

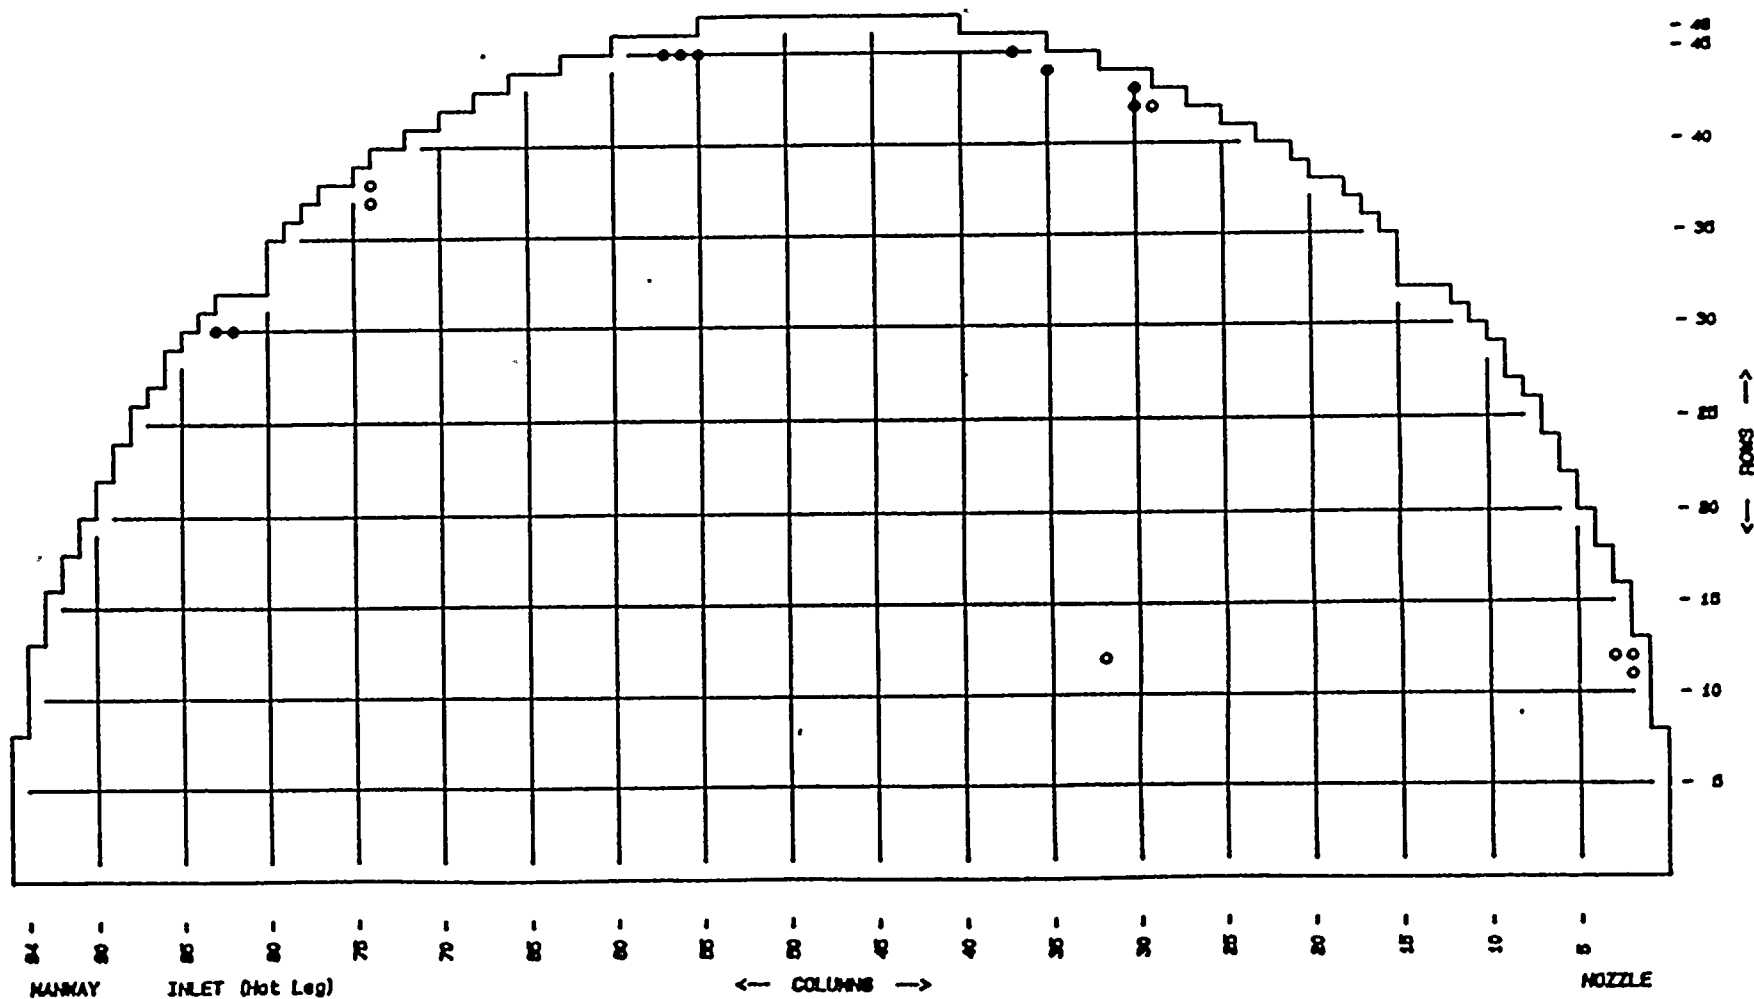
# UPPERMOST TUBE SUPPORT PLATE DENTS (RESPONSE TO NRCB 88-02)

X - DENTS - COLD LEG TOP TSP (0)

O - DENTS - HOT LEG TOP TSP (16)

TOTAL TUBES ASSIGNED: 16

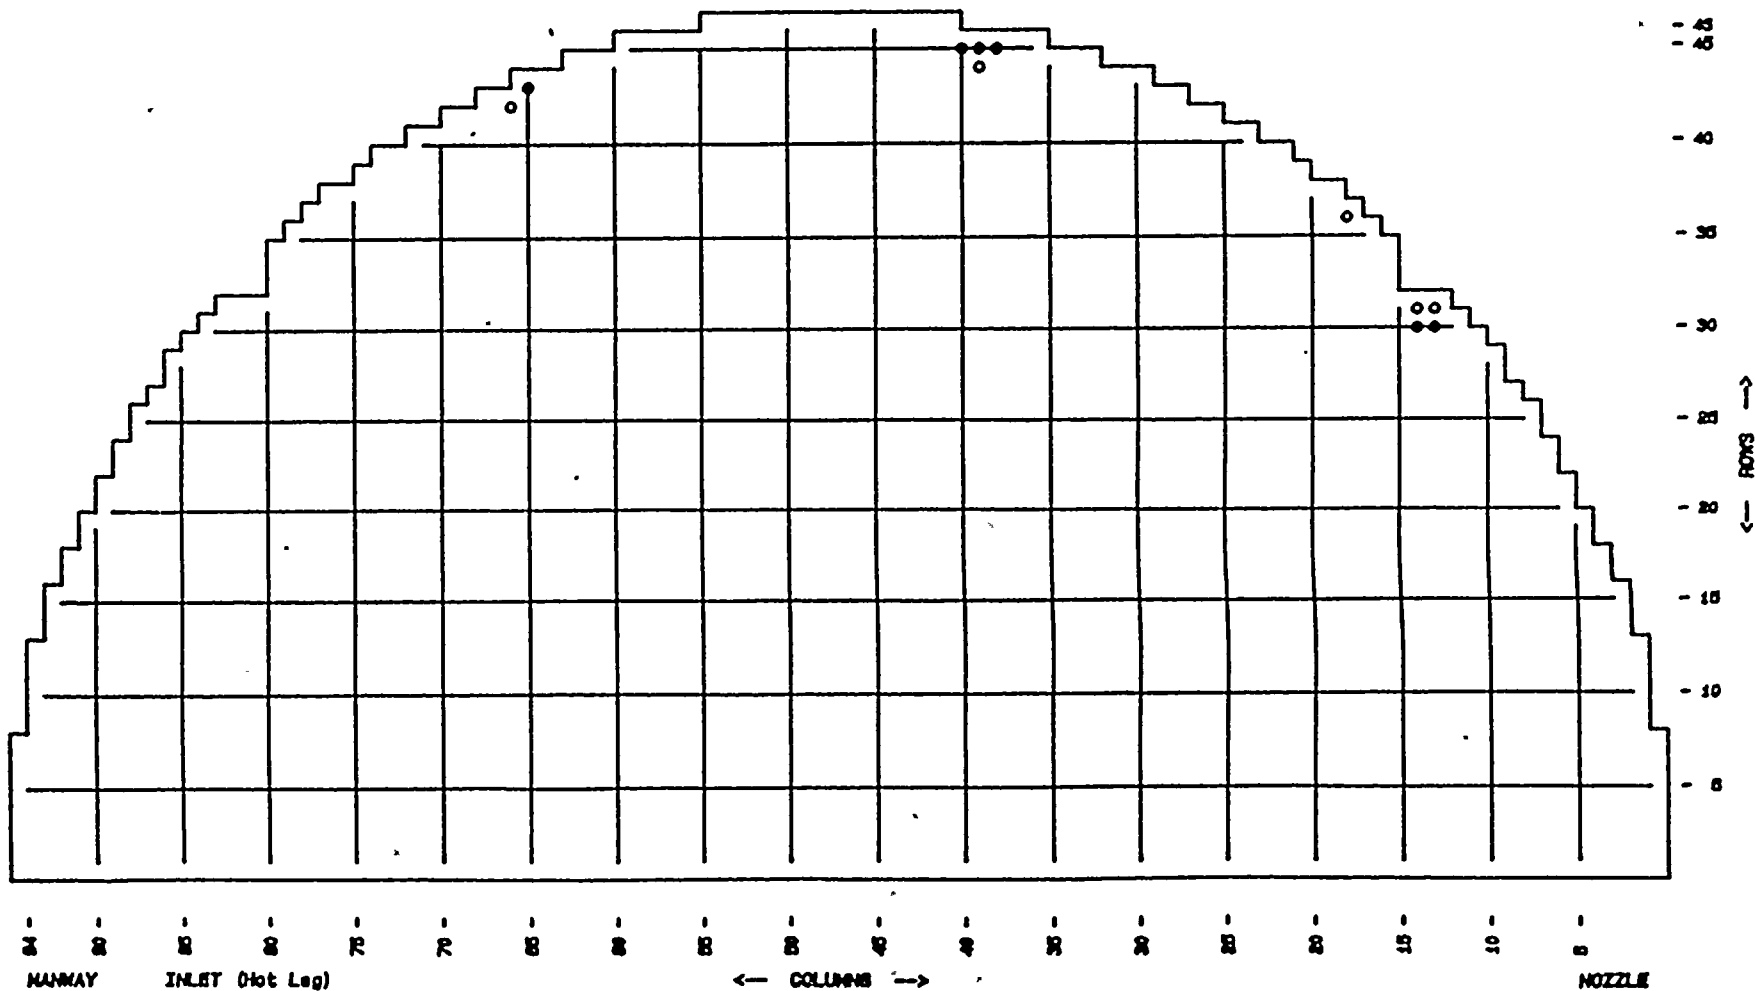
# UPPERMOST TUBE SUPPORT PLATE DENTS (RESPONSE TO NRCB 88-02)

X - DENTS - COLD LEG TOP TSP (0)

O - DENTS - HOT LEG TOP TSP (11)

TOTAL TUBES ASSIGNED: 11
