AEP:NRC:1074

Donald C. Cook Nuclear Plant Units 1 and 2  
Docket Nos. 50-315 and 50-316  
License Nos. DPR-58 and DPR-74  
ALLEGATIONS FROM A FORMER MAINTENANCE WORKER

SUBJECT: Steam Generator Manway Bolt  
And Bolt Holes

SUBJECT: D. C. Cook Plant Unit 2 Primary Side Services

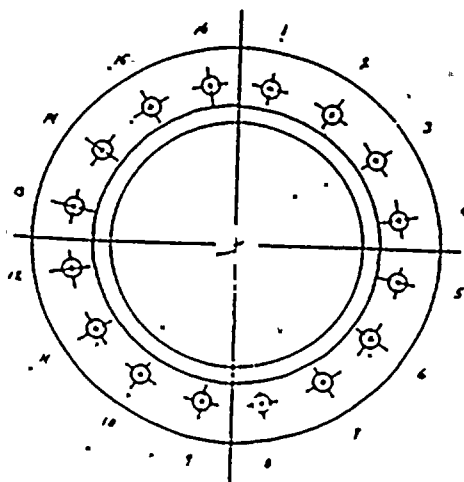
Table I  
Bolt Hole Locations <sup>(1)</sup> With Heli-Coil Inserts

Final review of the visual inspection and gauging results identified 22 bolt holes as requiring repair. In all cases, bolt hole repair was by a Heli-Coil insert. Table I documents the location of the repaired bolt holes.

S/G 21	No Heli-Coils installed.
S/G 22	Installed Heli-Coil inserts for the following bolt holes. H/L 2, 7, 10, 11 C/L 4, 7
S/G 23	Installed Heli-Coil inserts for the following bolt holes. H/L 2, 3 C/L 1, 2, 14
S/G 24	Installed Heli-Coil inserts for the following bolt holes. H/L 1, 3, 5, 7, 8, 9 C/L 1, 5, 11, 14, 15

(1) Bolt hole number sequence
