SUBJECT: LER 89-002-01: on 890116, non-svc induced deformation of
 energy core cooling sys suction line. W/890407 ltr.
 W/8 ltr.

LICENSEE EVENT REPORT (LER)

FACILITY NAME (1) D. C. Cook Plant - Unit 2										DOCKET NUMBER (2) 0 5 0 0 0 3 1 6 1										PAGE (3) OF 0 6																													
TITLE (4) Non-Service Induced Deformation of Energy Core Cooling System Suction Line Seismic Restraint																																																	
EVENT DATE (5) MONTH DAY YEAR 0 1 1 6 8 9 8 9									LER NUMBER (6) YEAR SEQUENTIAL NUMBER REVISION NUMBER 0 0 2 0 1 0									REPORT DATE (7) MONTH DAY YEAR 4 0 7 8 9									OTHER FACILITIES INVOLVED (8) FACILITY NAMES DOCKET NUMBER(S) 0 5 0 0 0 0																						
OPERATING MODE (9) 6										THIS REPORT IS SUBMITTED PURSUANT TO THE REQUIREMENTS OF 10 CFR §: (Check one or more of the following) (11)																																							
POWER LEVEL (10) 0 0 0										20.402(b) 20.405(a)(1)(i) 20.405(a)(1)(ii) 20.405(a)(1)(iii) 20.405(a)(1)(iv) 20.405(a)(1)(v)										20.405(c) 50.36(c)(1) 50.36(c)(2) 50.73(a)(2)(i) 50.73(a)(2)(ii) 50.73(a)(2)(iii)										50.73(a)(2)(iv) 50.73(a)(2)(v) 50.73(a)(2)(vi) 50.73(a)(2)(vii)(A) 50

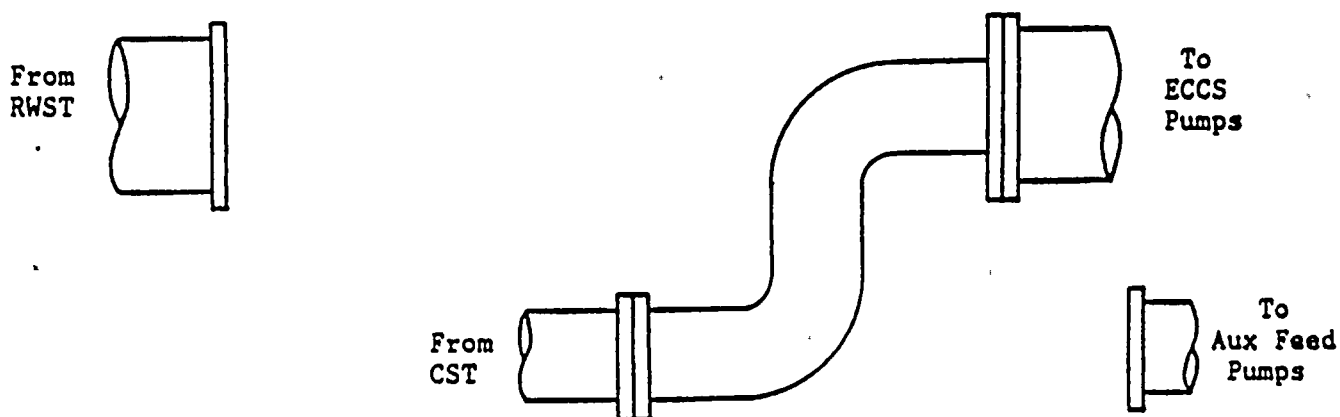
PIPING CONFIGURATION USED FOR FLUSHING AND TESTING

A review of modifications made to the system identified one potential cause for the deformation of 2GSI-L102. In order to facilitate flushing and other startup activities prior to initial unit startup a modification was made to the system, (changing this section of piping to a spool piece) to allow this portion of piping to be removed and replaced with a "jumper" spool piece. The modification, performed in 1976, was completed with one minor change to the original design; i.e., the subject restraint was moved to prevent interference with newly installed flanges. No other problems were noted. A Quality Control inspection report from August 1977 noted no problems with the restraint. The startup activities removed the modified pipe section and replaced it with a spool piece connecting the ECCS pump suction to the Condensate Storage Tank (CST) (see ATTACHMENT 1). Upon completion of the startup activities, the piping was restored. It is believed that the deformation of the restraint occurred during this evolution; however, no documentation of such deformation could be located. The corresponding restraint for Unit 1 was examined. There was no similar modification performed on Unit 1 and no deformation of the restraint was seen.

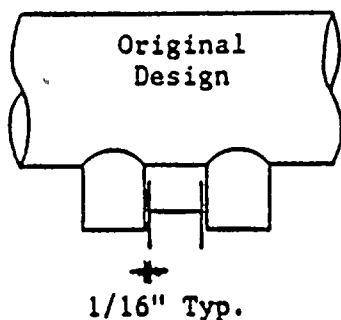
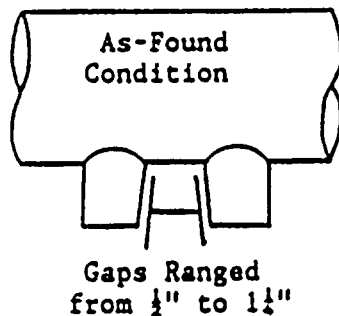
SUPPORT 2-GSI-L102 DETAIL

The deformation of the restraint was identified as deformation of the I-beam attached to the wall, along with deformation of two stanchions attached to the suction pipe (see ATTACHMENT 1). The deformation caused significant increases in the gap between the I-beam and the stanchions. Examination of the ECCS piping itself revealed no damage. The original seismic design required a one-sixteenth inch gap on each side. The gaps found from the deformation ranged from one-half to one and one-quarter inches. The design of the restraint is for seismic considerations and by definition is exempt from ISI visual examination per ASME Section XI. The purpose is primarily to restrain the suction line axially. It carries nominal loads during normal plant operation.

The investigation concluded that it is highly unlikely that the deformation of 2GSI-L102 was service induced as there have been no recorded unusual operating conditions, including a Design Basis Earthquake, which could have resulted in such significant deformation. The location of the restraint, on the suction side of the ECCS pumps, supports the likelihood that this type of deformation did not occur during service.

It was judged that the deformation on pipe support No. 2-GSI-L102 was not service induced for the following reasons.

- 1) The 24" RWST discharge is a low pressure suction line for various safety related systems with slow closing valves on large branches. The possibility of water hammer load therefore has been judged to be infeasible since these valves are also not automatically actuated.
- 2) The piping system does not have any visible distress. Except for the damaged support 2-GSI-L102, no other pipe support has been identified to have any damage.
- 3) There has not been any Design Basis Earthquake occurrence during the plant life and no other significant load condition can be associated with the damage to the support.

Due to the extent of the deformation of 2GSI-L102, it was not possible to return the restraint to its original design configuration. A revised design was developed to reinforce the restraint and reestablish the gap clearances specified by the original seismic design. A modification was initiated along with an ASME Section XI repair plan to repair the restraint. Repairs have been completed and the restraint visually inspected for final acceptance.
