SUBJECT: LER 89-017-01:on 891019,loss of turbine driven auxiliary  
 feed pump flow retention due to inaccurate flow measurement.  
 W/8 ltr.

## LICENSEE EVENT REPORT (LER)

TITLE (4) Loss of Turbine Driven Auxiliary Feed Pump Flow Retention Due To Inaccurate Flow Measurement																			
---	--	--	--	--	--	--	--	--	--	--	--	--	--	--	--	--	--	--	--

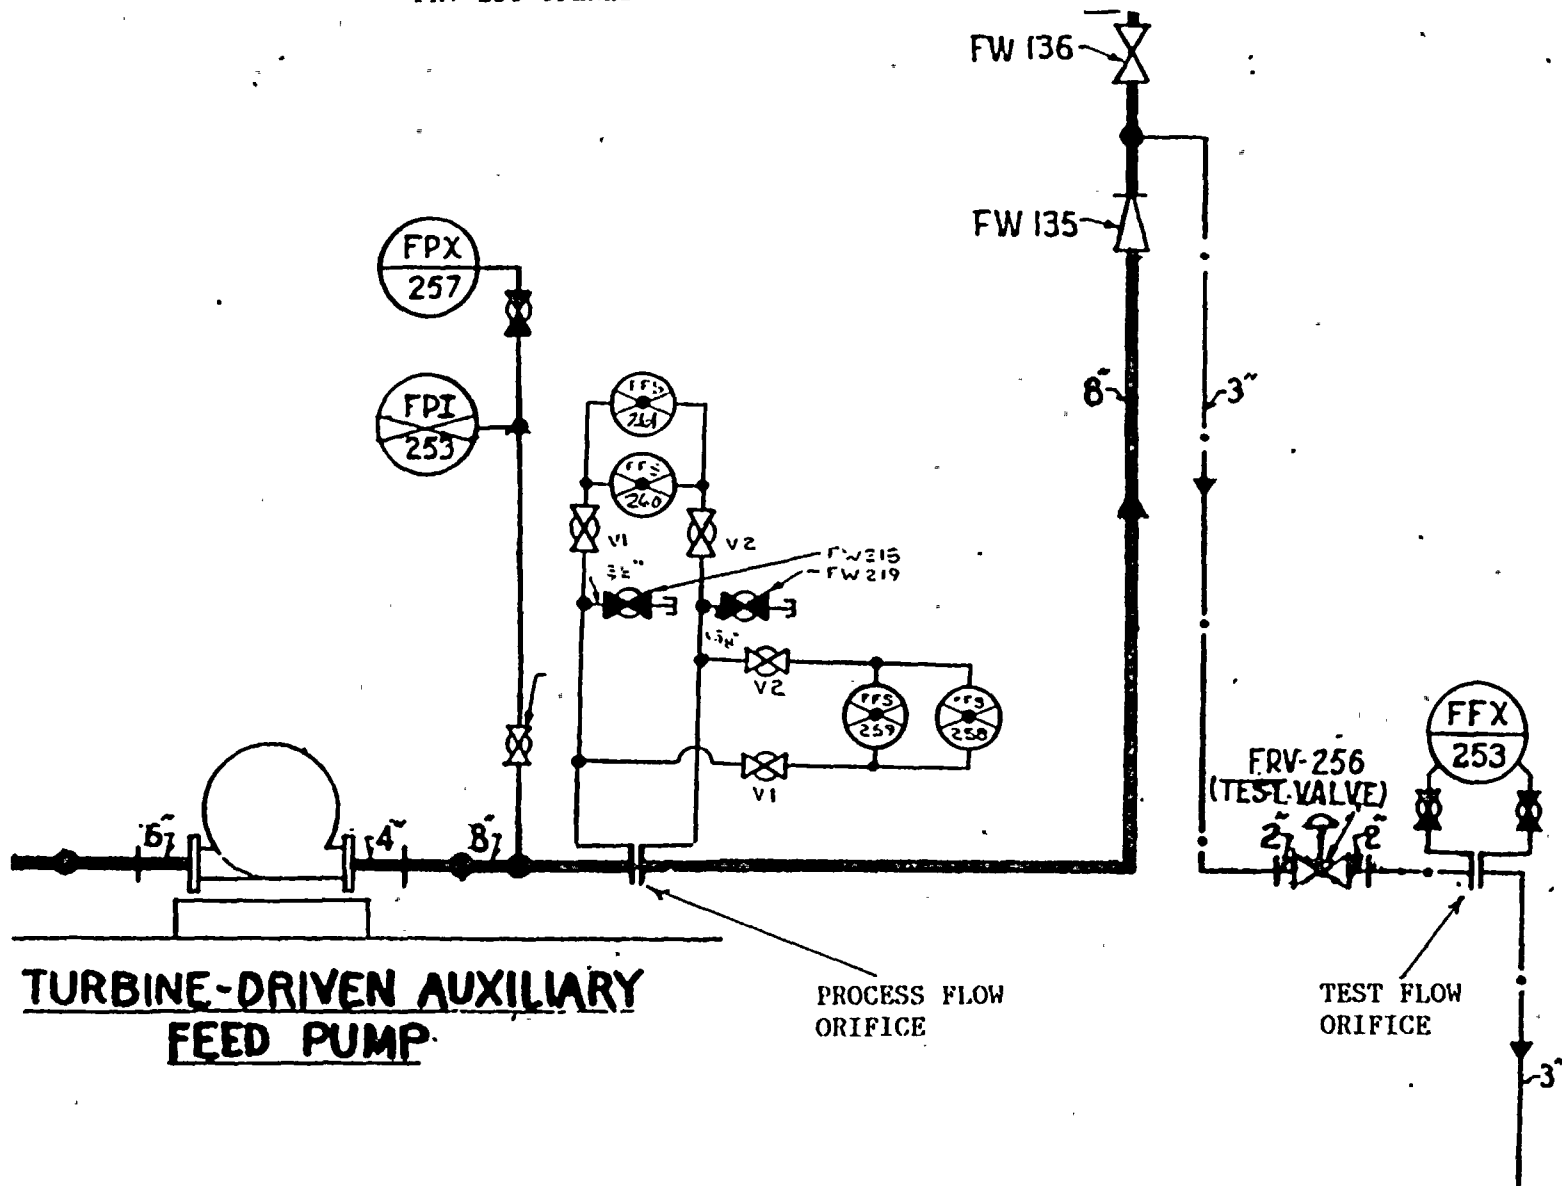
## TURBINE DRIVEN AUXILIARY FEED PUMP RECIRCULATION LINEUP

On October 19, 1989 at 0900 hours, an NRC Inspector conducting an IST Audit discovered an instrument discrepancy between the Turbine Driven Auxiliary Feedpump (TDAFP) (EIIS/BA-P) test line flow indication (FFX-253) and the in-series process flow indicating switches (FFS-258 and FFS-260) (EIIS/BA-FS). Attached is a drawing describing the configuration of these instruments. Instrumentation at the process flow switches indicated a flow of 550 GPM while test instrumentation indicated a flow of 700 GPM. The process flow switch actuates a flow retention signal when the TDAFP flow reaches 975 GPM. This flow retention function prevents pump runout during a feedwater line break. With the process instrumentation reading 78 percent of actual flow, the flow retention function would have actuated at a TDAFP approximate flow of approximately 1225 GPM. Therefore, flow retention would not have actuated before pump runout occurred.

FW-136 CLOSED  
FRV-256 OPENED
