SUBJECT: Forwards addl info re util 900126 revised response to NRC  
 Bulletin 88-002, per NRC 900509 request.

DISTRIBUTION CODE: IE13D COPIES RECEIVED: LTR 1 ENCL 1 SIZE: 49  
 TITLE: Bulletin Response, 88-02 Rapidly Propagating Fatigue Cracks in Steam

Donald C. Cook Nuclear Plant Units 1 and 2  
Docket Nos. 50-315 and 50-316  
License Nos. DPR-58 and DPR-74  
NRC BULLETIN 88-02; REQUEST FOR ADDITIONAL INFORMATION

BULLETIN 88-02: REQUEST FOR ADDITIONAL INFORMATION

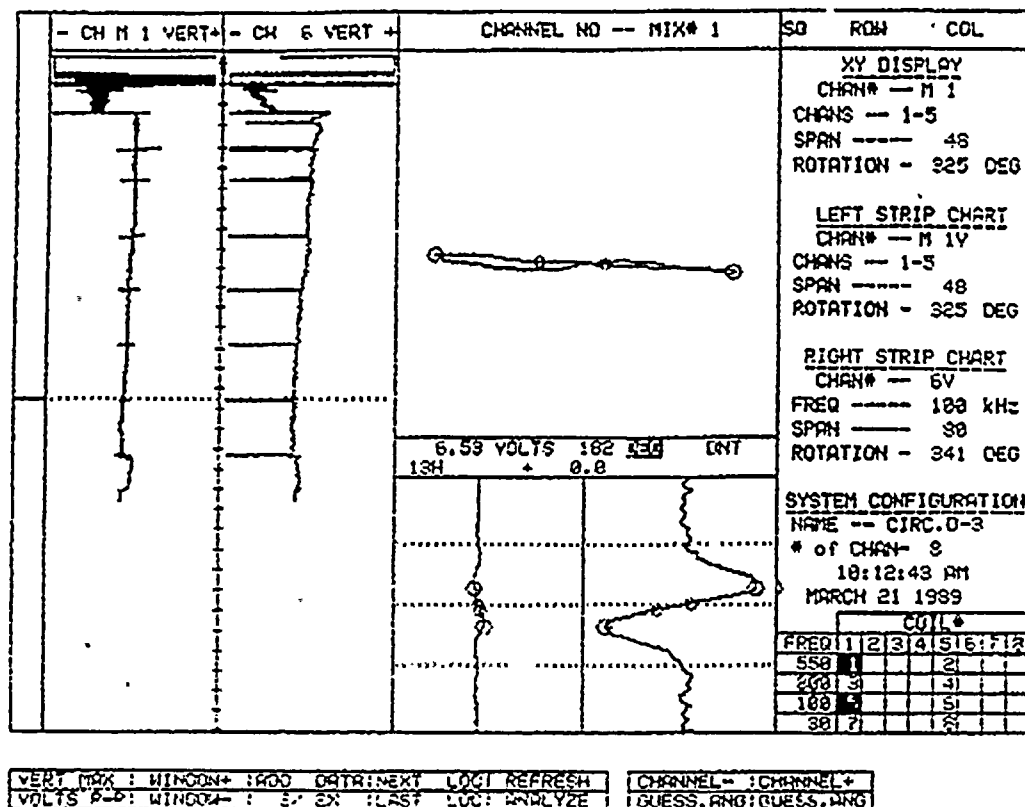
Figure 1

1. Establish a 400/100 kHz differential mix.
  - a. Suppress simulated support ring on ASME standard.
  - b. Set probe motion horizontal with the 100 percent through-wall artificial flaw going down and to the right first.
2. Using 400 kHz, set volts using the simulated support ring on the ASME standard to six volts and store to all channels.
3. Evaluate the seventh support plate on both the hot and cold legs for denting and evidence of corrosion or magnetite.
  - a. Denting
    - 1) Signal in the 400/100 kHz differential mix is horizontal, moving to the left first (see Figure 1).

Typical service-induced dent; note - 550/100 kHz differential mix for the particular tube wall thickness in this plant is comparable to 400/100 kHz differential mix for Cook Unit 1 tubing.

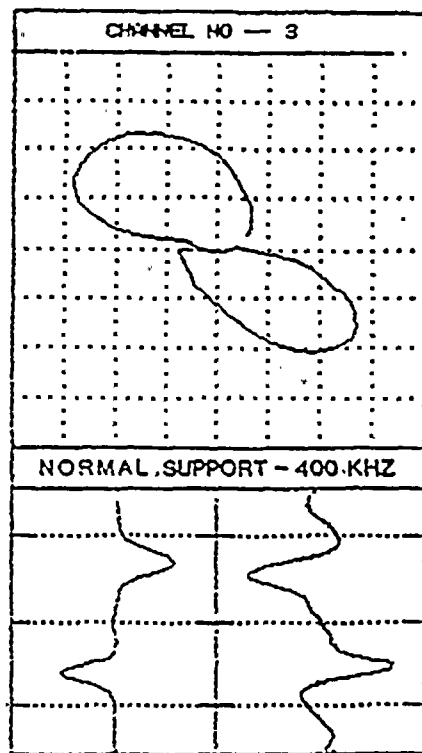
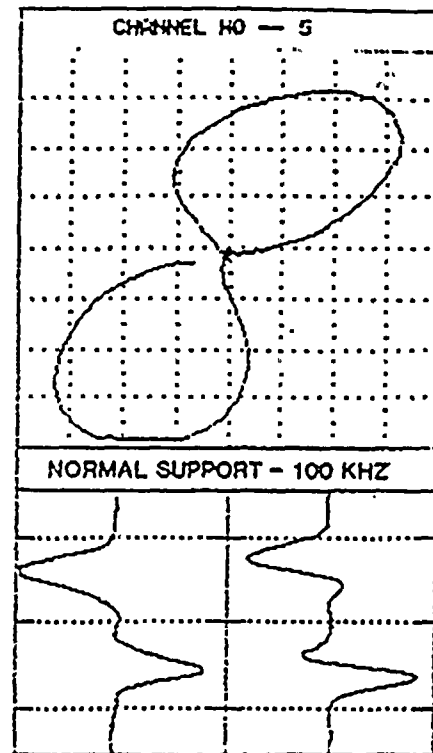
Figure 2

- 1) Toggle through all channels for distorted signals (i.e., anything other than normal support plate signals as shown in Figure 2).
- 2) When distorted signal is observed in the support plate crevice, report distortion as magnetite if the 100 kHz differential signal moves in an upward direction first and the 400 kHz differential signal moves down first (see Figure 3).
- 3) Observe 10 kHz differential for evidence of support plate ligament damage which would be indicative of severe corrosion.

"Normal" Support Plate Signal

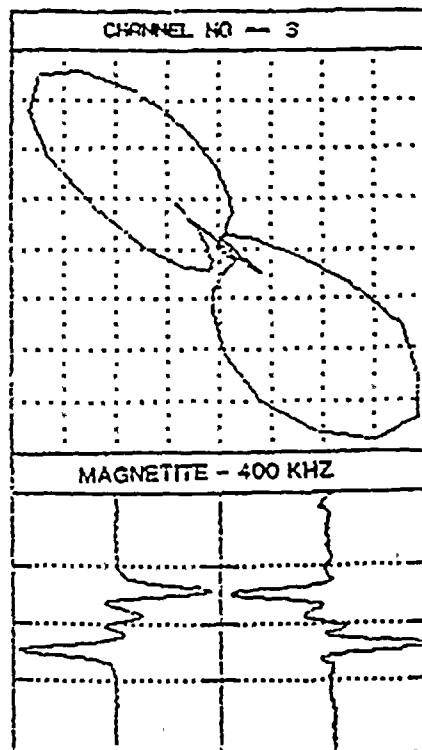
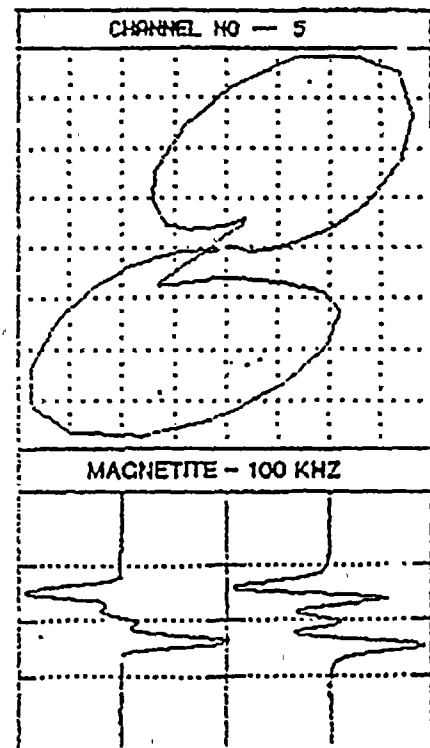
Figure 3

Distorted Signal at Support Plate  
Reported as Magnetite

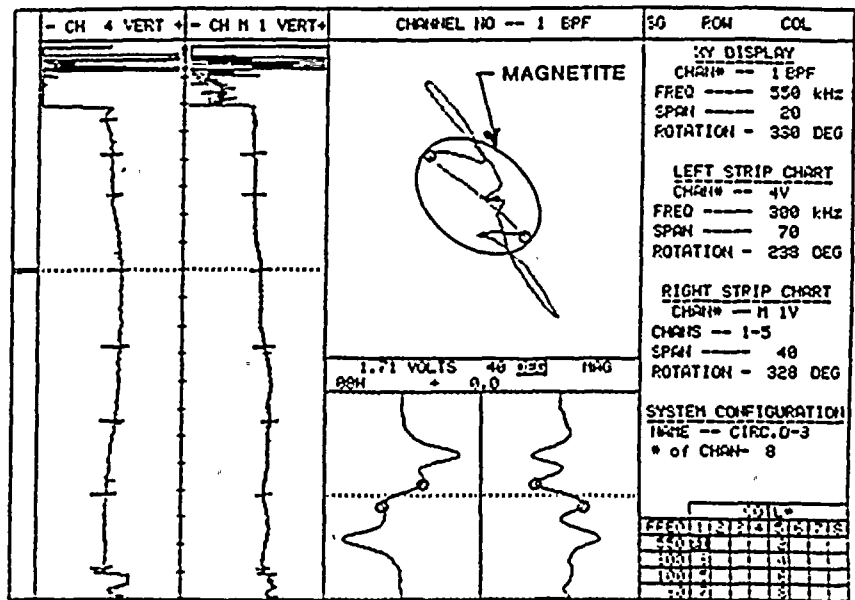
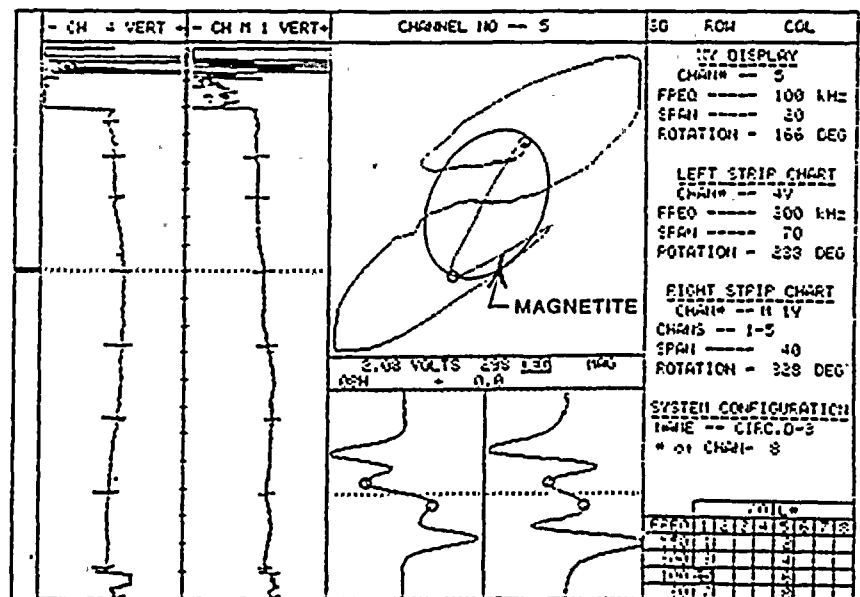
Figure 4

Support Plate Crevice Gap." While the study was performed using array coil technology to evaluate the degree of magnetite packing present at a tube-to-support plate intersection, the results can be extended to bobbin coil data for detection of magnetite. Conam has augmented the training by familiarizing analysts with actual field data from plants with denting and magnetite formation (see Figures 4 and 5).

Example of magnetite signal; see Figure 5 for additional channels on same tube.

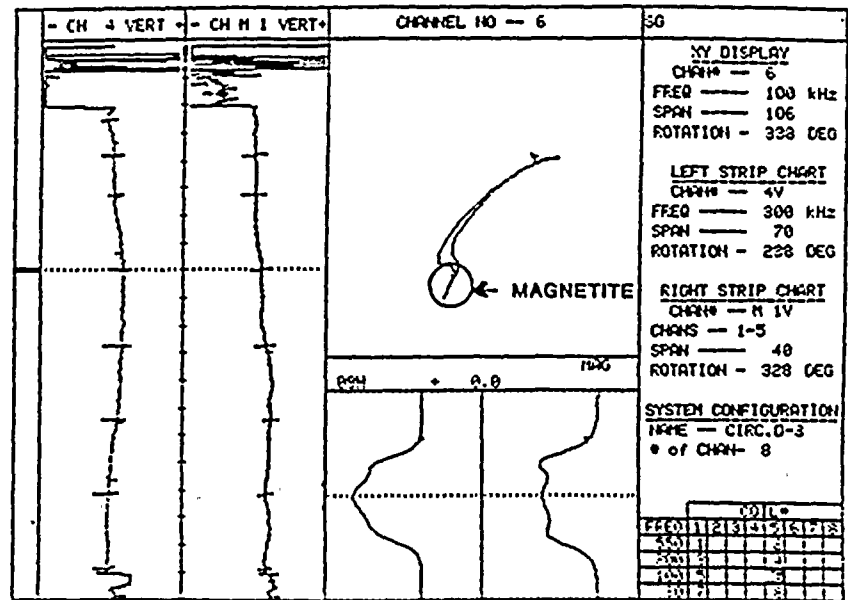
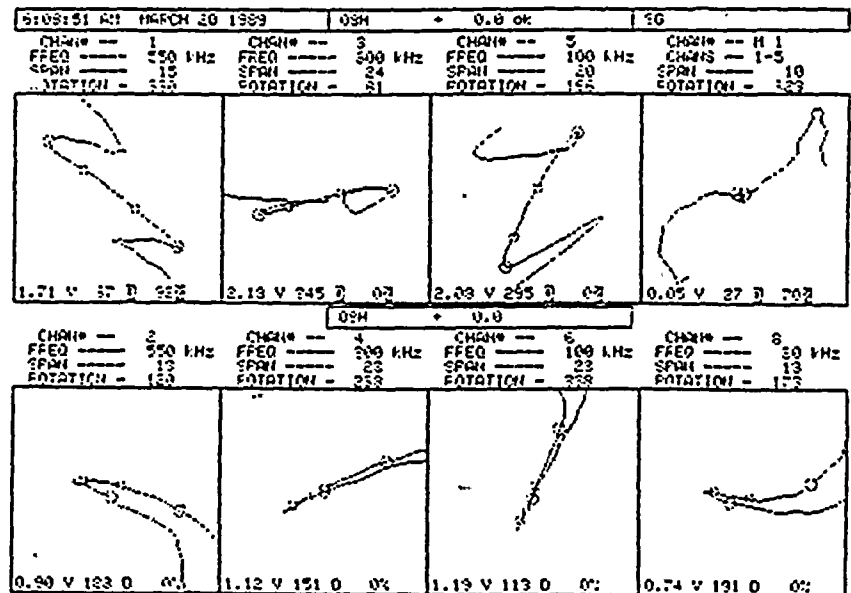
Figure 5

Example of magnetite signal; see Figure 4 for additional channels on same tube.

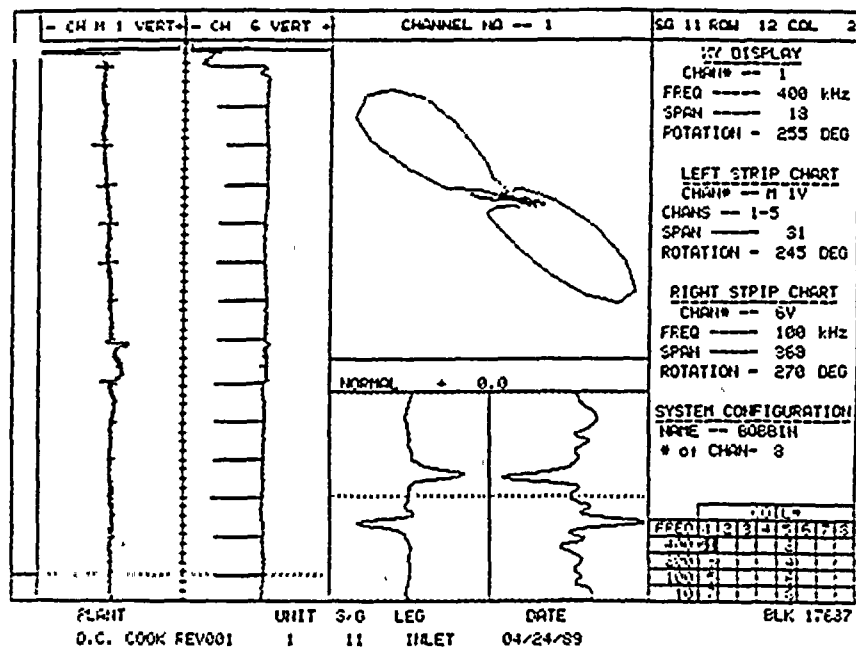
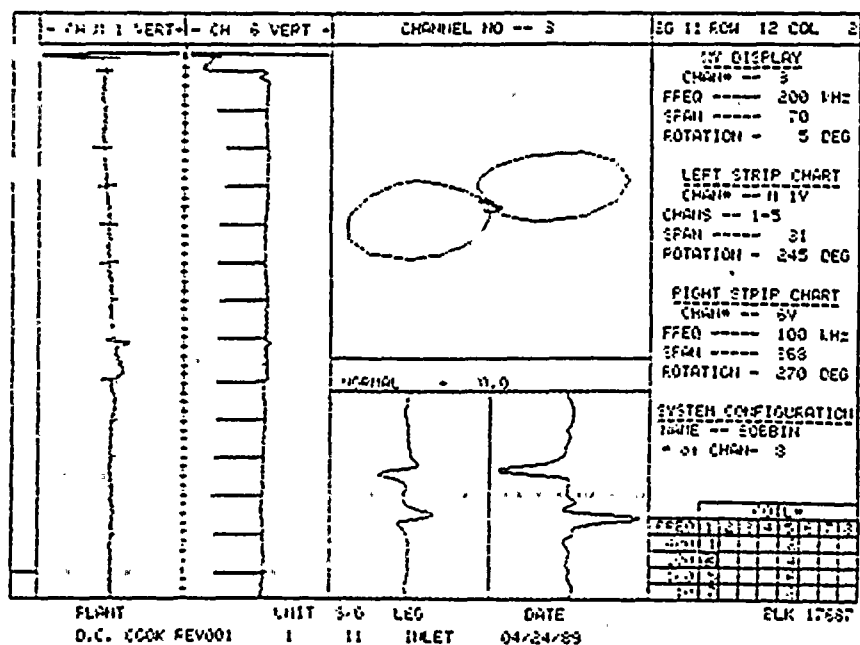
Figure 6

SG No. 11, Tube R12C2, 2nd cold leg support

Typical of "normal" support plate intersection (400 kHz differential and 200 kHz differential shown in top and bottom displays; see Figure 7 for additional channels).

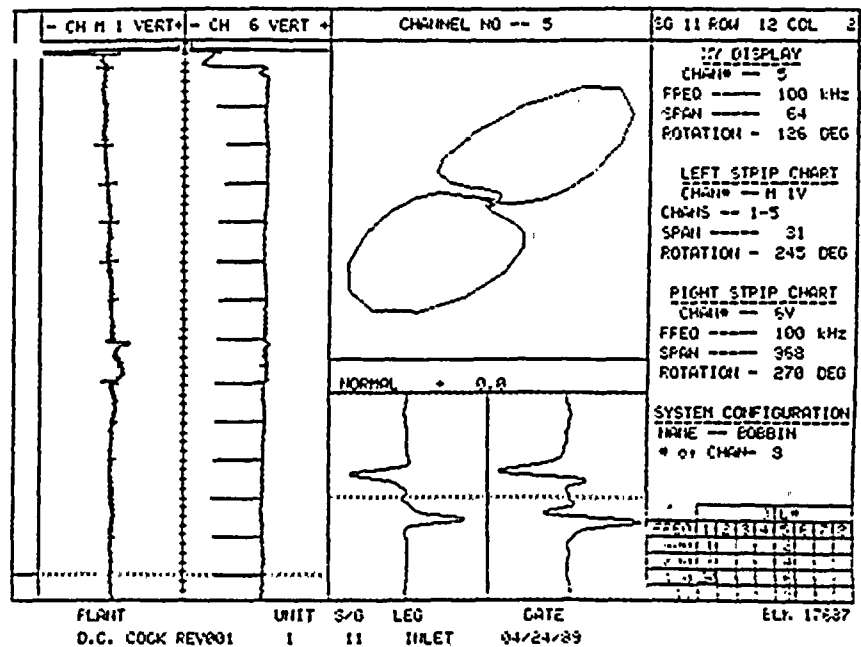
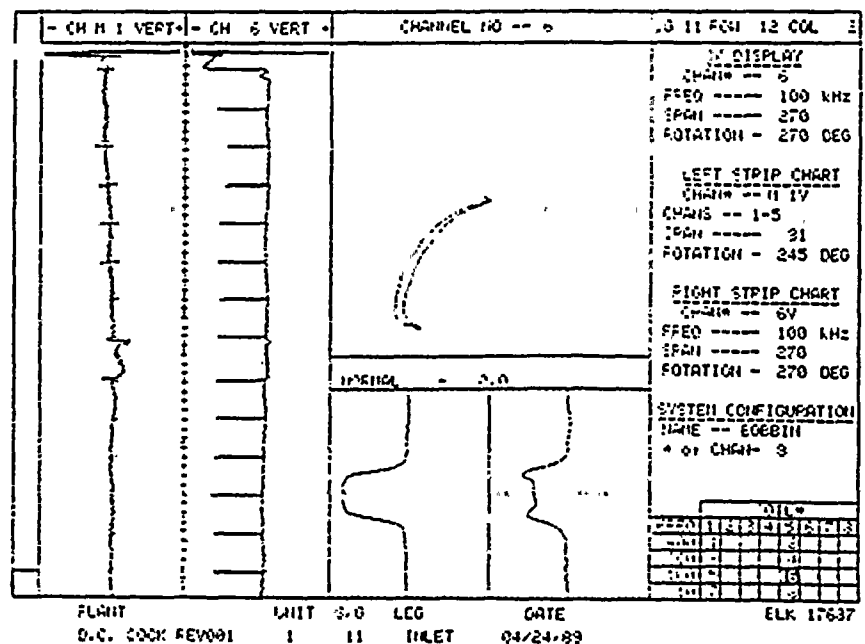
Figure 7

SG No. 11, Tube R12C2, 2nd cold leg support

Typical of "normal" support plate intersection (100 kHz differential and 100 kHz absolute shown in top and bottom displays; see Figure 6 for additional channels).

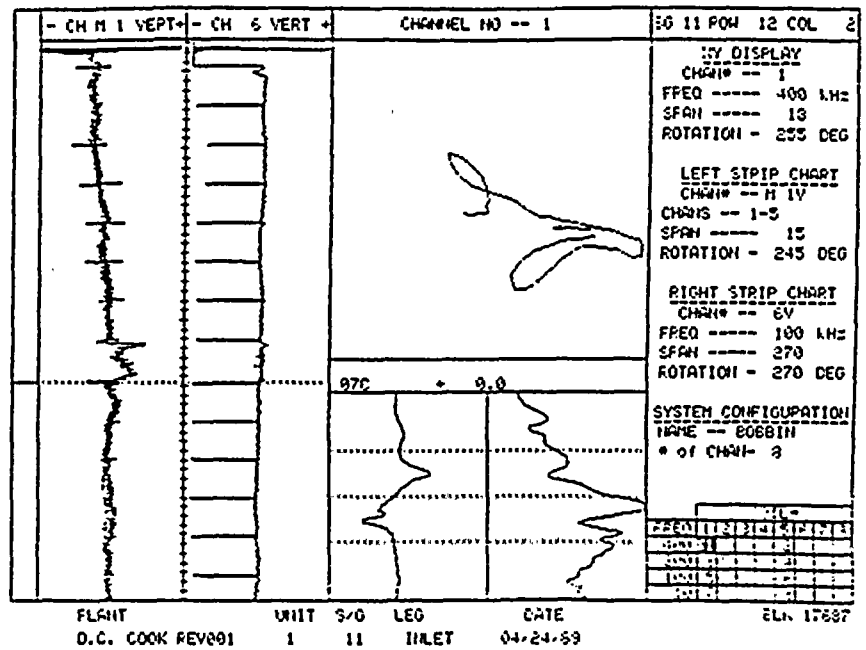
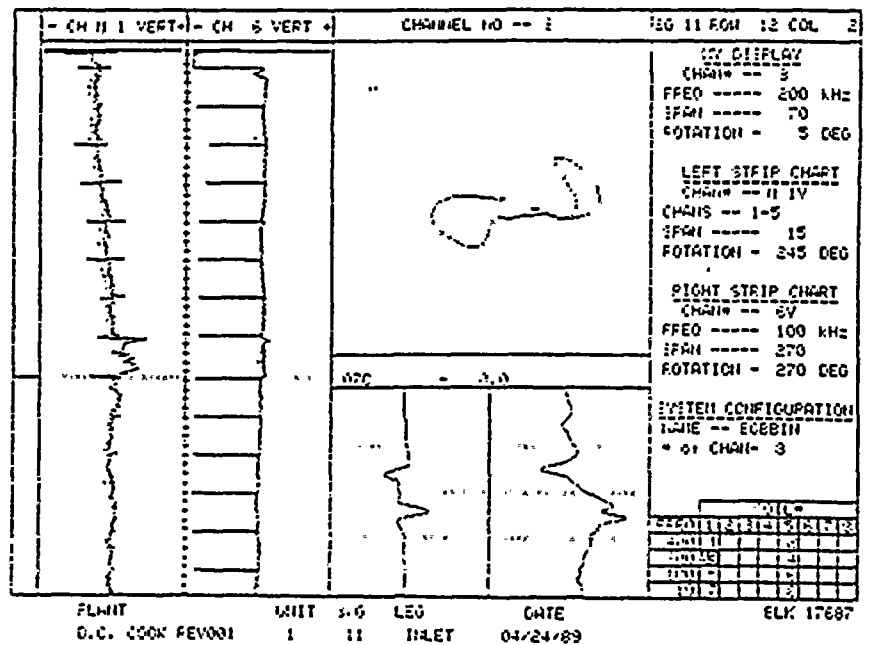
Figure 8

SG No. 11, Tube R12C2, 7th cold leg support

Representative "anomalous" signal at support plate intersection (400 kHz differential and 200 kHz differential shown in top and bottom displays; see Figures 9 and 10 for additional channels).

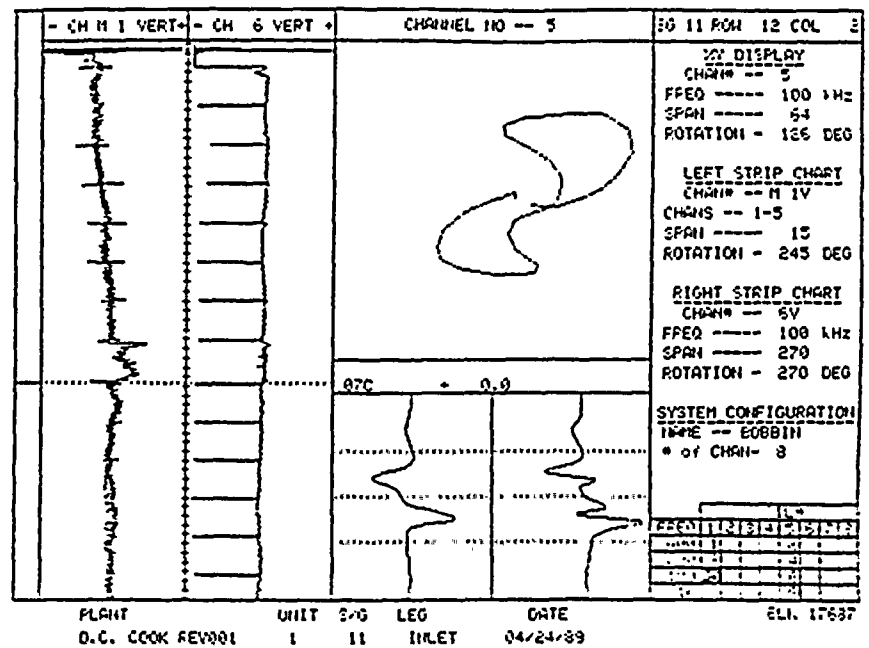
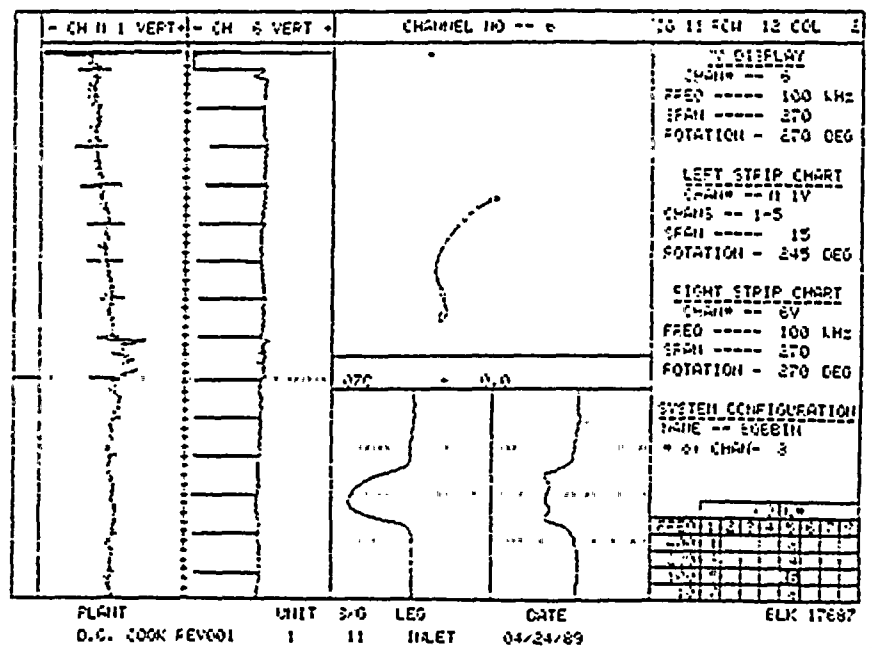
Figure 9

SG No. 11, Tube R12C2, 7th cold leg support

Representative "anomalous" signal at support plate intersection (100 kHz differential and 100 kHz absolute shown in top and bottom displays; see Figures 8 and 10 for additional channels).

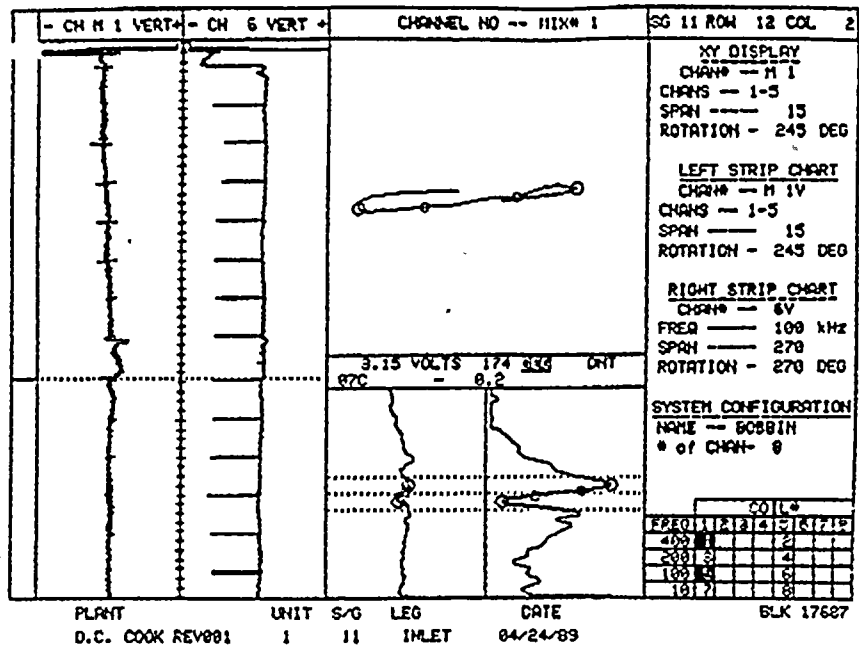
Figure 10

SG No. 11, Tube R12C2, 7th cold leg support

Representative "anomalous" signal at support plate intersection (400/100 kHz differential mix at -0.2 inches shown in display; see Figures 8 and 9 for additional channels).

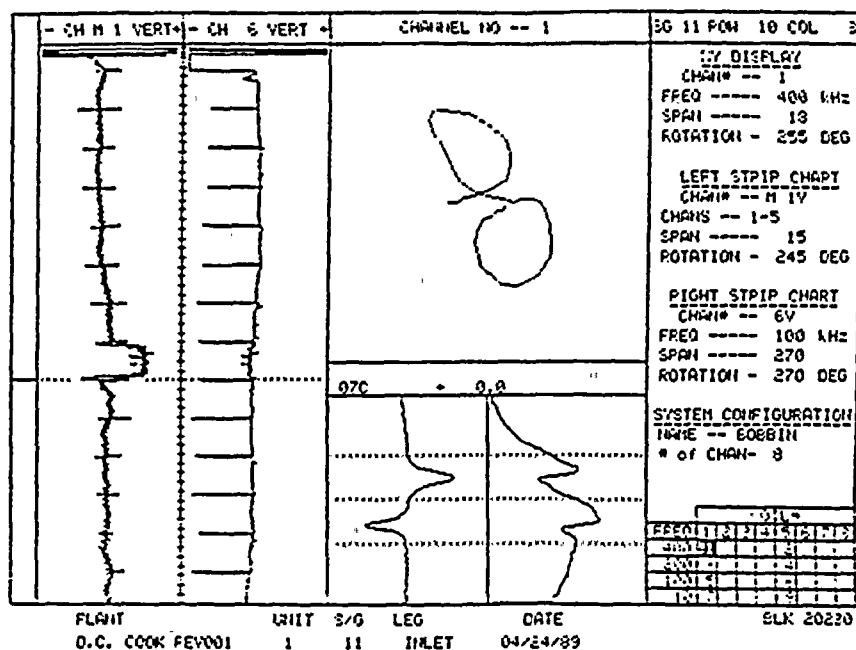
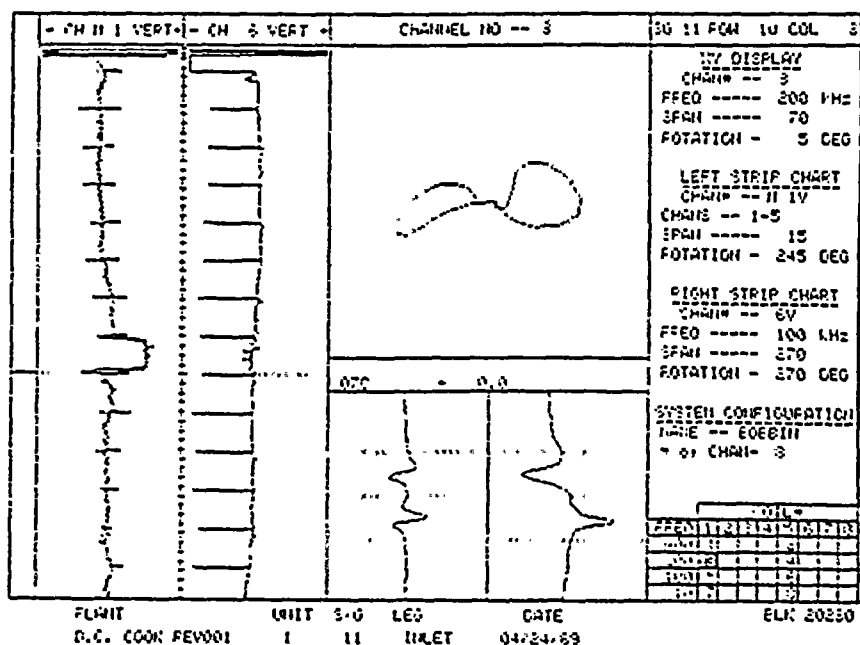
Figure 11

SG No. 11, Tube R10C3, 7th cold leg support

Representative "anomalous" signal at support plate intersection (400 kHz differential and 200 kHz differential shown in top and bottom displays; see Figure 12 for additional channels).

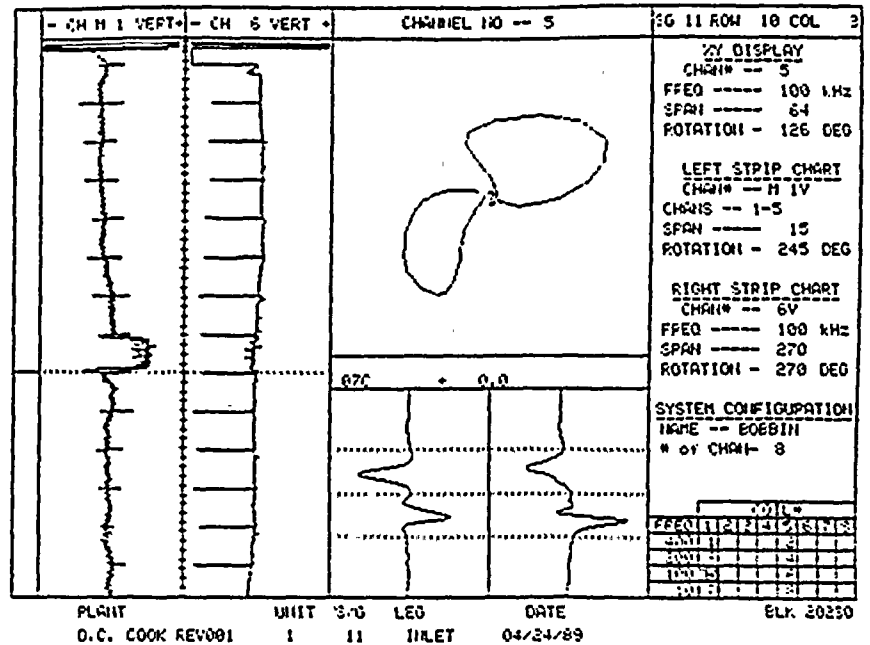
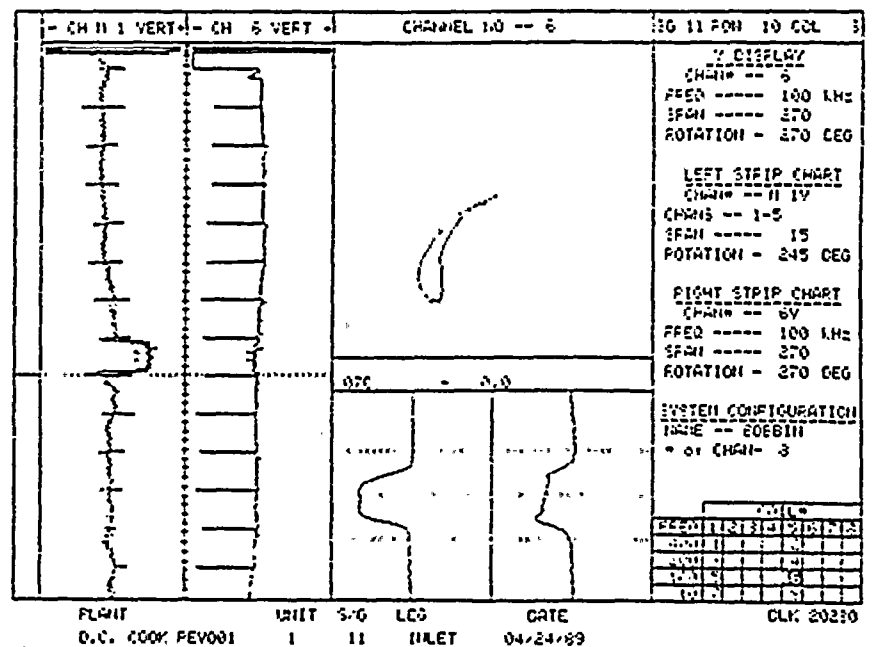
Figure 12

SG No. 11, Tube R10C3, 7th cold leg support

Representative "anomalous" signal at support plate intersection (100 kHz differential and 100 kHz absolute shown in top and bottom displays; see Figure 11 for additional channels).

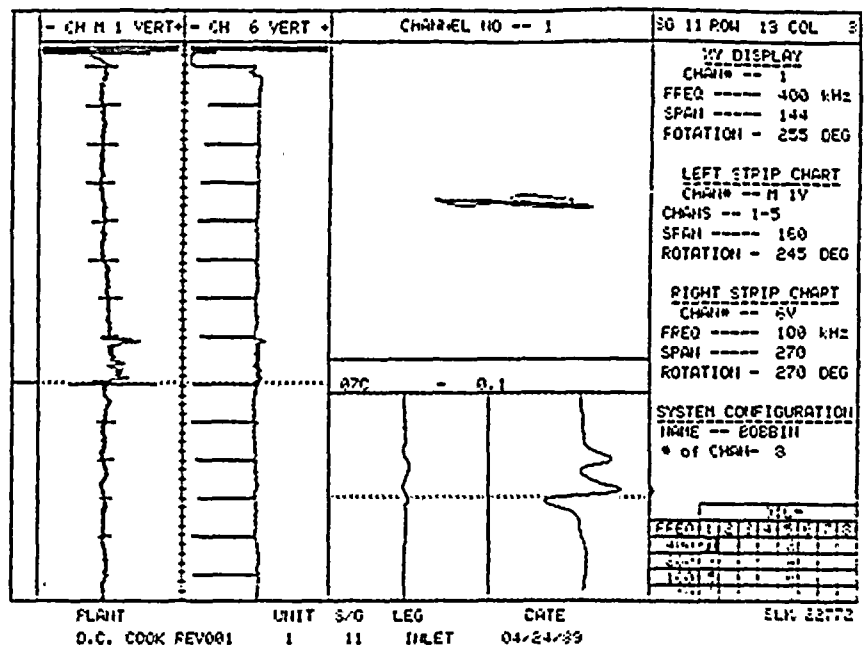
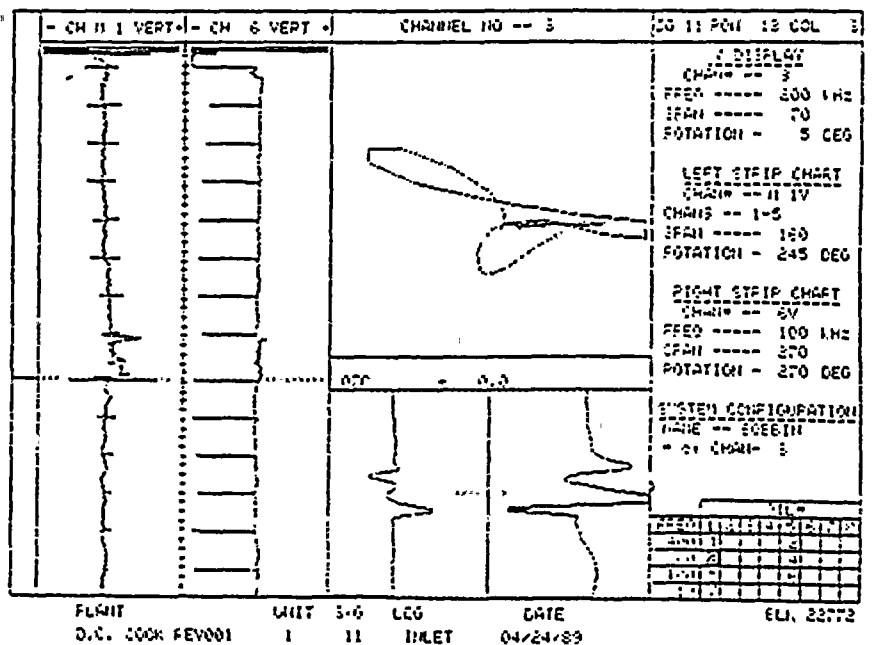
Figure 13

SG No. 11, Tube R13C3, 7th cold leg support

Representative "anomalous" signal at support plate intersection (400 kHz differential and 200 kHz differential shown in top and bottom displays; see Figure 14 and 15 for additional channels).

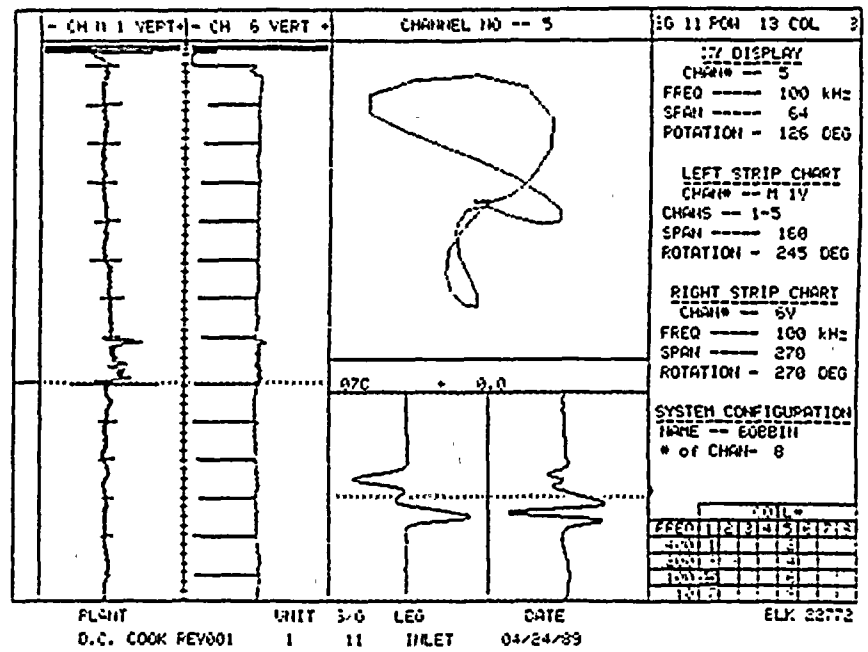
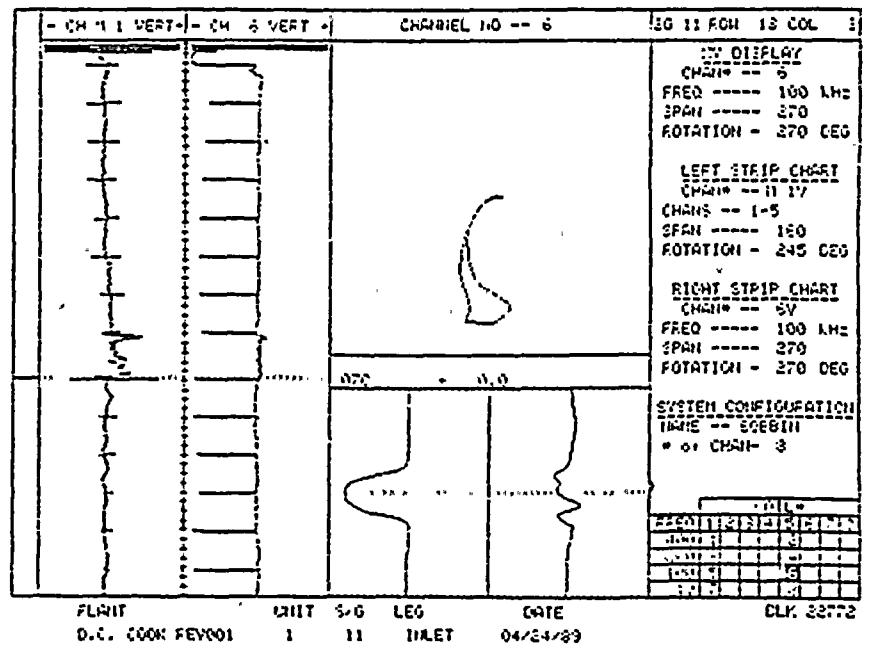
Figure 14

SG No. 11, Tube R13C3, 7th cold leg support

Representative "anomalous" signal at support plate intersection (100 kHz differential and 100 kHz absolute shown in top and bottom displays; see Figures 13 and 15 for additional channels).

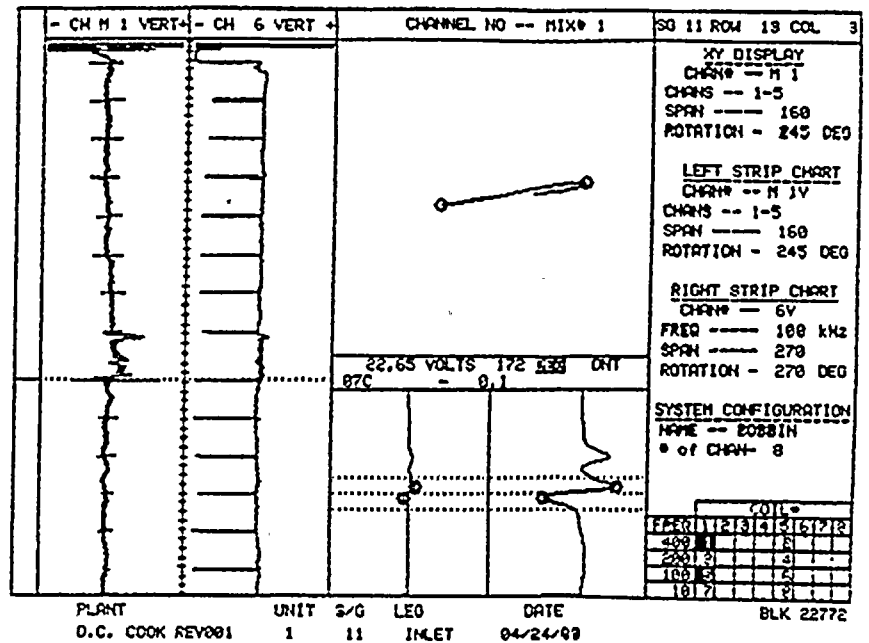
Figure 15

SG No. 11, Tube R13C3, 7th cold leg support

Representative "anomalous" signal at support plate intersection (400 kHz differential mix at -0.1 inches shown in display; see Figures 13 and 14 for additional channels).

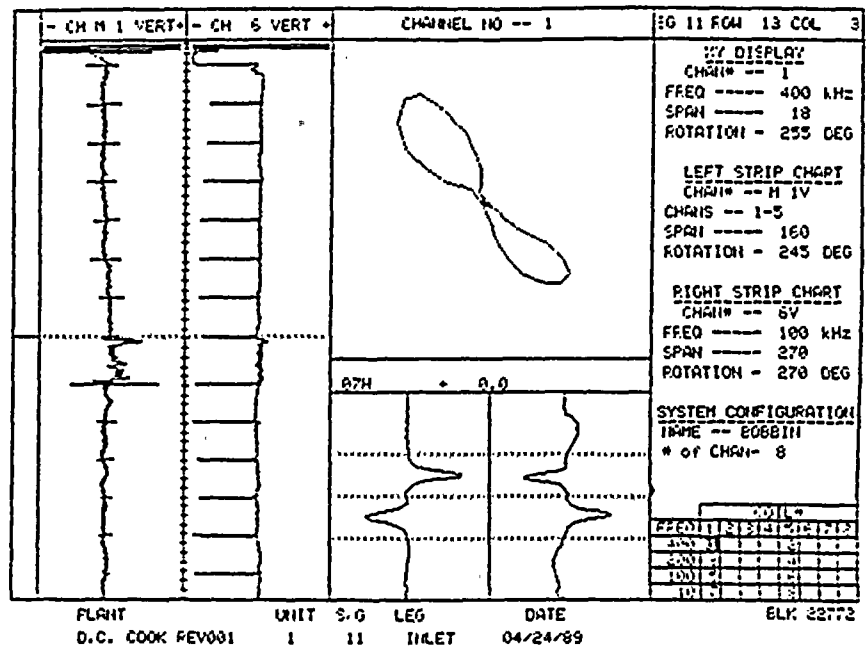
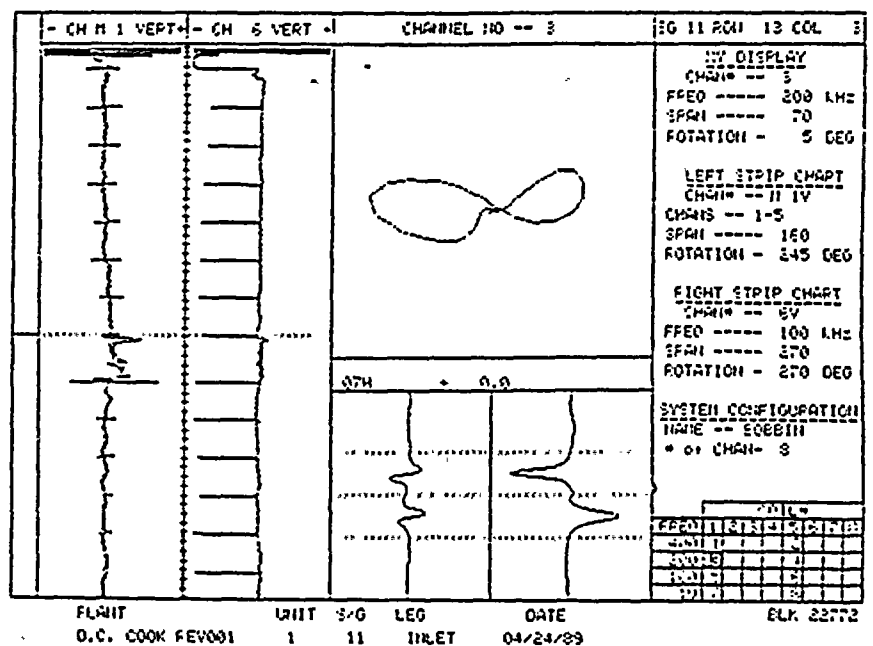
Figure 16

SG No. 11, Tube R13C3, 7th hot leg support

Representative "anomalous" signal at support plate intersection (400 kHz differential and 200 kHz differential shown in top and bottom displays; see Figure 17 for additional channels).

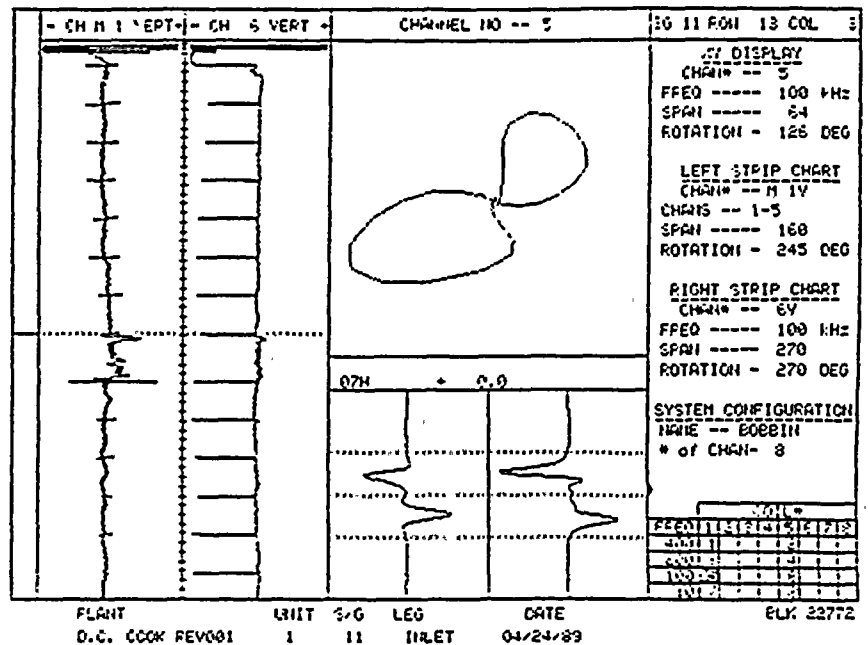
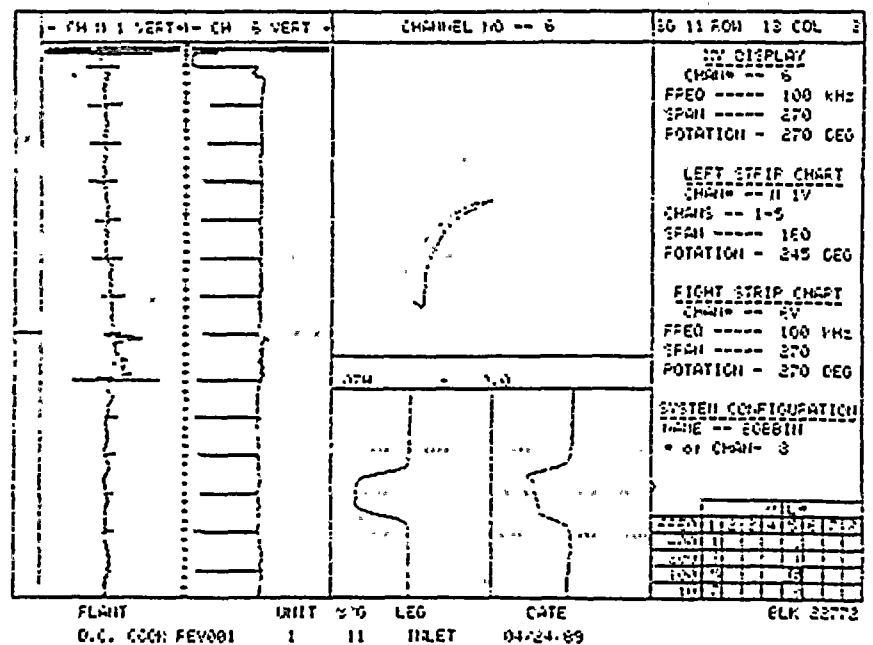
Figure 17

SG No. 11, Tube R13C3, 7th hot leg support

Representative "anomalous" signal at support plate intersection (100 kHz differential and 100 kHz absolute shown in top and bottom displays; see Figure 16 for additional channels).

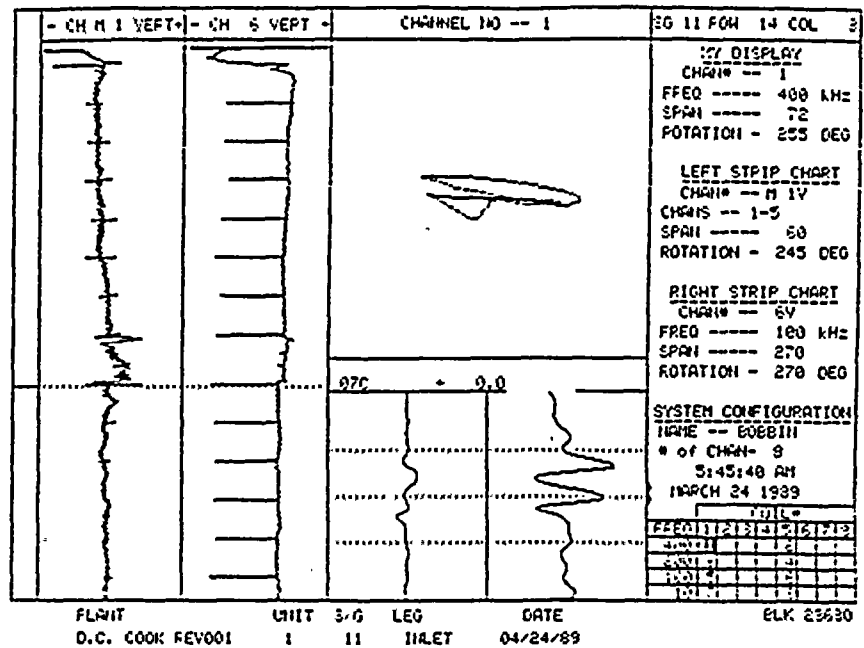
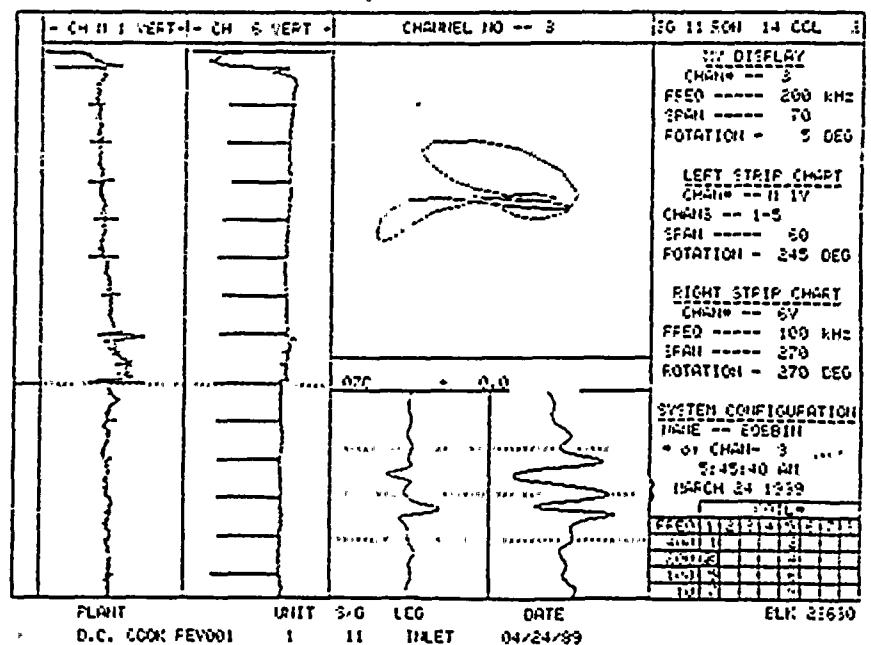
Figure 18

SG No. 11, Tube R14C3, 7th cold leg support

Representative "anomalous" signal at support plate intersection (400 kHz differential and 200 kHz differential shown in top and bottom displays; see Figures 19 and 20 for additional channels).

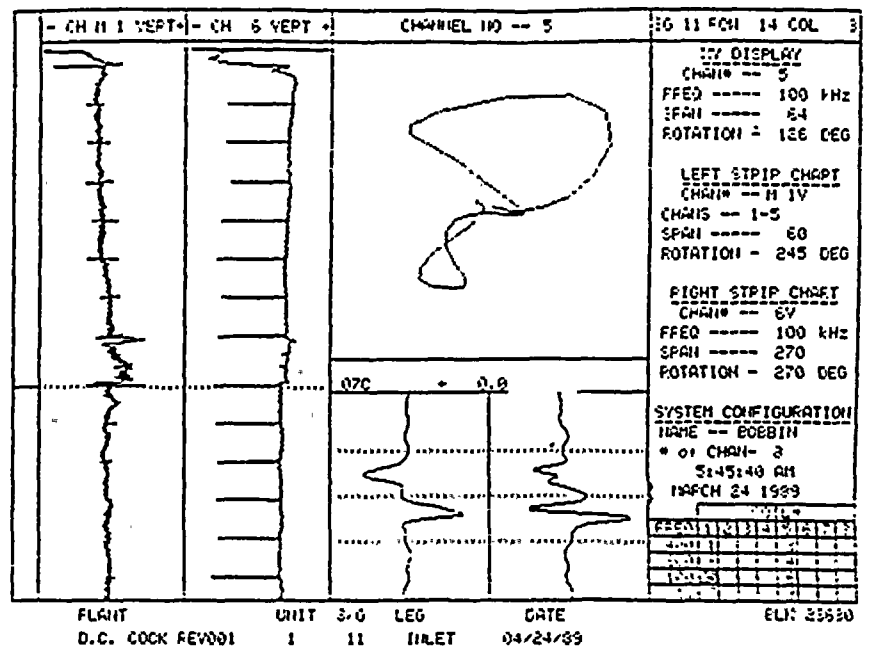
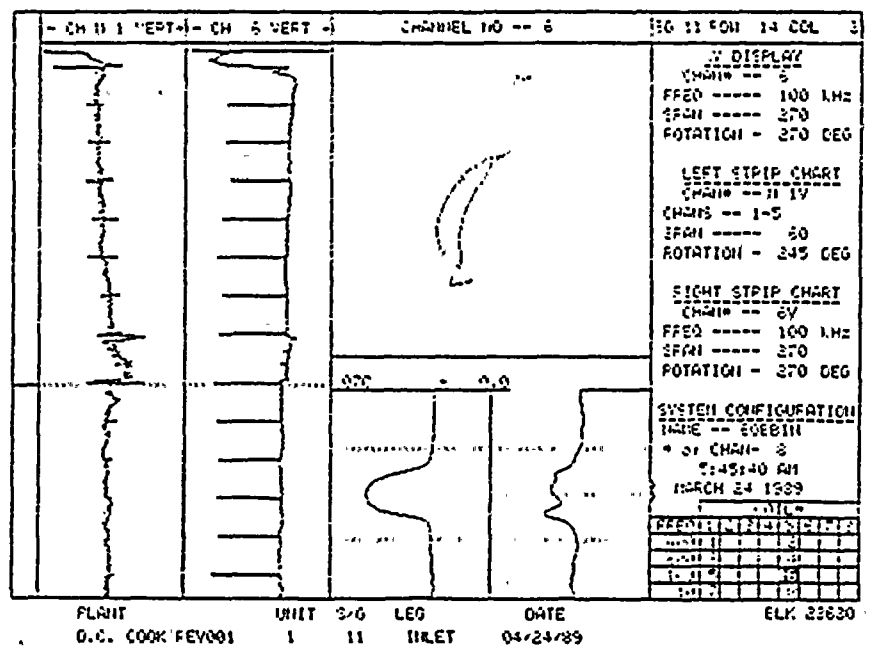
Figure 19

SG No. 11, Tube R14C3, 7th cold leg support

Representative "anomalous" signal at support plate intersection (100 kHz differential and 100 kHz absolute shown in top and bottom displays; see Figures 18 and 20 for additional channels).

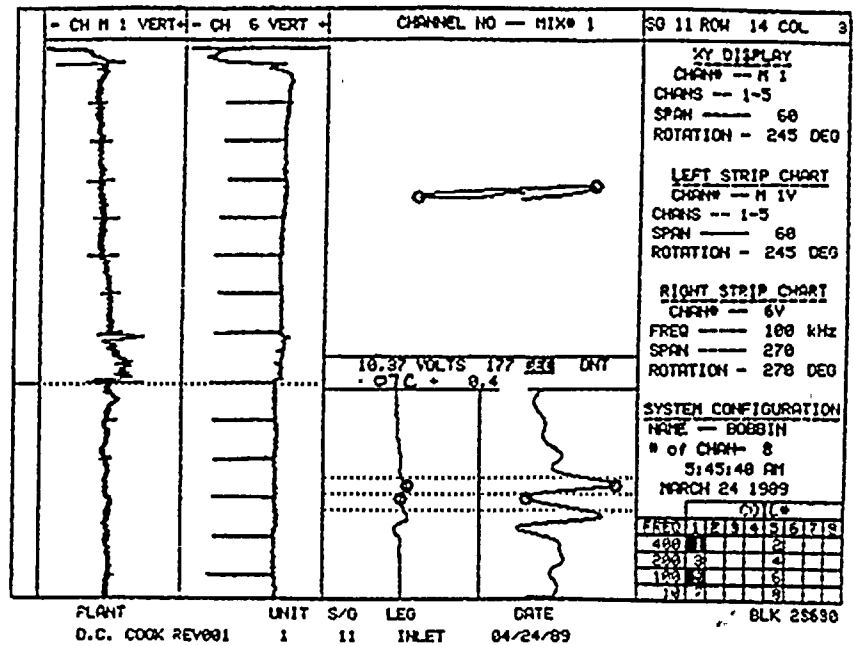
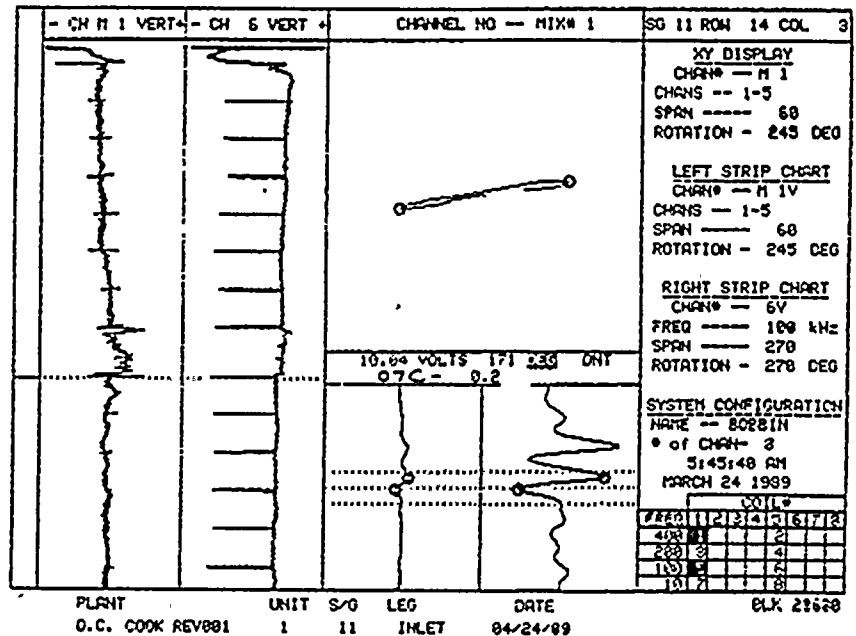
Figure 20

SG No. 11, Tube R14C3, 7th cold leg support

Representative "anomalous" signal at support plate intersection (400 kHz differential mix at +0.4 inches and -0.2 inches shown in top and bottom displays; see Figures 18 and 19 for additional channels).

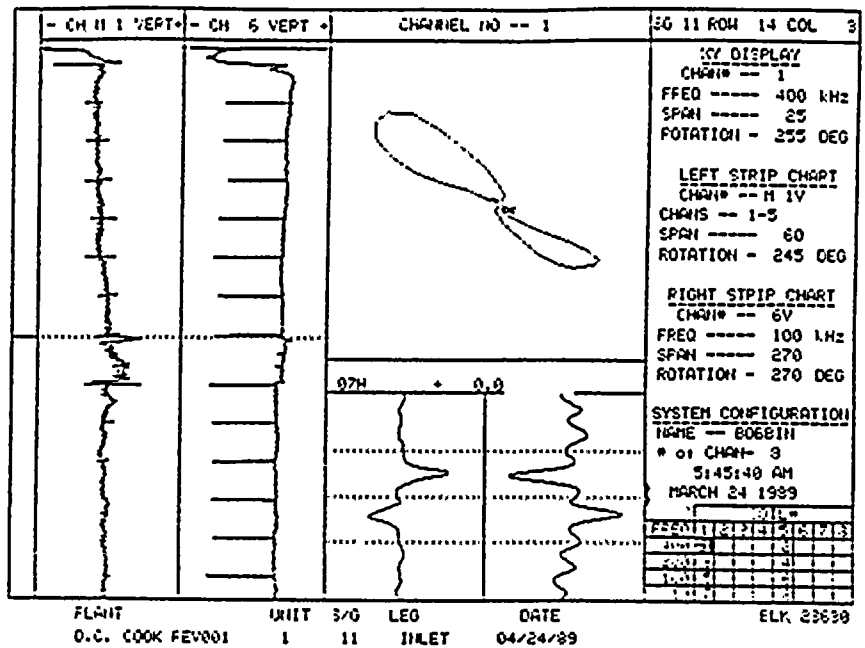
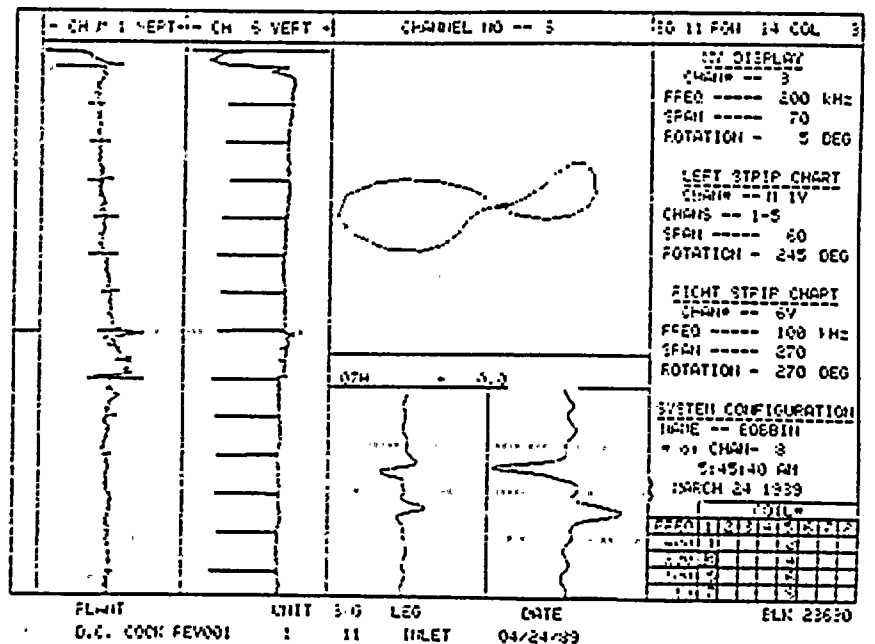
Figure 21

SG No. 11, Tube R14C3, 7th hot leg support

Representative "anomalous" signal at support plate intersection (400 kHz differential and 200 kHz differential shown in top and bottom displays; see Figure 22 for additional channels).
