SUBJECT: Forwards addl info re util 900126 revised response to NRC  
 Bulletin 88-002, per NRC 900509 request.

DISTRIBUTION CODE: IE13D COPIES RECEIVED: LTR 1 ENCL 1 SIZE: 49  
 TITLE: Bulletin Response, 88-02 Rapidly Propagating Fatigue Cracks in Steam

Donald C. Cook Nuclear Plant Units 1 and 2  
Docket Nos. 50-315 and 50-316  
License Nos. DPR-58 and DPR-74  
NRC BULLETIN 88-02; REQUEST FOR ADDITIONAL INFORMATION

BULLETIN 88-02: REQUEST FOR ADDITIONAL INFORMATION

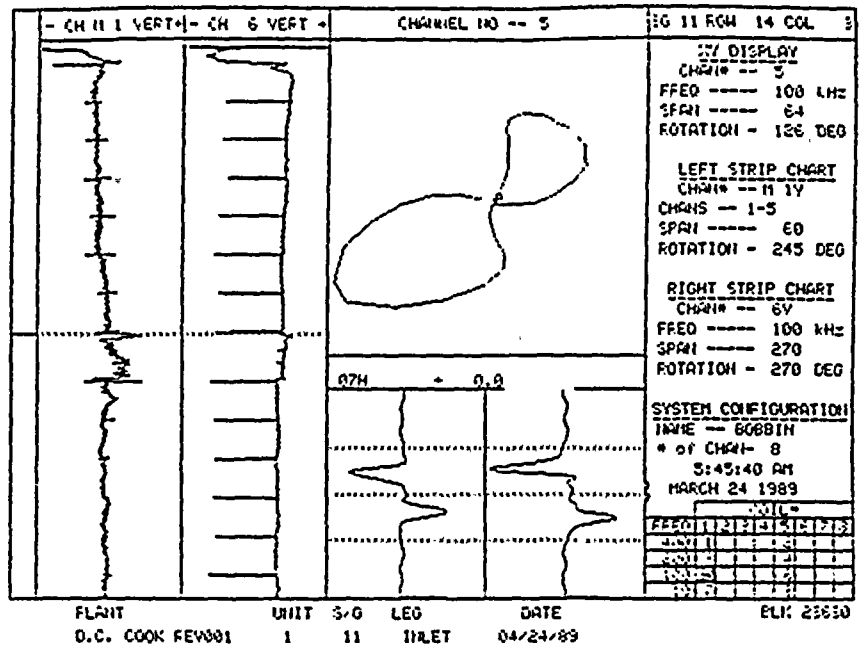
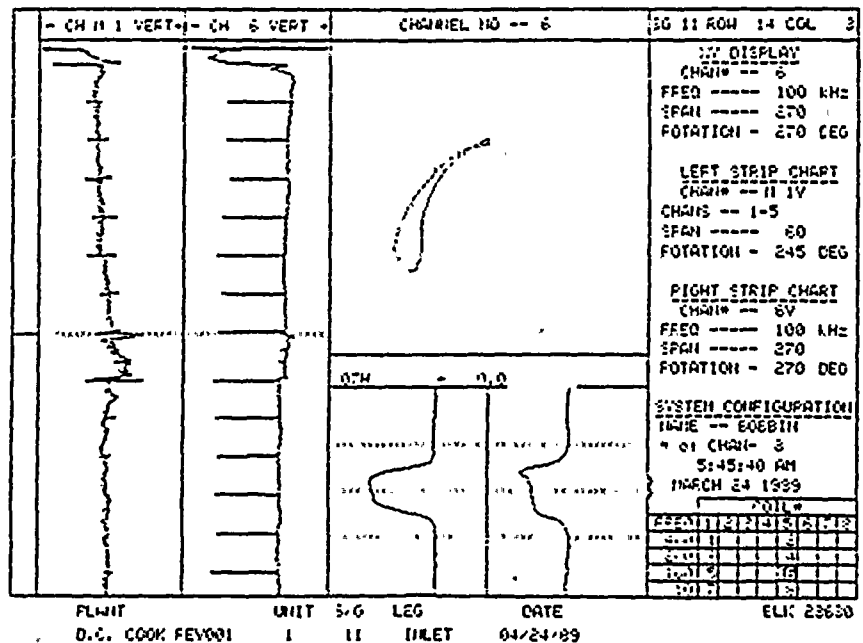
Figure 22

SG No. 11, Tube R14C3, 7th hot leg support

Representative "anomalous" signal at support plate intersection (100 kHz differential and 100 kHz absolute shown in top and bottom displays; see Figure 21 for additional channels).

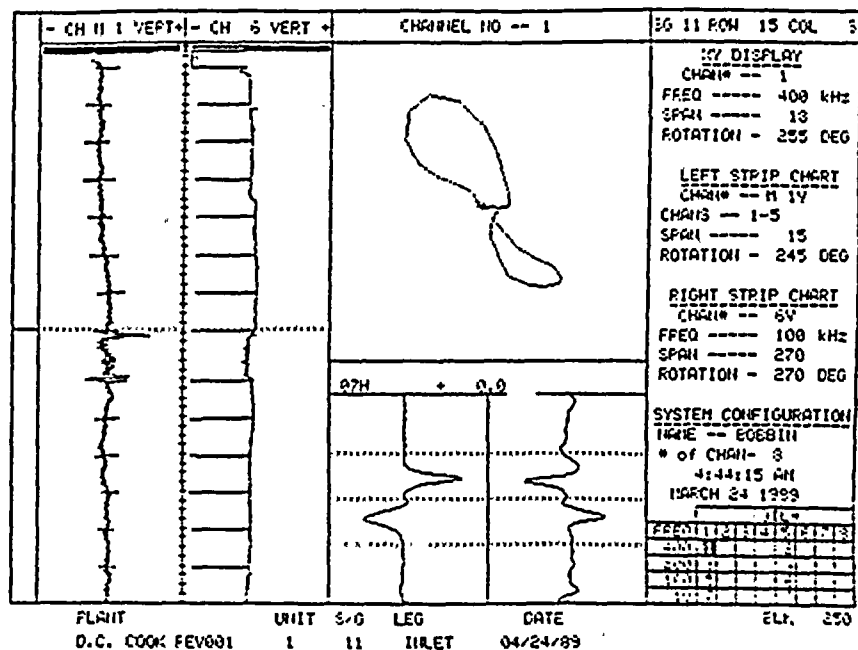
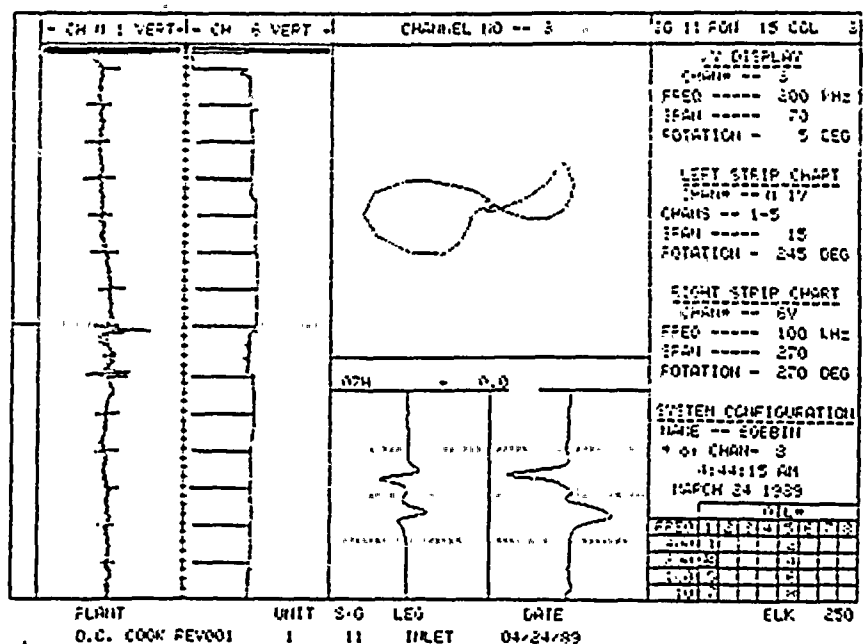
Figure 23

SG No. 11, Tube R15C3, 7th hot leg support

Representative "anomalous" signal at support plate intersection (400 kHz differential and 200 kHz differential shown in top and bottom displays; see Figure 24 for additional channels).

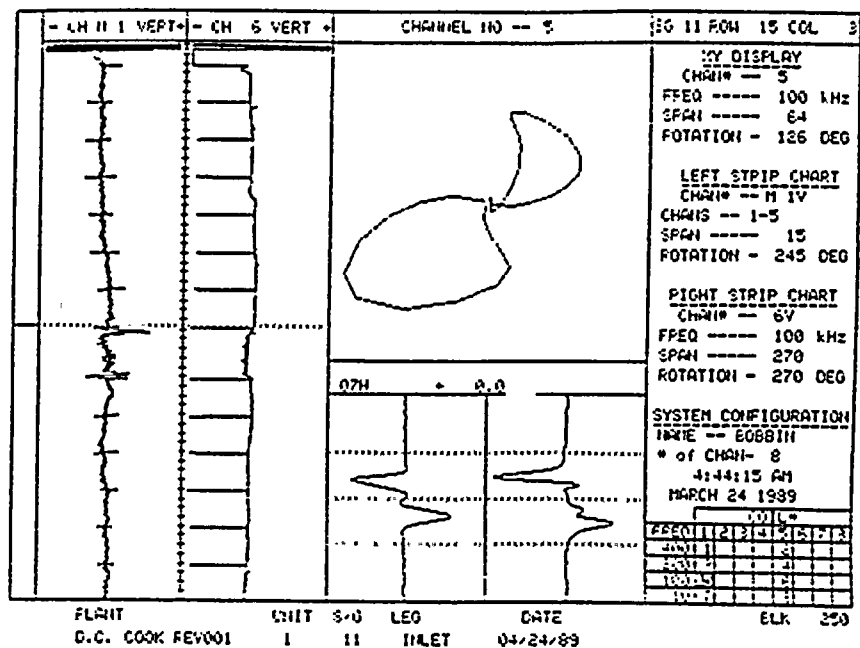
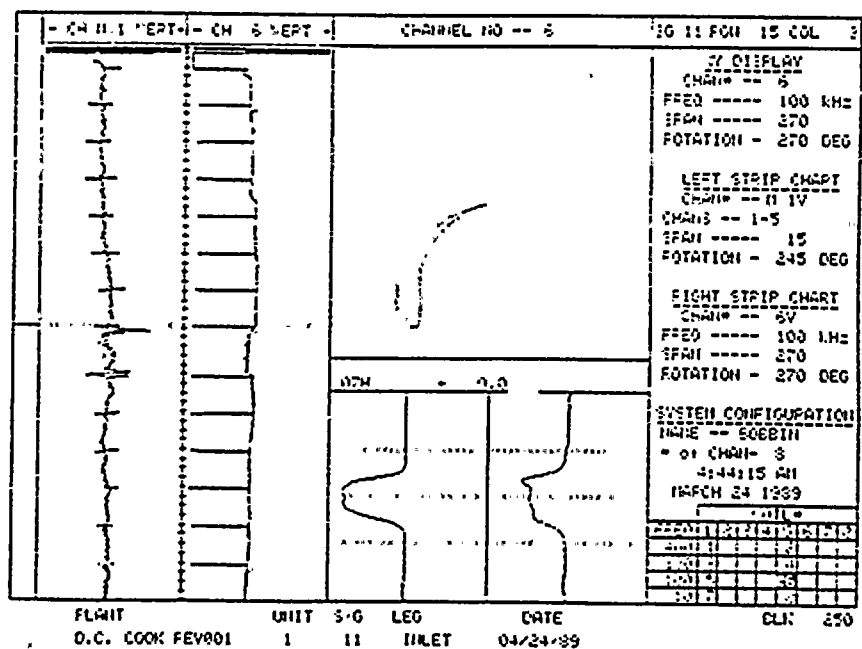
Figure 24

SG No. 11, Tube R15C3, 7th hot leg support

Representative "anomalous" signal at support plate intersection (100 kHz differential and 100 kHz absolute shown in top and bottom displays; see Figure 23 for additional channels).

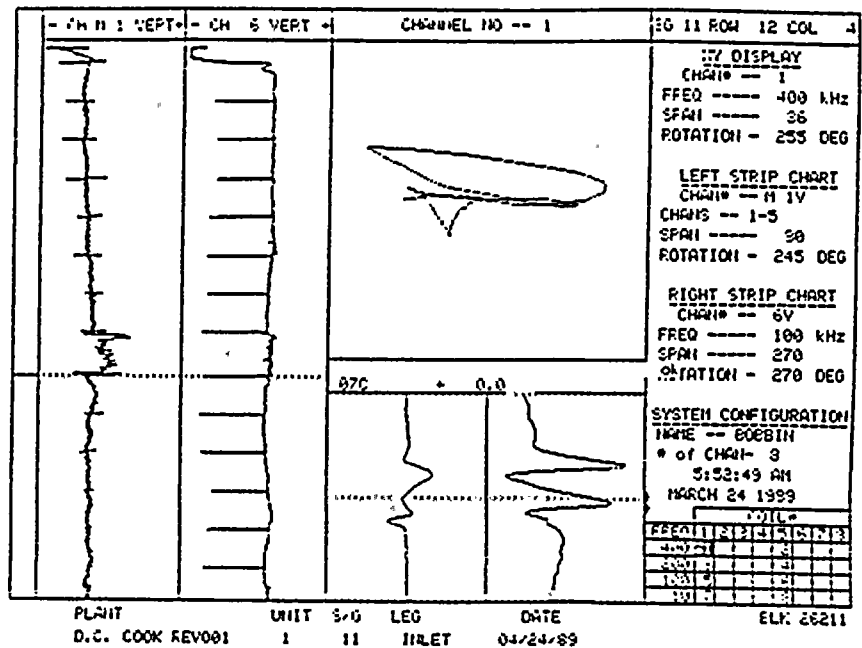
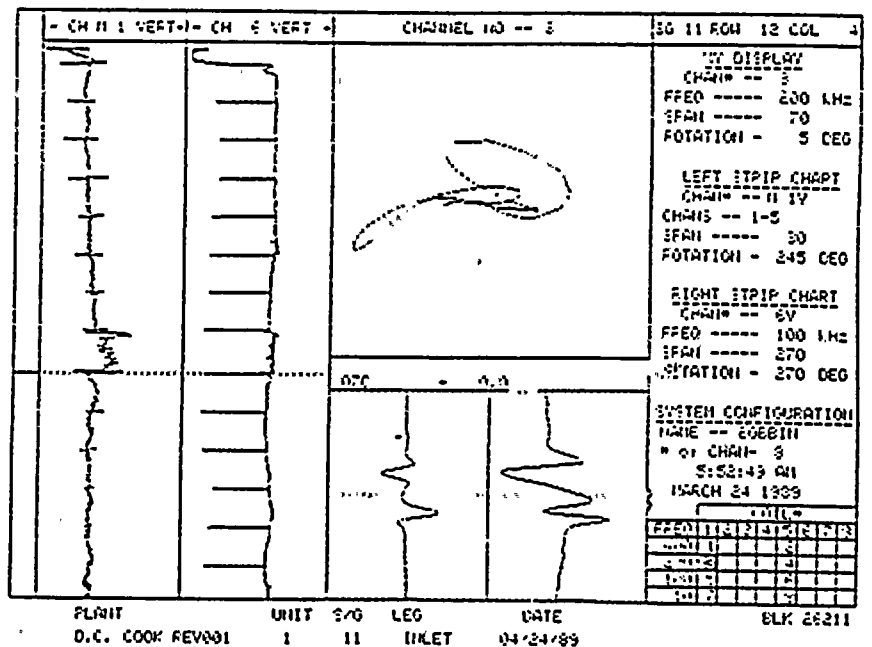
Figure 25

SG No. 11, Tube R12C4, 7th cold leg support

Representative "anomalous" signal at support plate intersection (400 kHz differential and 200 kHz differential shown in top and bottom displays; see Figures 26 and 27 for additional channels).

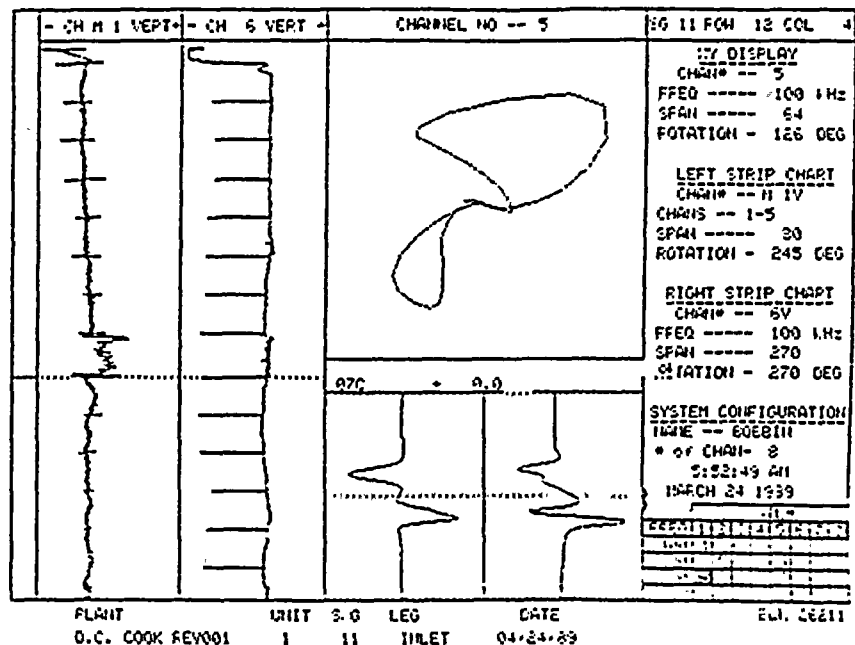
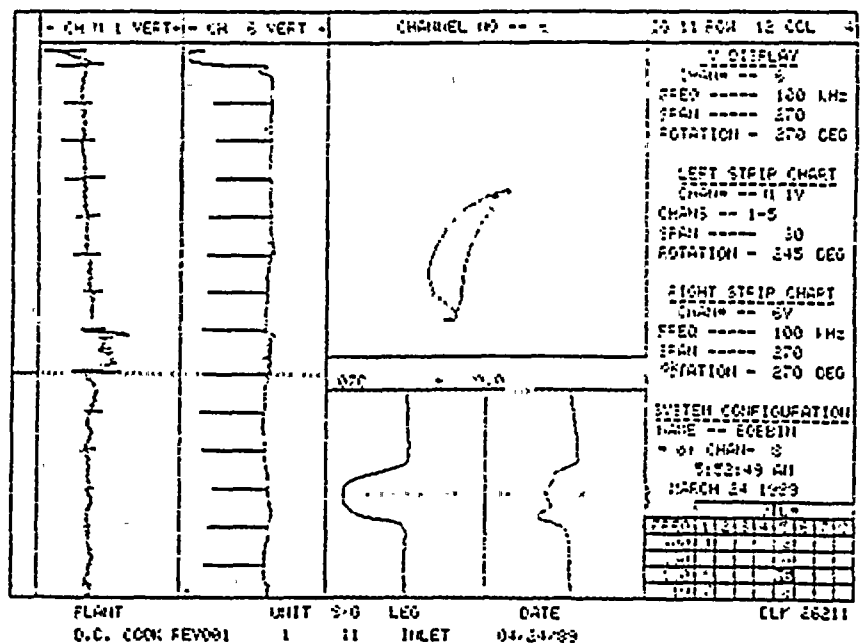
Figure 26

SG No. 11, Tube R12C4, 7th cold leg support

Representative "anomalous" signal at support plate intersection (100 kHz differential and 100 kHz absolute shown in top and bottom displays; see Figure 25 and 27 for additional channels).

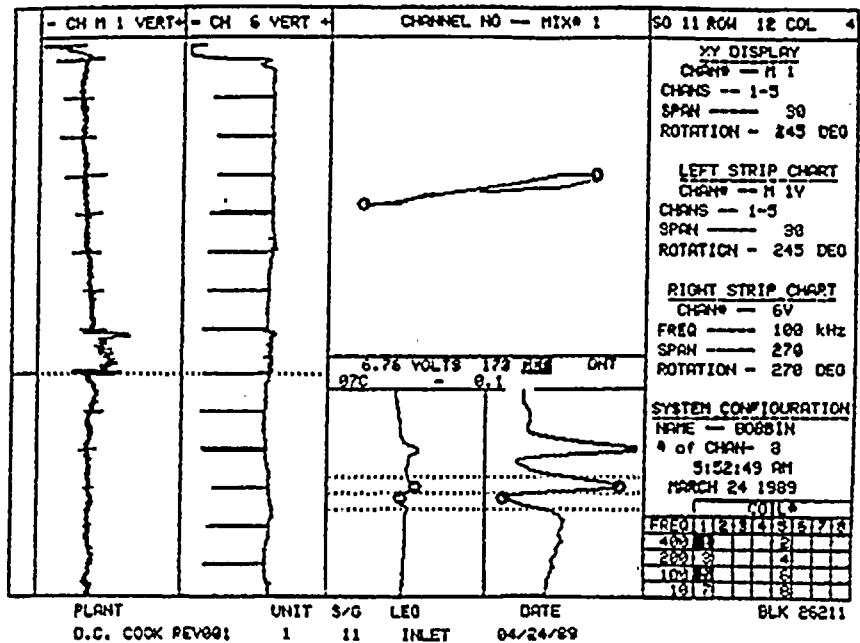
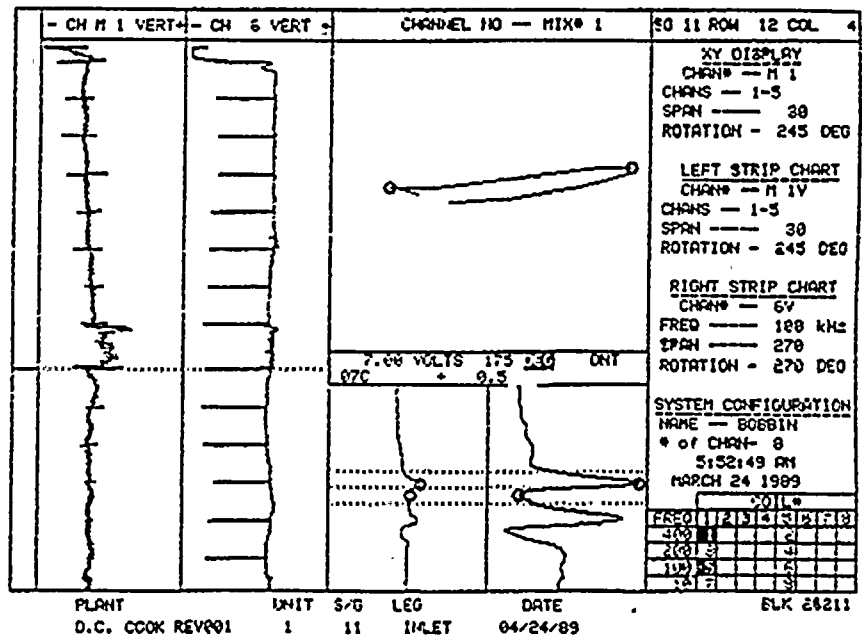
Figure 27

SG No. 11, Tube R12C4, 7th cold leg support

Representative "anomalous" signal at support plate intersection (400 kHz differential mix at -0.1 inches and +0.5 inches shown in top and bottom displays; see Figures 25 and 26 for additional channels).

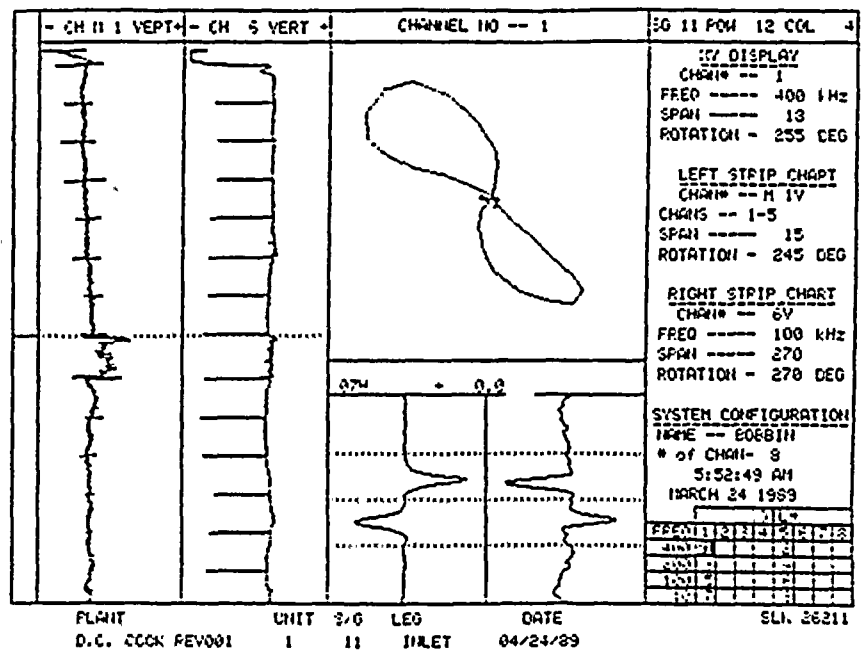
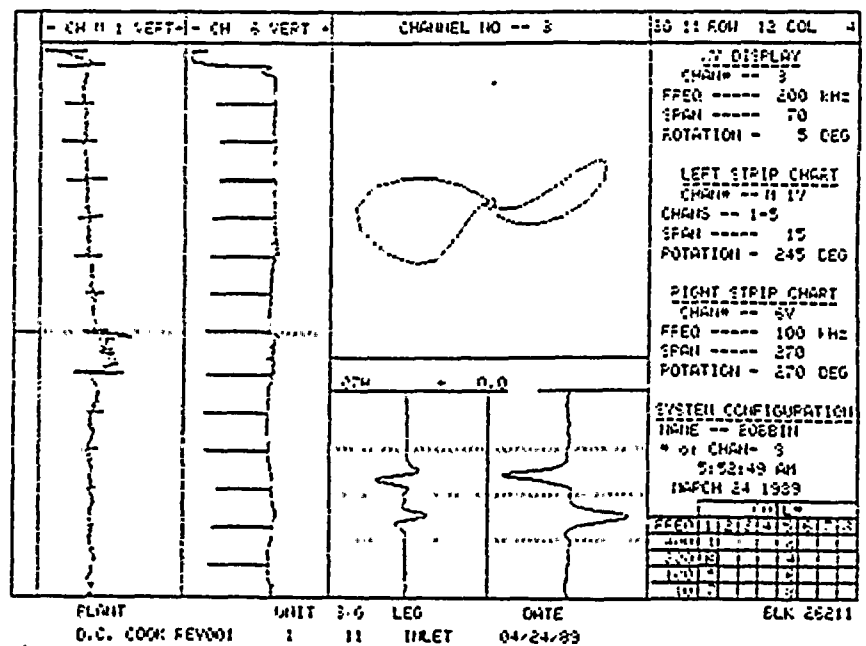
Figure 28

SG No. 11, Tube R12C4, 7th hot leg support

Representative "anomalous" signal at support plate intersection (400 kHz differential and 200 kHz differential shown in top and bottom displays; see Figure 29 for additional channels).

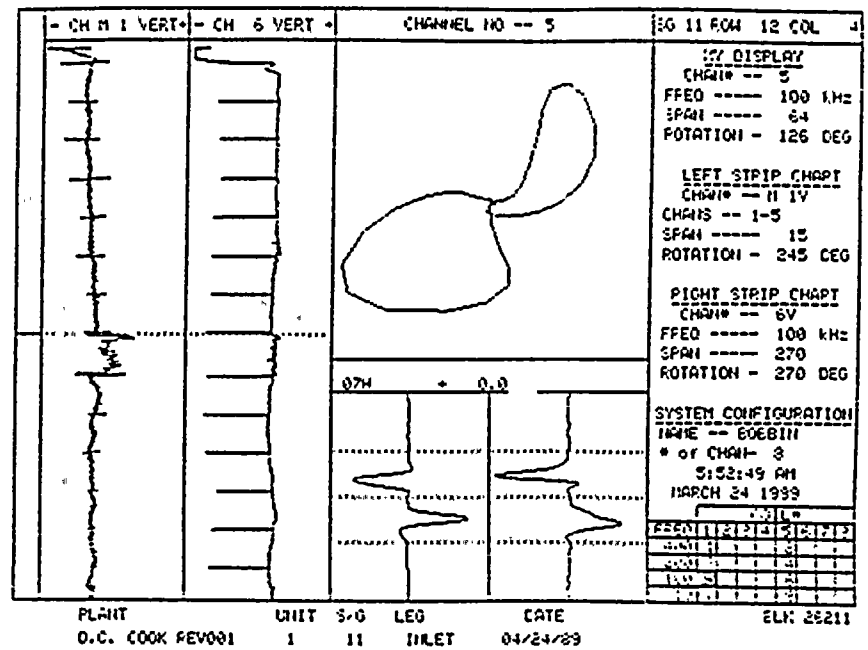
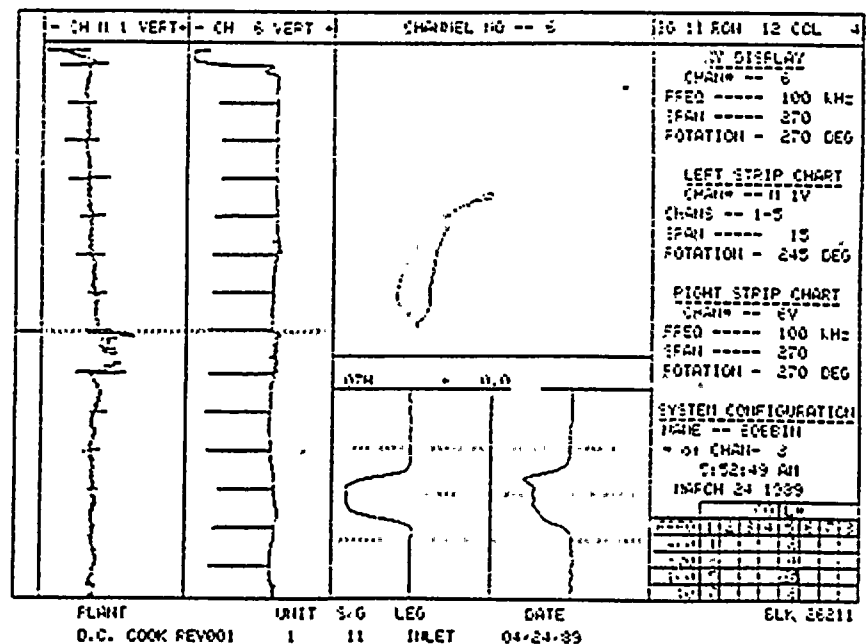
Figure 29

SG No. 11, Tube R12C4, 7th hot leg support

Representative "anomalous" signal at support plate intersection (100 kHz differential and 100 kHz absolute shown in top and bottom displays; see Figure 28 for additional channels).

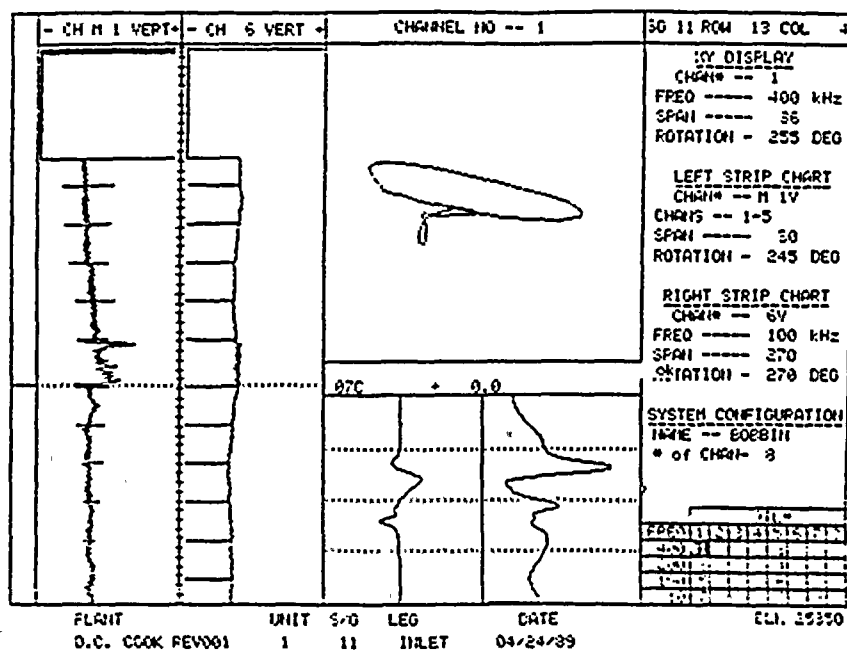
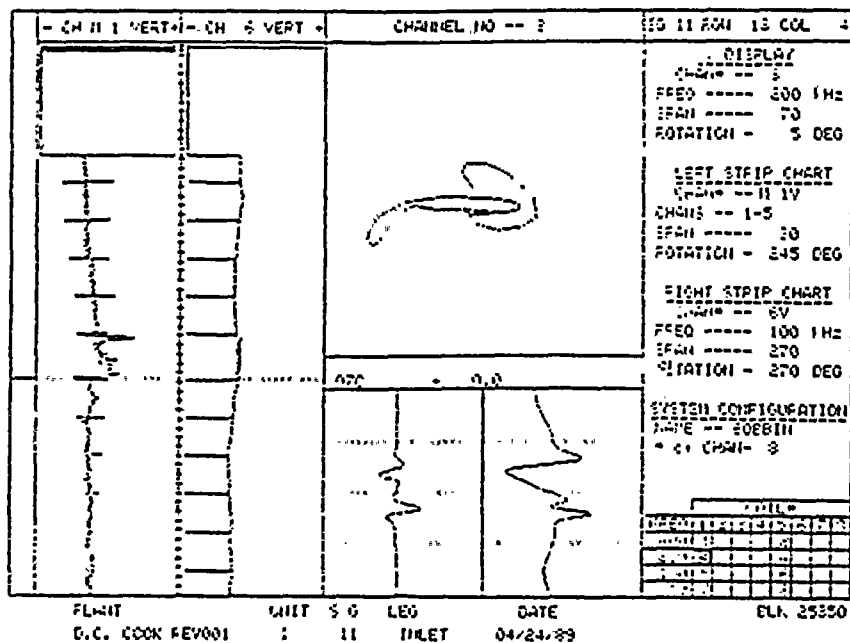
Figure 30

SG No. 11, Tube R13C4, 7th cold leg support

Representative "anomalous" signal at support plate intersection (400 kHz differential and 200 kHz differential shown in top and bottom displays; see Figures 31 and 32 for additional channels).

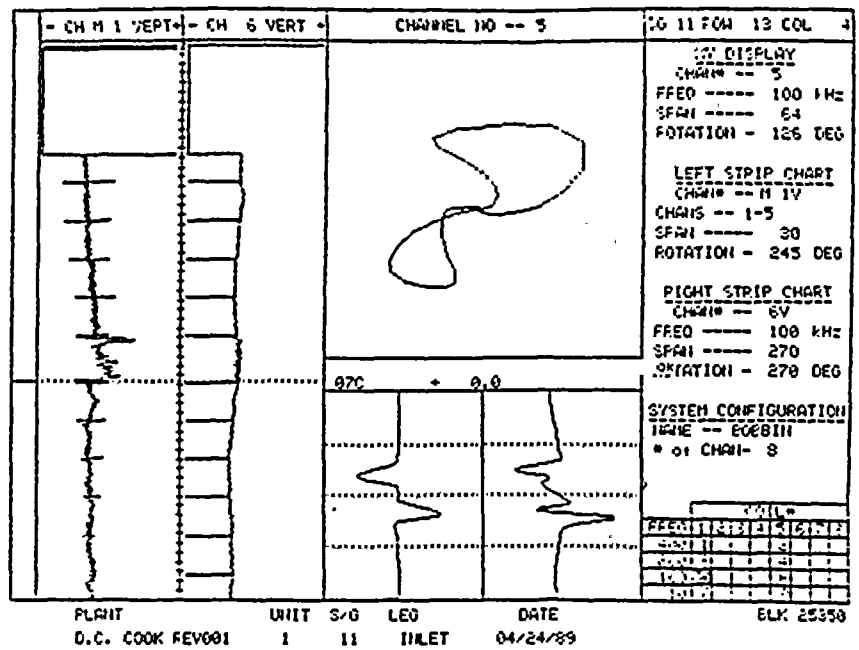
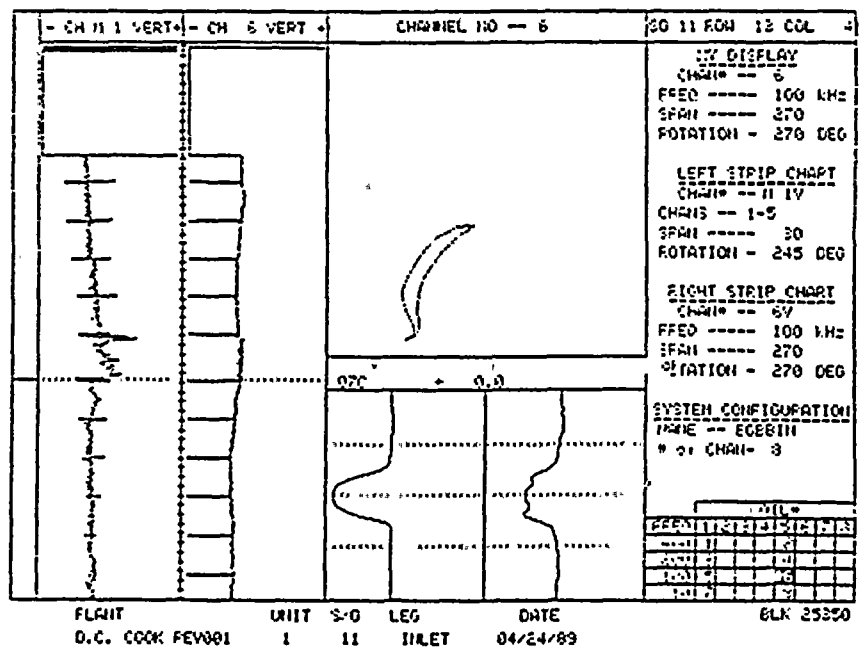
Figure 31

SG No. 11, Tube R13C4, 7th cold leg support

Representative "anomalous" signal at support plate intersection (100 kHz differential and 100 kHz absolute shown in top and bottom displays; see Figures 30 and 32 for additional channels).

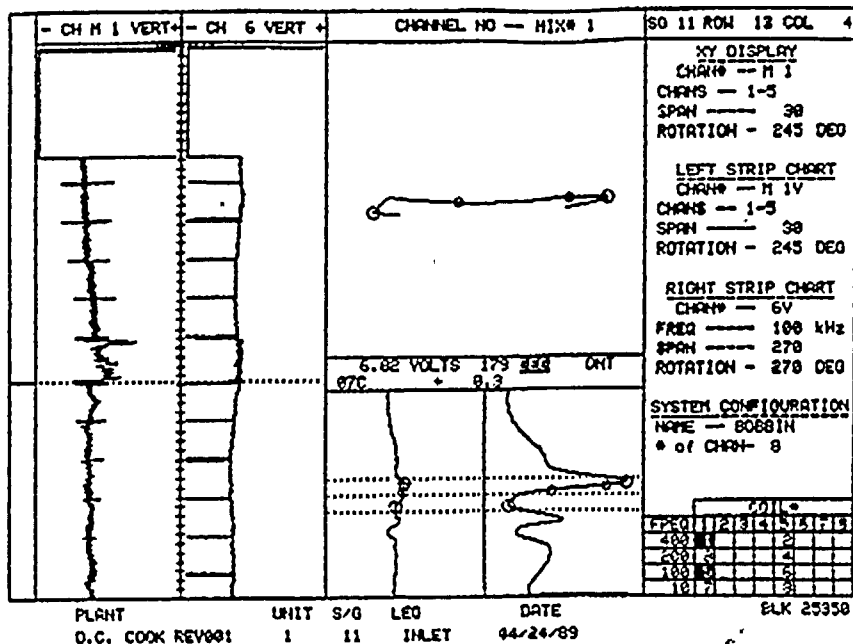
Figure 32

SG No. 11, Tube R13C4, 7th cold leg support

Representative "anomalous" signal at support plate intersection (400 kHz differential mix at +0.3 inches shown in display; see Figures 30 and 31 for additional channels).

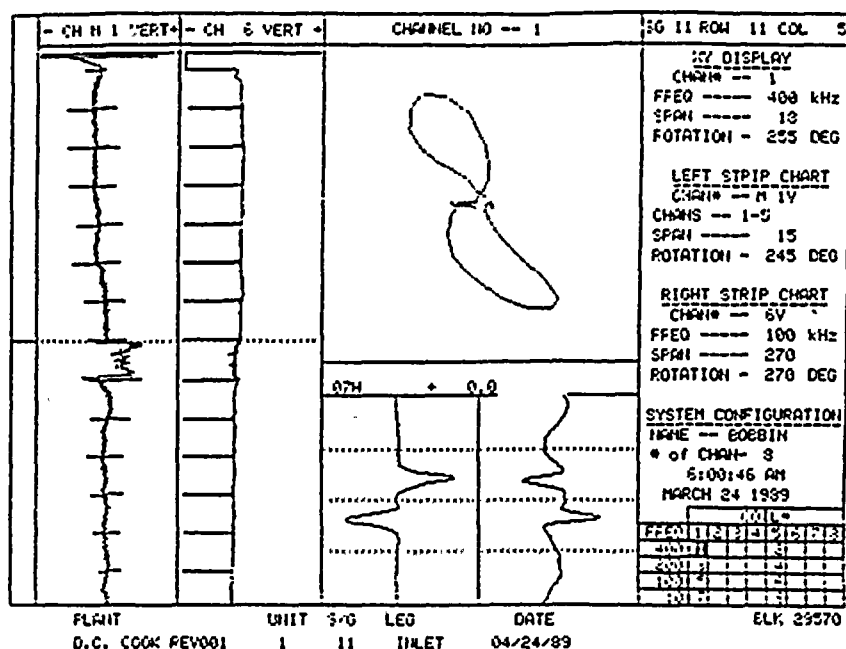
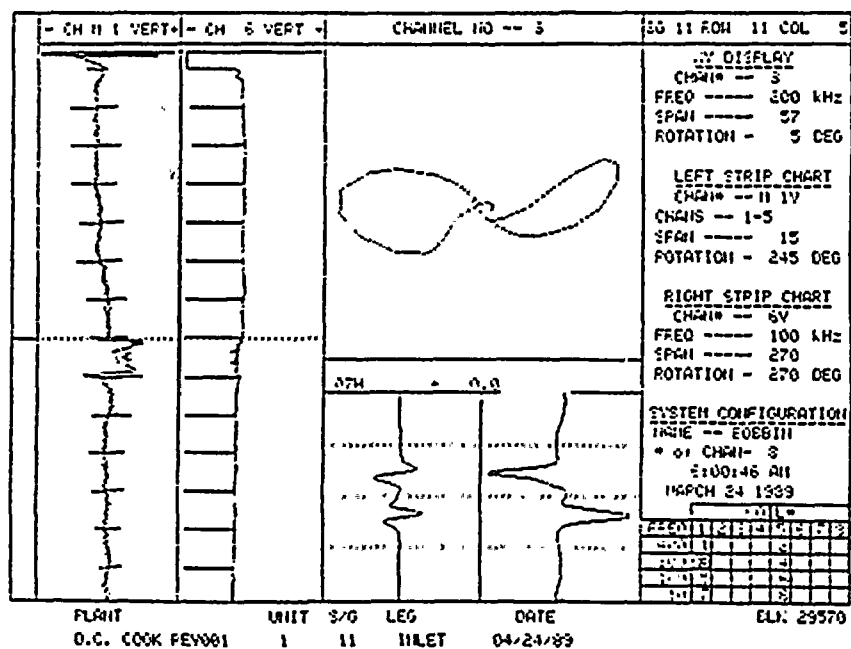
Figure 33

SG No. 11, Tube R11C5, 7th hot leg support

Representative "anomalous" signal at support plate intersection (400 kHz differential and 200 kHz differential shown in top and bottom displays; see Figure 34 for additional channels).

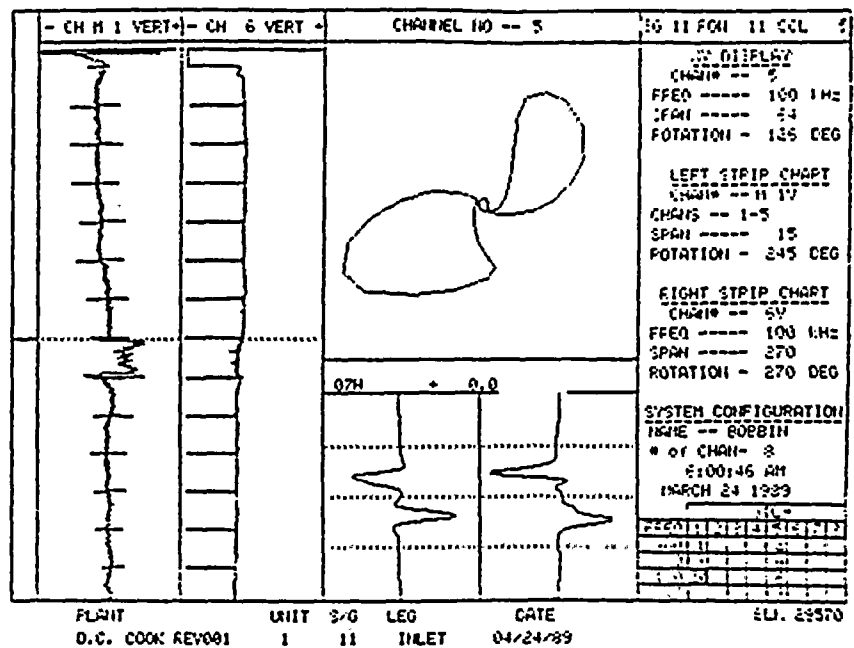
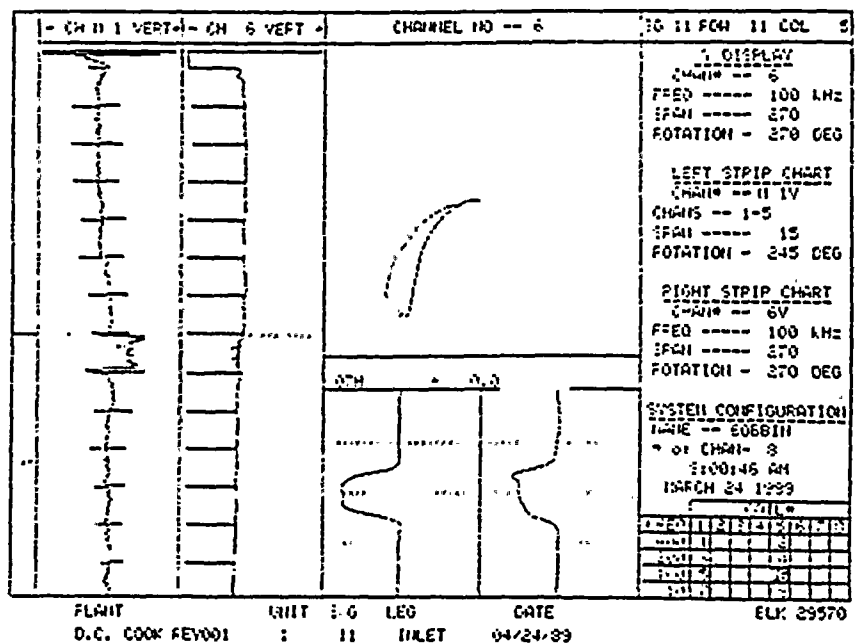
Figure 34

SG No. 11, Tube R11C5, 7th hot leg support

Representative "anomalous" signal at support plate intersection (100 kHz differential and 100 kHz absolute shown in top and bottom displays; see Figure 33 for additional channels).
