SUBJECT: LER 90-008-00:on 900619,10CFR App R deficiencies resulting
 in potential for loss of auto start of svc water pumps.
 W/9 ltr.

LICENSEE EVENT REPORT (LER)

FACILITY NAME (1) D.C. Cook Nuclear Plant, Unit 1										DOCKET NUMBER (2) 0 5 0 0 0 3 1 5				PAGE (3) 1 OF 0 6										
TITLE (4) 10 CFR Appendix R Deficiencies Resulting in Potential for Loss of Auto Start of Service Water Pumps Due to Incorrect Implementations of Design Change																								
EVENT DATE (5)			LER NUMBER (6)				REPORT DATE (7)			OTHER FACILITIES INVOLVED (8)														
MONTH	DAY	YEAR	YEAR	SEQUENTIAL NUMBER	REVISION NUMBER	MONTH	DAY	YEAR	FACILITY NAMES				DOCKET NUMBER(S)											
0	6	0	1	9	0	9	0	0	0	8	0	0	0	8	3	1	9	0	D.C. Cook, Unit 2				0 5 0 0 0 3 1 6	
OPERATING MODE (9) 1			THIS REPORT IS SUBMITTED PURSUANT TO THE REQUIREMENTS OF 10 CFR §: (Check one or more of the following) (11)																					
POWER LEVEL (10) 0 8 3			20.402(b)				20.405(c)				50.73(a)(2)(iv)				73.71(b)

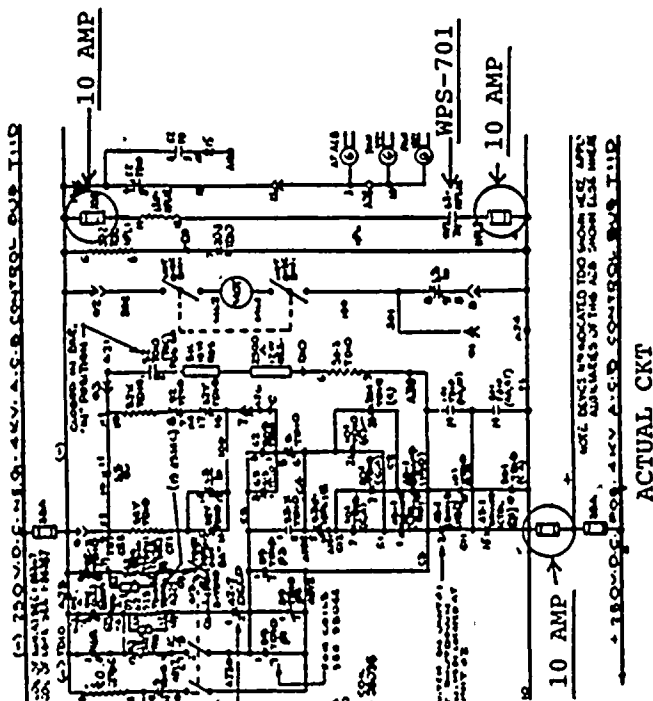
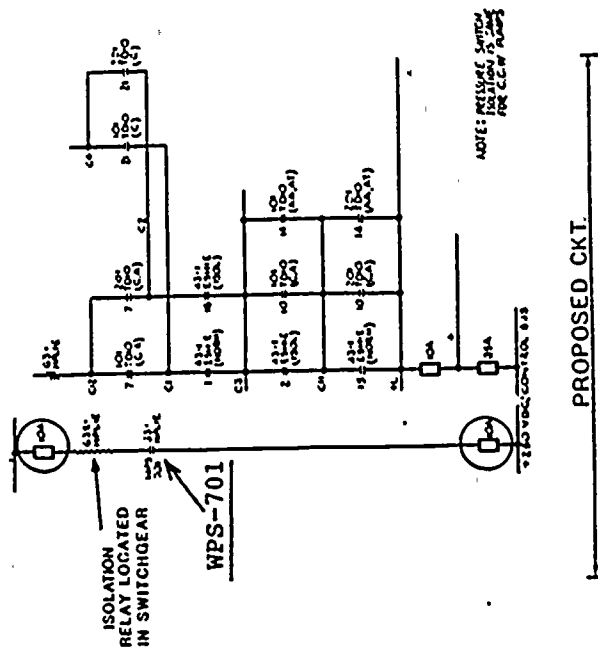
To get a better understanding of the problem, please refer to the attached sketch. This sketch is typical for all ESW and CCW pumps. The circuit labeled "Proposed CKT" shows how the isolation was supposed to be provided. In the "Proposed Circuit," the pressure switch contact and the isolation relay would be isolated from the rest of the control circuit by 10 amp fuses. A fault at pressure switch WPS-701 would result in one of the isolation relay fuses being blown. The 10 amp control circuit fuse would be left unaffected.

The circuit labeled "Actual CKT" shows what was actually installed. As shown on the sketch, the 10 amp isolation relay fuses were placed in series with the 10 amp control circuit fuse.

Since the fuses have the same rating and characteristics, there is a chance that the control circuit fuse would blow before the isolation relay fuse in the event of a fault at WPS-701. If this happened, the pump's close circuit would become inoperable. If the pump was already running, it would continue to run, but if it was not running or was subsequently shutdown, the pump could not be restarted without manual action by the operators at the pump's electrical breaker.

The immediate corrective action was to replace the 10 amp isolation relay fuses with 5 amps fuses to provide proper fuse coordination with the 10 amp control circuit fuse. This action was completed in both units on June 22, 1990.

The breaker control circuits for Unit 2 ESW and CCW pumps will be modified during the current Unit 2 refueling outage (Plant Modification number 12-MM-110). The breaker control circuits for Unit One ESW and CCW pumps will be modified during the next Unit One refueling outage (Plant Modification number 12-MM-110).
