ACCELERATED DISTRIBUTION DEMONSTRATION SYSTEM

SUBJECT: Informs of preliminary assessment of 900713 electrical
 contact accident at facility.

DESCRIPTION OF ACCIDENT - July 13, 1990

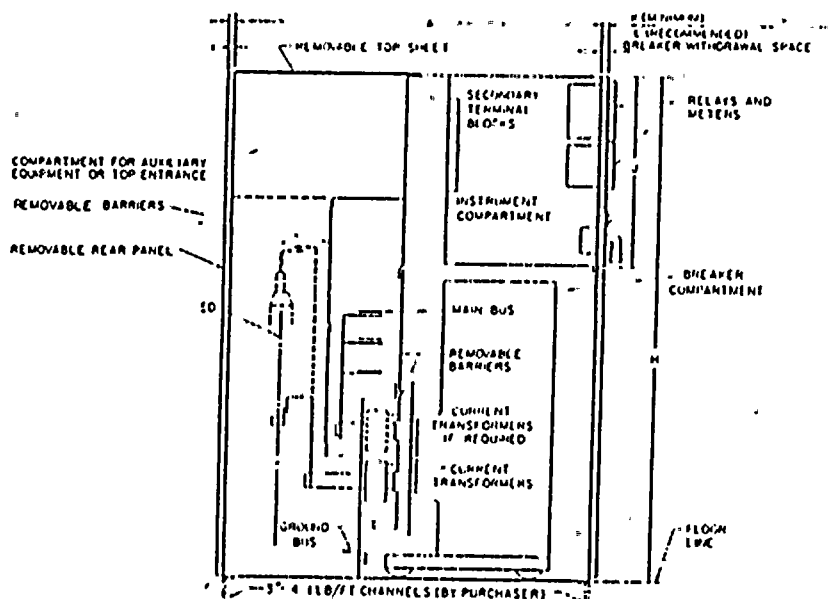
Typical Drawing of ITE 5HK 250 4KV Metal-Clad Switchgear

From the physical evidence, it appears that NSS-1 contacted the energized 4KV feed cables with his upper inside left arm and right chest. The resultant three phase fault was calculated at between 38,000 to 48,000 amps. The fault was cleared by overcurrent relays for breaker 2C6 in approximately 40 to 70 cycles. Analysis of bubbled and charred paint on walls indicate approximately 85% of the heat went left or north of the cabinet. The attached accident scene reconstruction drawing (see attachment 3) shows probable temperature profiles and probable individual's positions. The actual location of the CTs were on the stationary breaker stabs accessed from the front of the cabinet. The MMA, I&C Technician, and NSS-2 were wearing hard hats. NSS-1's hard hat was found near another breaker cabinet and showed no signs of heat damage. There was no high voltage personal protective equipment or high voltage test equipment found at the job site.

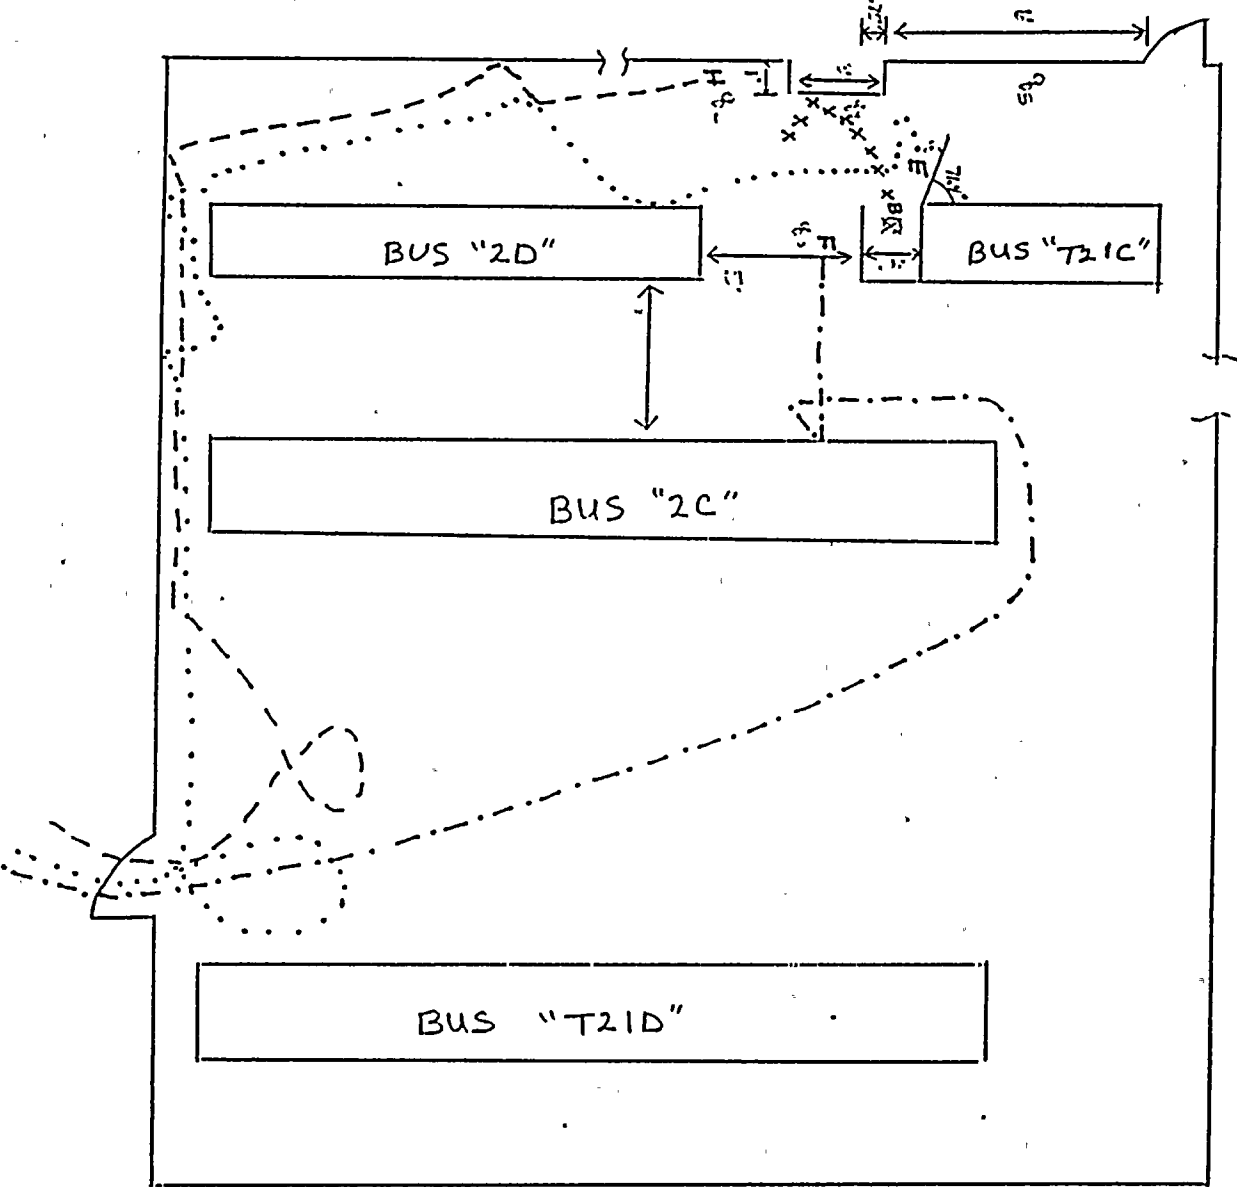
SUSPECTED MEANS OF ENTRY

Source: 4650F

q₁ - greater than 200°F

q₂ - greater than 250°F

q₃ - greater than 250°F

q₄ - greater than 250°F

q₅ - greater than 300°F
