SUBJECT: LER 90-008-00:on 900807,degradation of divider barrier seal
located between containment & crane walls occurred.

Indiana Michigan
Power Company
Cook Nuclear Plant
P.O. Box 458
Bridgman, MI 49106
616 465 5901

90-008-00

FACILITY NAME (1) D. C. COOK PLANT - UNIT 2										DOCKET NUMBER (2) 0 5 0 0 0 3 1 6 1										PAGE (3) 1 OF 0 6	
TITLE (4) DEGRADATION OF DIVIDER BARRIER SEAL LOCATED BETWEEN CONTAINMENT WALL AND CRANE WALL																					
EVENT DATE (5)			LER NUMBER (6)				REPORT DATE (7)			OTHER FACILITIES INVOLVED (8)											
MONTH	DAY	YEAR	YEAR	SEQUENTIAL NUMBER	REVISION NUMBER	MONTH	DAY	YEAR	FACILITY NAMES			DOCKET NUMBER(S)									
0 8	0 7	9 0	9 0	0 0 8	0 0	0 9	1 7	9 0	COOK PLANT - UNIT 1			0 5 0 0 0 3 1 5									
OPERATING MODE (9) 6			THIS REPORT IS SUBMITTED PURSUANT TO THE REQUIREMENTS OF 10 CFR §: (Check one or more of the following) (11)																		
POWER LEVEL (10) 0 0 0		20.402(b)				20.405(c)				50.73(a)(2)(iv)				73.71(b)

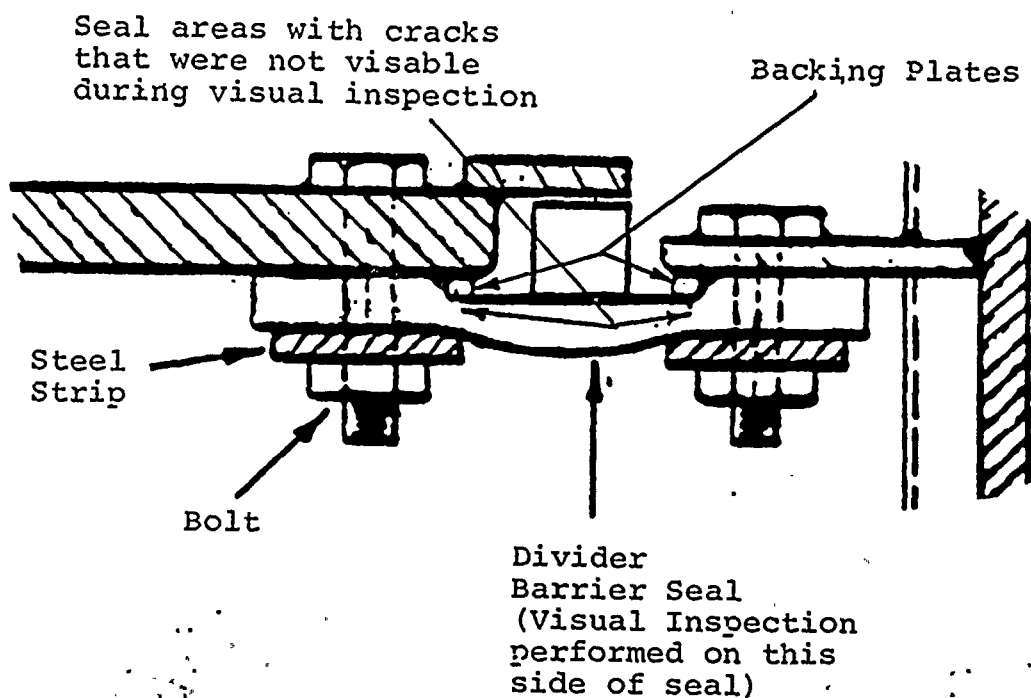
TYPICAL INSTALLATION OF DIVIDER BARRIER SEAL
WITH BACKING PLATES

The seal material (by Uniroyal, Model No. 3807) was found to be cracked and split. The seal material would separate upon removal and handling. Portions would split when removed from sealing surfaces or separate longitudinally along cracks not visible prior to removal. The cracks were in the area of the raised seating surface (see attached drawing). In the past, Uniroyal 41-300 seal material had been used to replace portions of the 3807 seal material. The 41-300 material showed no signs of degradation.

It could not be conclusively determined what caused the Divider Barrier Seal material to degrade in such a manner. It is possible that the 3807 seal material can not deal with the localized stress imposed upon it by the backing plate. The 41-300 seal material has been used to replace degraded portions of the 3807 material since 1981. Samples of both the 41-300 material and 3807 material were sent in for laboratory analysis. The physical properties (tensile strength and elongation at break) of the 41-300 seal material are far superior to the 3807 material. There has not been any indication that the previously installed 41-300 seal material had degraded.

Two types of seals exist, one with a backing plate made of steel and one without a backing plate. There is approximately 490 linear feet of the seal type with a backing plate and it has been conservatively estimated that, given the identified defect, this type of seal would open to a 1/16-inch gap. This would produce a bypass area of (490 ft.) (1/16 inch) (ft./12inch) = 2.55 sq. ft. There are 156 linear feet of seal type without a backing plate and it has been conservatively estimated that, given the identified defect, this type of seal would open to a 1.25 - inch gap. This would produce a bypass area of (156ft.) (1.25 inch) (ft./12 inch) = 16.25 sq. ft.

The entire Divider Barrier Seal is being replaced with Uniroyal, Model No. 41-300 material. The Unit 1 Divider Barrier Seal is also constructed from No. 3807 material. The 3807 material will be replaced during the upcoming refueling outage (Oct. - Nov., 1990).
