SUBJECT: LER 90-002-00:on 900110,MSIV inoperability due to condensate
 accumulation on vent side of operating piston.

90-002-00

FACILITY NAME (1) D. C. Cook Plant - Unit 2										DOCKET NUMBER (2) 0 5 0 0 0 3 1 6										PAGE (3) 1 OF 1 0				
TITLE (4) Main Steam Isolation Valve Inoperability - Due to Condensate Accumulation on Vent Side of Operating Piston																								
EVENT DATE (5)			LER NUMBER (6)					REPORT DATE (7)			OTHER FACILITIES INVOLVED (8)													
MONTH	DAY	YEAR	YEAR		SEQUENTIAL NUMBER		REVISION NUMBER	MONTH	DAY	YEAR	FACILITY NAMES						DOCKET NUMBER(S)							
											Cook Plant - Unit 1						0 5 0 0 0 3 1 5							
0	1	1	0	9	0	9	0	0	0	2	0	0	0	2	0	9	9	0	0 5 0 0 0 3 1 5					
OPERATING MODE (9)			THIS REPORT IS SUBMITTED PURSUANT TO THE REQUIREMENTS OF 10 CFR §: (Check one or more of the following) (11)																					
3			20.402(b)					20.405(c)					60.73(a)(2)(iv)					73.71(b)						
POWER LEVEL (10)			20.406(a)(1)(i)					50.36(c)(1)					60.73(a)(2)(v)					73.71(c)						
0 0 0			20.406(a)(1)(ii)					50.36(c)(2)					60.73(a)(2)(vi)					OTHER (Specify in Abstract below and in Text, NRC Form 356A)

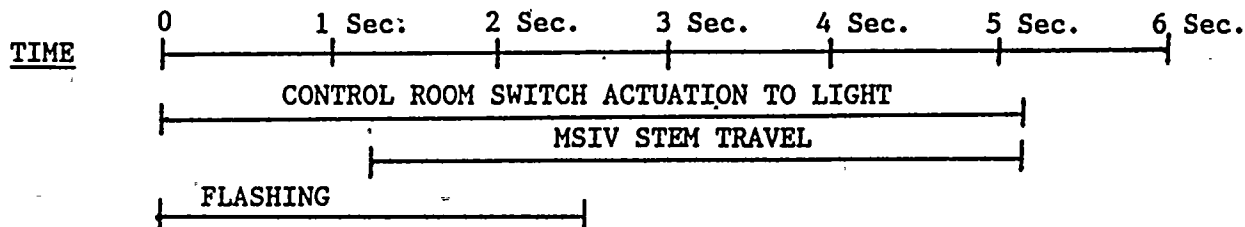
On January 10, 1990, a series of diagnostic tests were performed to determine the extent that condensate within the MSIV operating cylinder volume could affect MSIV stroke time. A strip chart was used to record pressure within the volume as a function of time. Closure time was measured in the control room, measuring the time from the dump valve switch actuation until the MSIV valve light indicated the valve was closed. MSIV stem travel time was measured locally. The following time line is similar to each MSIV tested and represents typical circumstances experienced by all MSIV's.

Local observation verified substantial quantities of water and steam being discharged from the vent stack from T=0 until MSIV stem travel began.

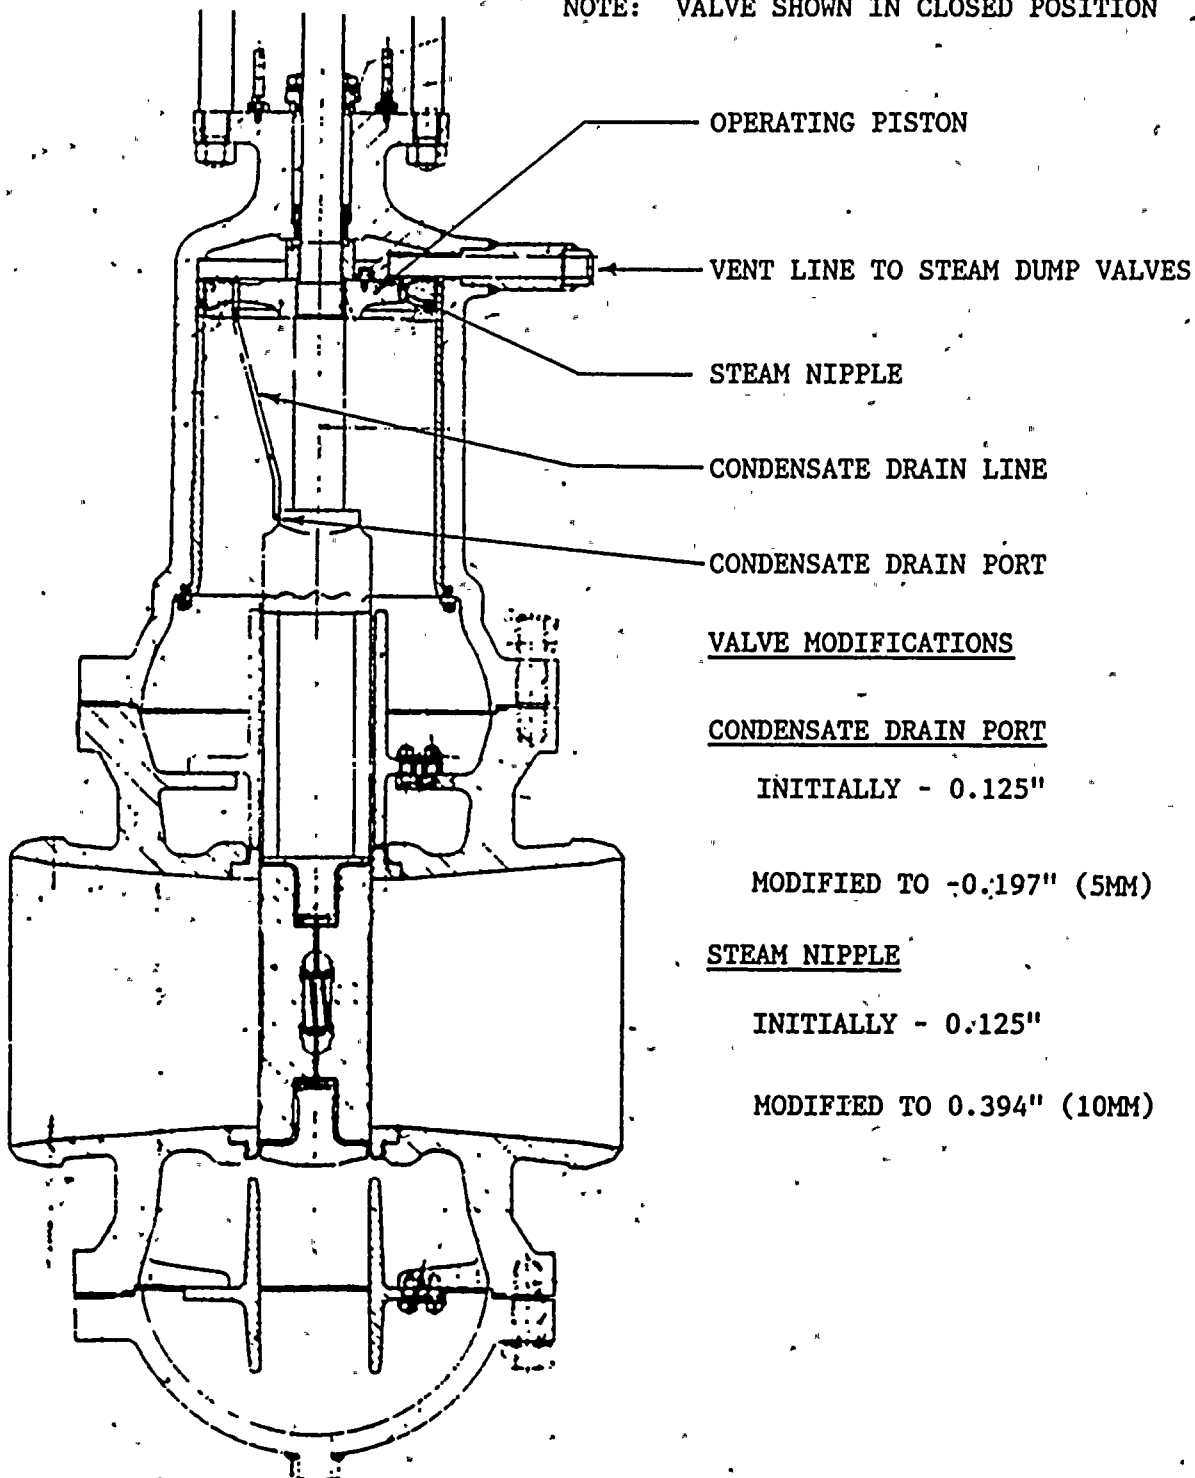
MAIN STEAM ISOLATION VALVE

Investigation revealed that the failure of the MSIV's was caused by excessive condensate accumulation on the vent side of the MSIV operating piston. The excessive condensate accumulation was a result of the following contributing factors:

The combined effects of one and two above resulted in increased condensation rates, developing greater Delta-P across the operating piston than assumed by design during normal operation (MSIV's in steady-state open position). The rate at which condensate can flow down from the upper volume through the drain tube is limited by the diameter of the drain tube port holes. Condensate will accumulate within the upper equalizing volume if it cannot be drained faster than it forms. If the steam nipple is insufficiently sized, a Delta-P will exist across the piston restricting condensate drainage.

NOTE: VALVE SHOWN IN CLOSED POSITION

After all available sources of information were technically evaluated, it was determined that all Unit 2 MSIV's would be modified via Minor Modification 2-MM-079. Under this modification the diameter of drain tube port holes would be increased from 1/8" (0.125") to 5mm (0.197") and the diameter of the equalizing steam nipple would be increased from 1/8" (0.125") to 10mm (0.394"). Two performance related functions would be improved in this manner.

1. Increasing the size of the drain tube port holes provides a larger area to improve condensate flow through the actuator piston.
2. Increasing the size of the equalizing steam nipple will provide a less restrictive path for steam to pass up through the piston to maintain equilibrium and prevent steam from passing through the drain tube and inhibit drainage.

VALVE MODIFICATIONSCONDENSATE DRAIN PORT

INITIALLY - 0.125"

MODIFIED TO -0.197" (5MM)

STEAM NIPPLE

MODIFIED TO 0.394" (10MM)

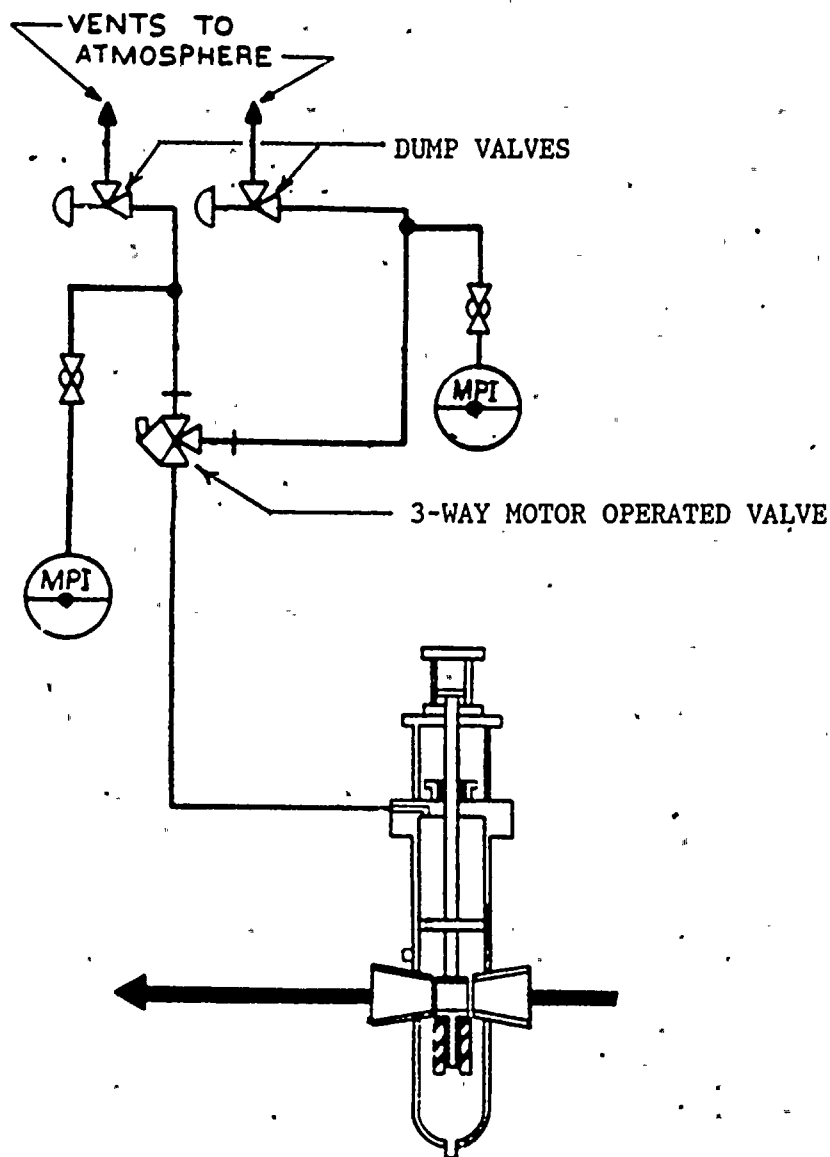
MAIN STEAM ISOLATION VALVE VENT PIPING

Insulation on MSIV, the vent piping and associated valves was less than current design specifications. The insufficient insulation resulted in increased condensation rates in the MSIV.

It was also discovered at this time that the insulation on the MSIV, vent piping and associated valves was less than the current design specification requirements. This contributed to a larger variance in temperature (Delta-T) resulting in more heat transfer and increasing the condensation rate.

Repair activities included disassembly of the MSIV's to enlarge the condensate drain tube port and the equalizing steam nipple. Additional insulation was placed on the MSIV's, vent piping and valves.
