SUBJECT: Responds to NRC 900309 ltr re violations noted in Insp Rept 9  
 50-316/90-08.

Donald C. Cook Nuclear Plant Unit 2  
Docket No. 50-316  
License No. DPR-74  
NRC INSPECTION REPORT NO. 50-316/90008 (DRP);  
RESPONSE TO NOTICE OF VIOLATION

RESPONSE TO VIOLATION

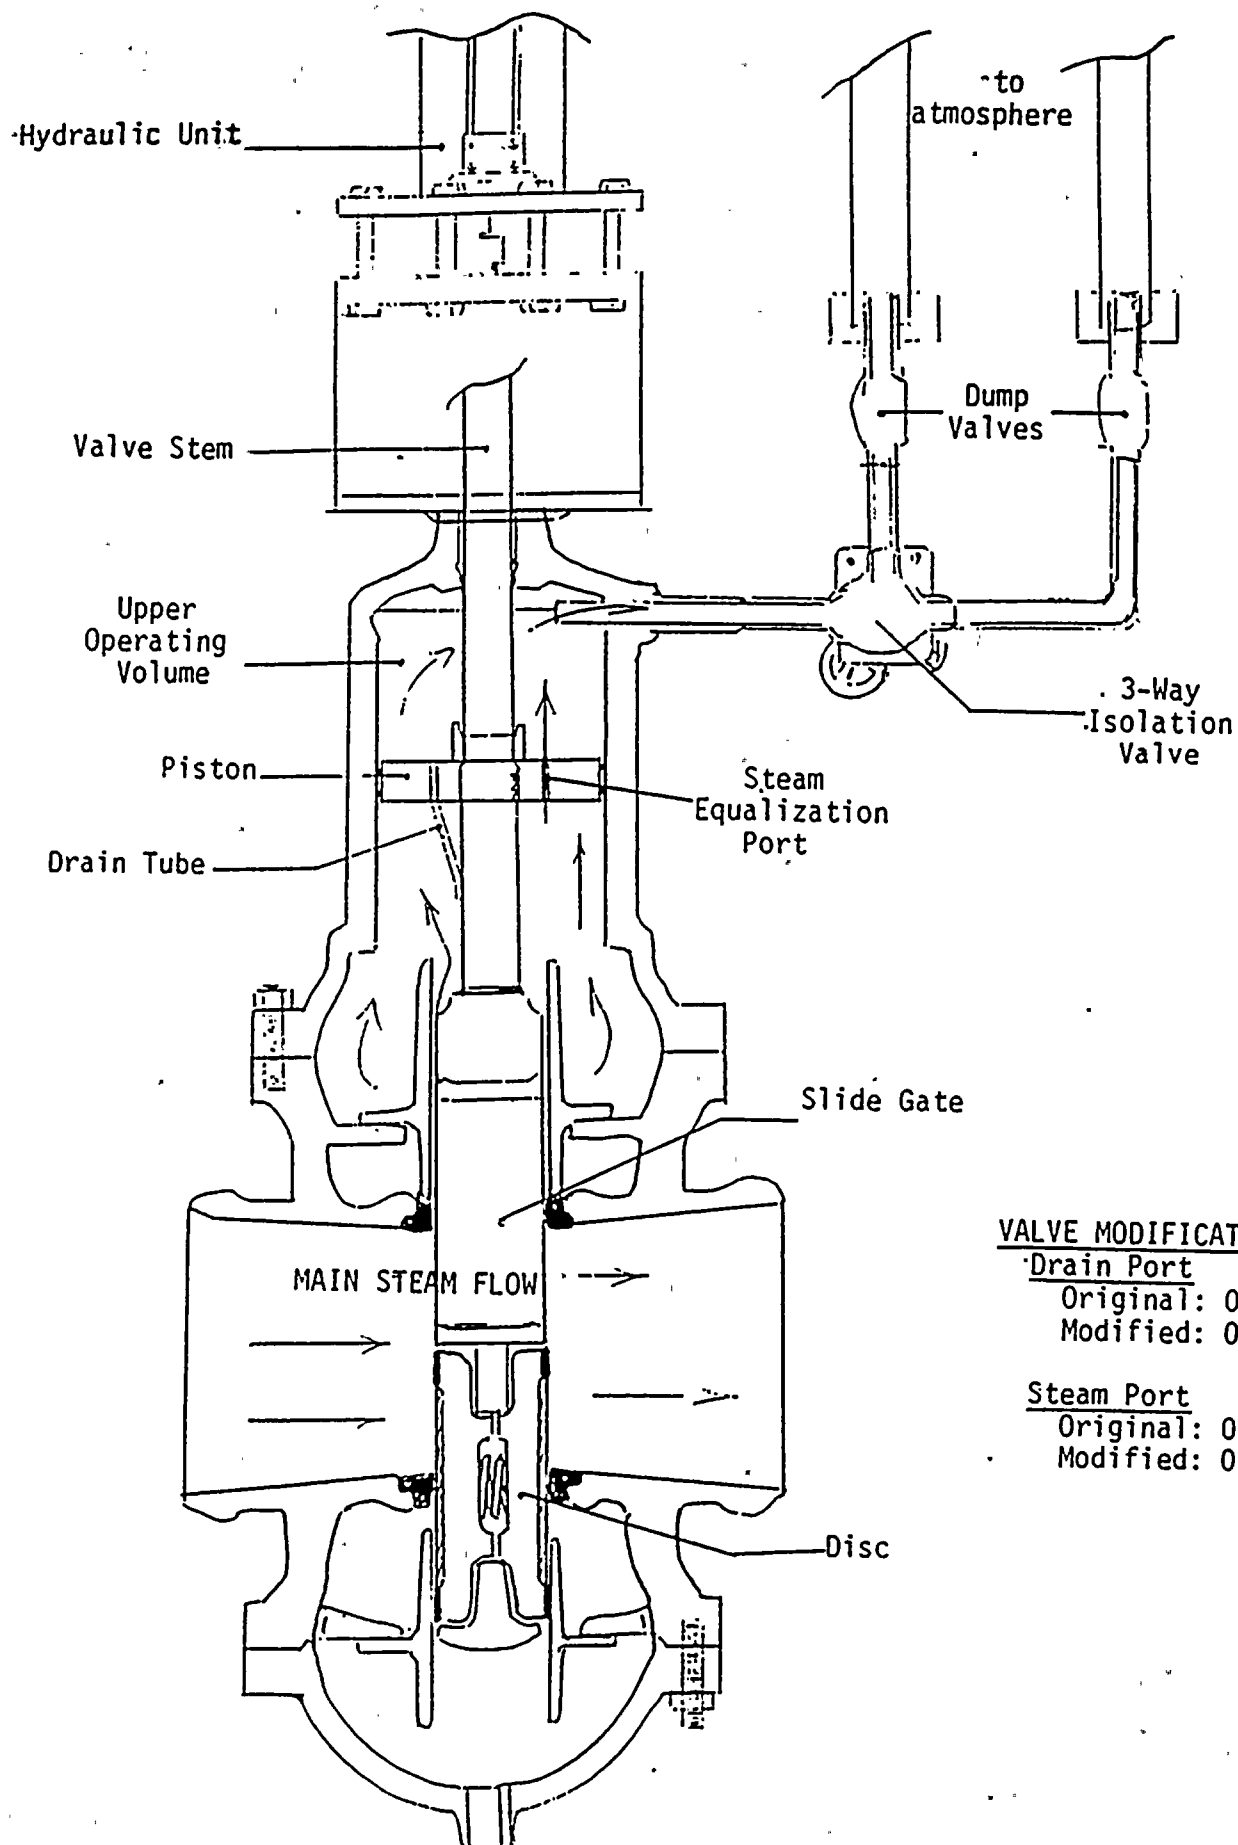
FIGURE 1: MAIN STEAM ISOLATION VALVE

The main steam isolation valves (MSIVs) used at the Cook Nuclear Plant are parallel slide stop valves (see Figure 1). Main steam pressure equilibrium across the operating piston maintains a normally open position at power. During testing, the MSIV safety function is simulated by venting steam from the top of the piston through an open dump valve to close the MSIV. The steam venting creates a large pressure differential across the piston that forces disc travel into the main steam flow path, thus blocking main steam flow.

First, the insulation on the MSIVs, vent piping and associated valves was less than current design specifications. The insufficient insulation resulted in increased condensation rates in the MSIVs. Secondly, the quantity of condensate that can collect is related to the mass of saturated steam permitted to enter the upper equalizing steam volume. Dump valve seat leakage allows steam to escape from this volume. The escaping steam is replaced by additional saturated steam which increases the differential pressure across the piston and prevents drainage. The combined effects of the foregoing factors results in increased condensation rates which leads to development of a greater pressure differential across the operating piston than that assumed in the original design of the MSIVs for normal operation. The MSIV actuator design is therefore a contributor to the observed condition. The rate at which condensate can flow from the upper equalizing volume through the drain tube is limited by the diameter of the drain tube port holes. Condensate will accumulate in the upper equalizing volume if the drain tube port holes are too small to drain the condensate faster than it forms. In addition, if the MSIV steam nipple diameter is too small, a differential pressure will exist across the piston further restricting condensate drainage.

A cooldown to bring Unit 2 to Mode 5 (cold shutdown) was initiated on January 11, 1990. Upon reaching Mode 5, all four MSIVs were disassembled and a visual examination of each valve was performed. The examinations showed that the MSIV drain tubes had not experienced any physical degradation that could have restricted condensate drainage. Based on the visual examinations, the results of the investigation discussed above and a technical evaluation of all other available sources of information on the observed condition, several actions were initiated to correct the problem of unacceptable accumulation of condensate in the MSIV upper volume. The diameter of the drain tube port holes on all Unit 2 MSIVs was increased from 0.125 inch to 0.197 inch in order to improve condensate flow through the operating piston. The diameter of the equalizing steam nipple was also increased, from 0.125 inch to 0.394 inch. The increase in steam nipple size provides a less restrictive path for steam to pass through the piston to maintain equilibrium and prevents steam from passing through the drain tube thus inhibiting drainage. In addition to these physical modifications to the MSIVs, the insulation on the MSIVs, vent piping and associated valves was increased in order to reduce

#### VALVE MODIFICATIONS

##### Drain Port

Original: 0.125"

Modified: 0.197" (5mm)

##### Steam Port

Modified: 0.394" (10mm)
