REGULATORY INFORMATION DISTRIBUTION SYSTEM (RIDS)

SUBJECT: LER 89-017-02:on 891019,loss of turbine-driven auxiliary
 feed pump flow retention occurred.W/901102 ltr.

Operating Licenses DPR-75
Docket No. 50-316

FACILITY NAME (1) D. C. Dook Plant - Unit 2										DOCKET NUMBER (2) 0 5 0 0 0 3 1 6				PAGE (3) 1 OF 0 6								
TITLE (4) Loss of Turbine Driven Auxiliary Feed Pump Flow Retention Due to Inaccurate Flow Measurement																						
EVENT DATE (5)			LER NUMBER (6)				REPORT DATE (7)			OTHER FACILITIES INVOLVED (8)												
MONTH	DAY	YEAR	YEAR	SEQUENTIAL NUMBER	REVISION NUMBER	MONTH	DAY	YEAR	FACILITY NAMES				DOCKET NUMBER(S)									
1	0	1	9	8	9	8	9	0	1	7	0	2	1	1	0	2	9	0	0 5 0 0 0 0			
OPERATING MODE (9) 1			THIS REPORT IS SUBMITTED PURSUANT TO THE REQUIREMENTS OF 10 CFR §: (Check one or more of the following) (11)																			
POWER LEVEL (10) 1 0 0			20.402(b)				20.405(c)				60.73(a)(2)(iv)				73.71(b)

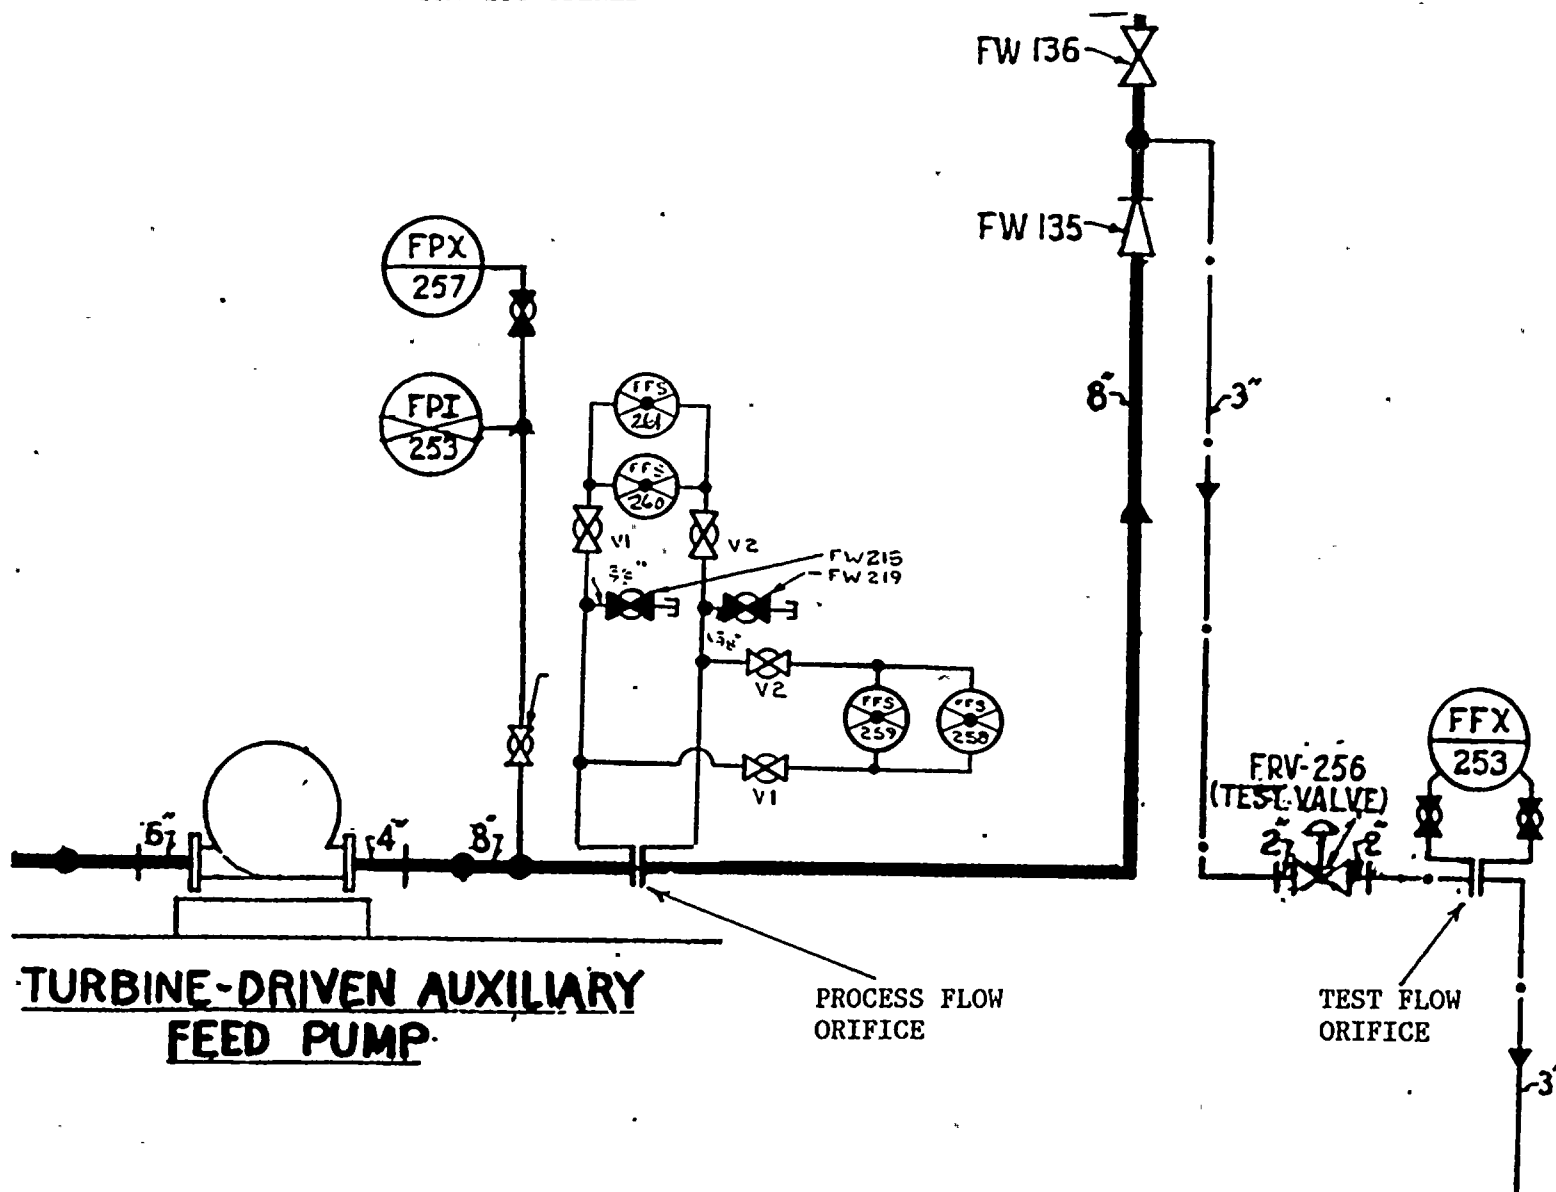
**TURBINE-DRIVEN AUXILIARY
FEED PUMP.****TURBINE DRIVEN AUXILIARY FEED PUMP RECIRCULATION LINEUP**FW-136 CLOSED
FRV-256 OPENED

On October 19, 1989 at 0900 hours, an NRC Inspector conducting an IST Audit discovered an instrument discrepancy between the Turbine Driven Auxiliary Feedpump (TDAFP) (EIIS/BA-P) test line flow indication (FFX-253) and the in-series process flow indicating flow switches (FFS-258 and FFS-260) (EIIS/BA-FS). Attached is a drawing describing the configuration of these instruments. Instrumentation at the process flow switches indicated a flow of 550 gpm while test instrumentation indicated a flow of 700 gpm. The process flow switch actuates a flow retention signal when the TDAFP flow reaches 975 gpm. This flow retention function prevents pump runout during feedwater line break. With the process instrumentation reading 78 percent of actual flow, the flow retention function would have actuated at a TDAFP approximate flow of approximately 1225 gpm. Therefore, flow retention would not have actuated before pump runout occurred.

Investigation has revealed that the 150 gpm difference between the process and test flow indication was initially discovered in 1978. The impact on the flow retention actuation setpoint was not realized at that time. The test and process orifices (EIIS/BA-OR) were removed and inspected in 1978. No discrepancies were noted, but it cannot be determined if the orifices were measured and verified to be the correct size. The process flow indication had not been used for testing since 1978. The test orifice had been used exclusively.

The cause for this instrument error cannot be determined at this time. However, investigation continues and includes the removal of the Unit 1 TDAFP flow orifice to verify its size.

The Unit 2 TDAFP test orifice was removed and verified to be the correct size. Calibration of the test and process instruments were verified. The Unit 1 TDAFP and the Unit 1 and 2 Motor Driven Auxiliary Feed Pumps (EIIS/BA-P) test and process flow indications were compared and found to be acceptable.

On October 25, 1989, the Unit 2 TDAFP process flow indicating switches, which provide flow retention actuation, were reset for proper actuation. The verified test orifice was used as a standard for determining the process orifice curve.
