SUBJECT: LER 90-008-01:on 900619,discovered that isolation relay
 circuitry for low header pressure auto start switch for
 essential svc water pumps installed incorrectly.Caused by
 design errors.Plant mod packet initiated.W/910104 ltr.

LICENSEE EVENT REPORT (LER)

FACILITY NAME (1) D. C. Cook Nuclear Plant, Unit 1										DOCKET NUMBER (2) 0 5 0 0 0 3 1 5 1				PAGE (3) OF 0 6										
TITLE (4) 10 CFR Appendix R Deficiencies Resulting in Potential for Loss of Auto Start of Service Water Pumps Due to Incorrect Implementations of Design Change																								
EVENT DATE (5)			LER NUMBER (6)				REPORT DATE (7)			OTHER FACILITIES INVOLVED (8)														
MONTH	DAY	YEAR	YEAR	SEQUENTIAL NUMBER	REVISION NUMBER	MONTH	DAY	YEAR	FACILITY NAMES				DOCKET NUMBER(S)											
0	6	0	1	9	0	9	0	0	0	8	0	1	0	1	0	4	9	1	D. C. Cook, Unit 2				0 5 0 0 0 3 1 6	
OPERATING MODE (9)			THIS REPORT IS SUBMITTED PURSUANT TO THE REQUIREMENTS OF 10 CFR §: (Check one or more of the following) (11)																					
POWER LEVEL (10)			20.402(b)				20.405(c)				50.73(a)(2)(iv)				73.71(b)									
0 8 3			20.406(a)(1)(i)				50.36(c)(1)				50.73(a)(2)(v)				73.71(c)

D. C. Cook Nuclear Plant, Unit 1

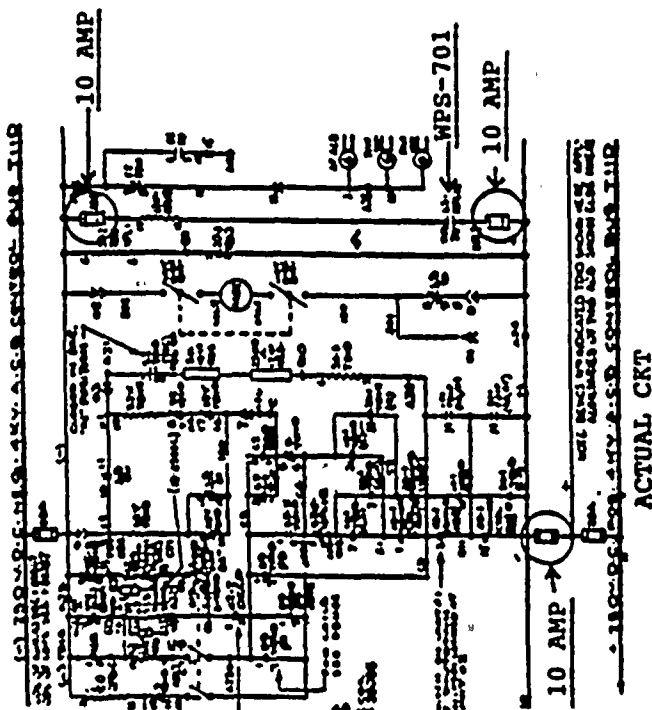
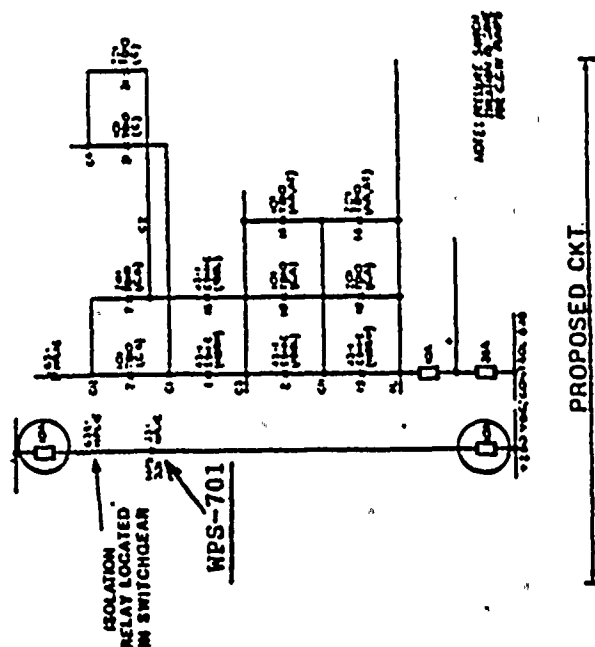
To get a better understanding of the problem, please refer to the attached sketch. This sketch is typical for all ESW pumps. The circuit labeled "Proposed CKT" shows how the isolation was supposed to be provided. In the "Proposed Circuit," the pressure switch contact and the isolation relay would be isolated from the rest of the control circuit by 10 amp fuses. A fault at pressure switch WPS-701 would result in one of the isolation relay fuses being blown. The 10 amp control circuit fuse would be left unaffected.

The circuit labeled "Actual CKT" shows what was actually installed. As shown on the sketch, the 10 amp isolation relay fuses were placed in series with the 10 amp control circuit fuse.

Since the fuses have the same rating and characteristics, there is a chance that the control circuit fuse would blow before the isolation relay fuse in the event of a fault at WPS-701. If this happened, the pump's closed circuit would become inoperable. If the pump was already running, it would continue to run, but if it was not running or was subsequently shut down, the pump could not be restarted without manual action by the operators at the pump's electrical breaker.

The immediate corrective action was to replace the 10 amp isolation relay fuses with 5 amp fuses to provide proper fuse coordination with the 10 amp control circuit fuse. This action was completed in both units on June 22, 1990.

The breaker control circuits for Unit Two ESW pumps will be modified during the current Unit Two refueling outage (Plant Modification Number 12-MM-110). The breaker control circuits for Unit One ESW pumps will be modified during the next Unit One refueling outage (Plant Modification Number 12-MM-110).
