SUBJECT: Requests temporary waiver of compliance w/Limiting Condition
 for Operation of Tech Spec Section 3.5.2 re ECCS boron
 injection tank charging sys to repair body-to-bonnet leak in
 valve 1-CS-356 in chemical & vol control sys.

AEP:NRG:1149

Donald C. Cook Nuclear Unit 1
License No. DPR-58
Docket No. 50-315
REQUEST FOR TEMPORARY REGIONAL WAIVER OF COMPLIANCE

March 28, 1991

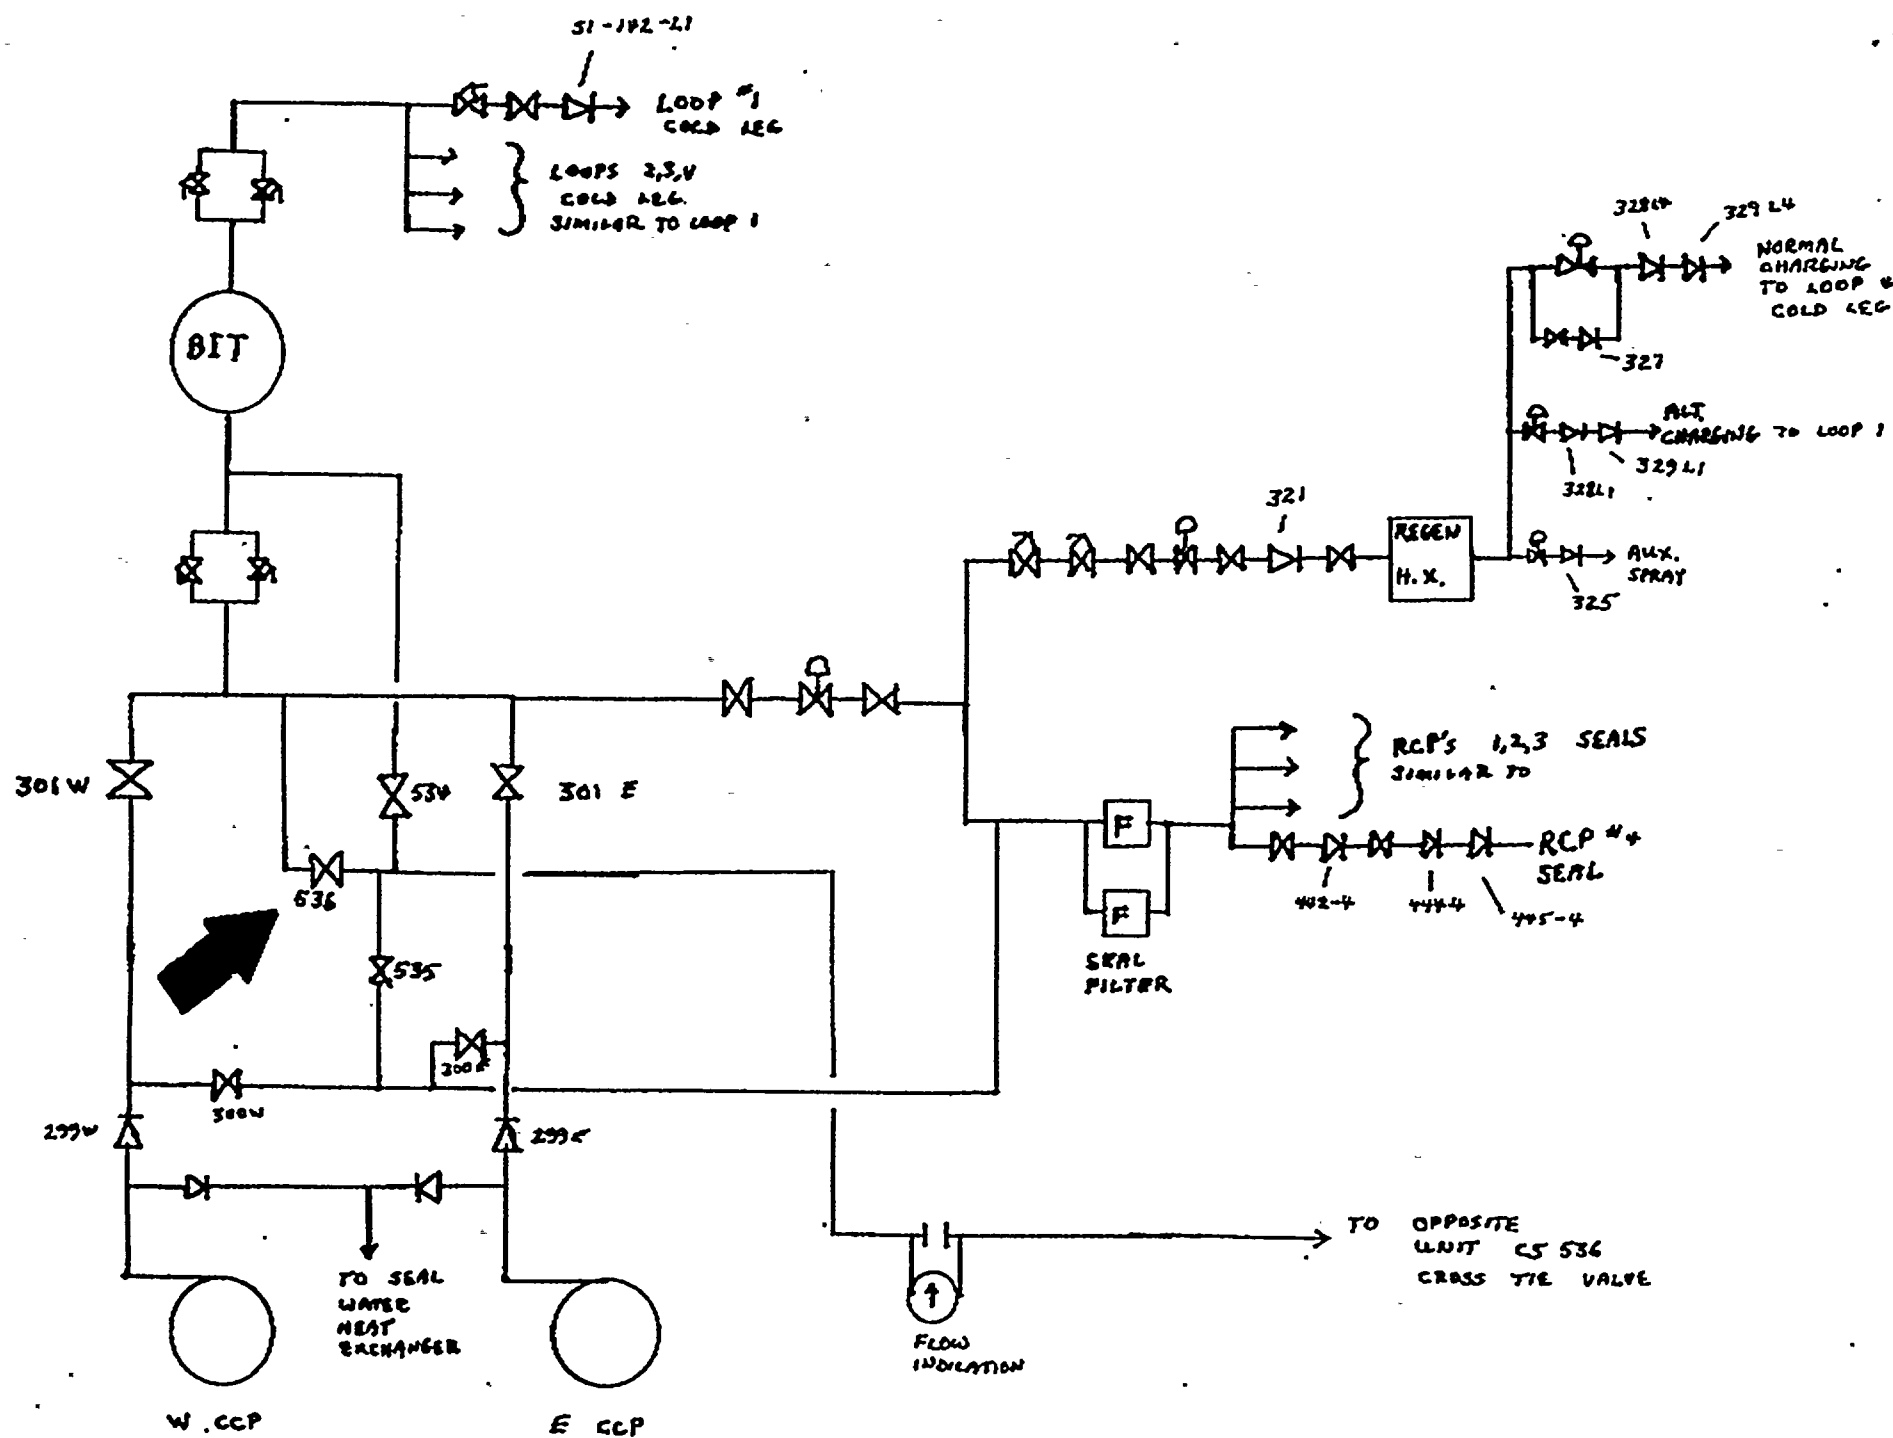
SIMPLIFIED FLOW DIAGRAM OF THE
UNIT 1 CVCS CROSS-TIE SYSTEM

This waiver of compliance is necessary in order to repair a body-to-bonnet leak in valve No. 1-CS-536, installed in the Cook Nuclear Plant Unit 1 chemical and volume control system (CVCS). Valve 1-CS-536 is a normally closed valve located in the charging pump cross-tie between Units 1 and 2.

event of an Appendix R fire. Subsequent to the last Unit 1 refueling outage, a leak of an estimated 30 gpm was discovered developed in valve 1-CS-536 installed in the Unit 1 charging flow cross-tie line. In the event of a fire in Unit 1, current procedures would require valve 2-CS-536 to be opened in order to provide seal water injection and RCS volume control to Unit 1 from the Unit 2 charging system. Although the charging system is of sufficient capacity to provide the necessary seal injection flow and RCS volume control even with the existence of the identified leak, the magnitude of the leak cannot be exactly quantified. This reduces our ability to confirm that charging flow from the unaffected to the affected unit during a fire is adequate using our existing emergency and safe shutdown procedures. This is because existing safe shutdown procedures require verification of adequate seal injection flow using a flow indicating device which, when providing flow to Unit 1 from the Unit 2 charging system, would be upstream of 1-CS-536 (and therefore upstream of the leak). As a result when Unit 1 is the affected unit and is being supplied from Unit 2 the total cross-tie flow can be measured; but since the exact leak rate from valve 1-CS-536 cannot be determined, the actual seal water injection flow to Unit 1 cannot be verified. When supplying Unit 2 from Unit 1 the actual flow to Unit 2 can be verified, however, containing the leakage water becomes both a containment problem and a radiological problem. (This problem, in fact, would exist regardless of which unit is the fire affected unit.) The leak, therefore, must be repaired. Our intent is to repair valve 1-CS-536 during power operation in order to avoid an unnecessary shutdown of Unit 1 with the consequent thermal cycling of the RCS and reactor vessel. A simplified flow diagram of the affected portion of the CVCS is provided in the attachment to this letter.

Our method for repairing valve 1-CS-536 during power operation is to establish a freeze seal in the four-inch line upstream of the valve, then, once the freeze seal is in place disassemble the valve, replace the valve bonnet, trim assembly and packing cartridges, reassemble the valve and return the system to its normal configuration. It is expected that the time during which we will need to rely on the freeze seal for pressure boundary retention will be less than four hours, with the repair activity itself expected to require less than one hour.
