METALLURGICAL INVESTIGATION OF WALL THINNING
AND LEAKAGE OF THE BMI THIMBLE TUBING AT
D.C. COOK UNIT 2

Gutti V. Rao

January 1991

WESTINGHOUSE ELECTRIC CORPORATION
Nuclear and Advanced Technology Division
P. O. Box 2728
Pittsburgh, Pennsylvania 15230-2728

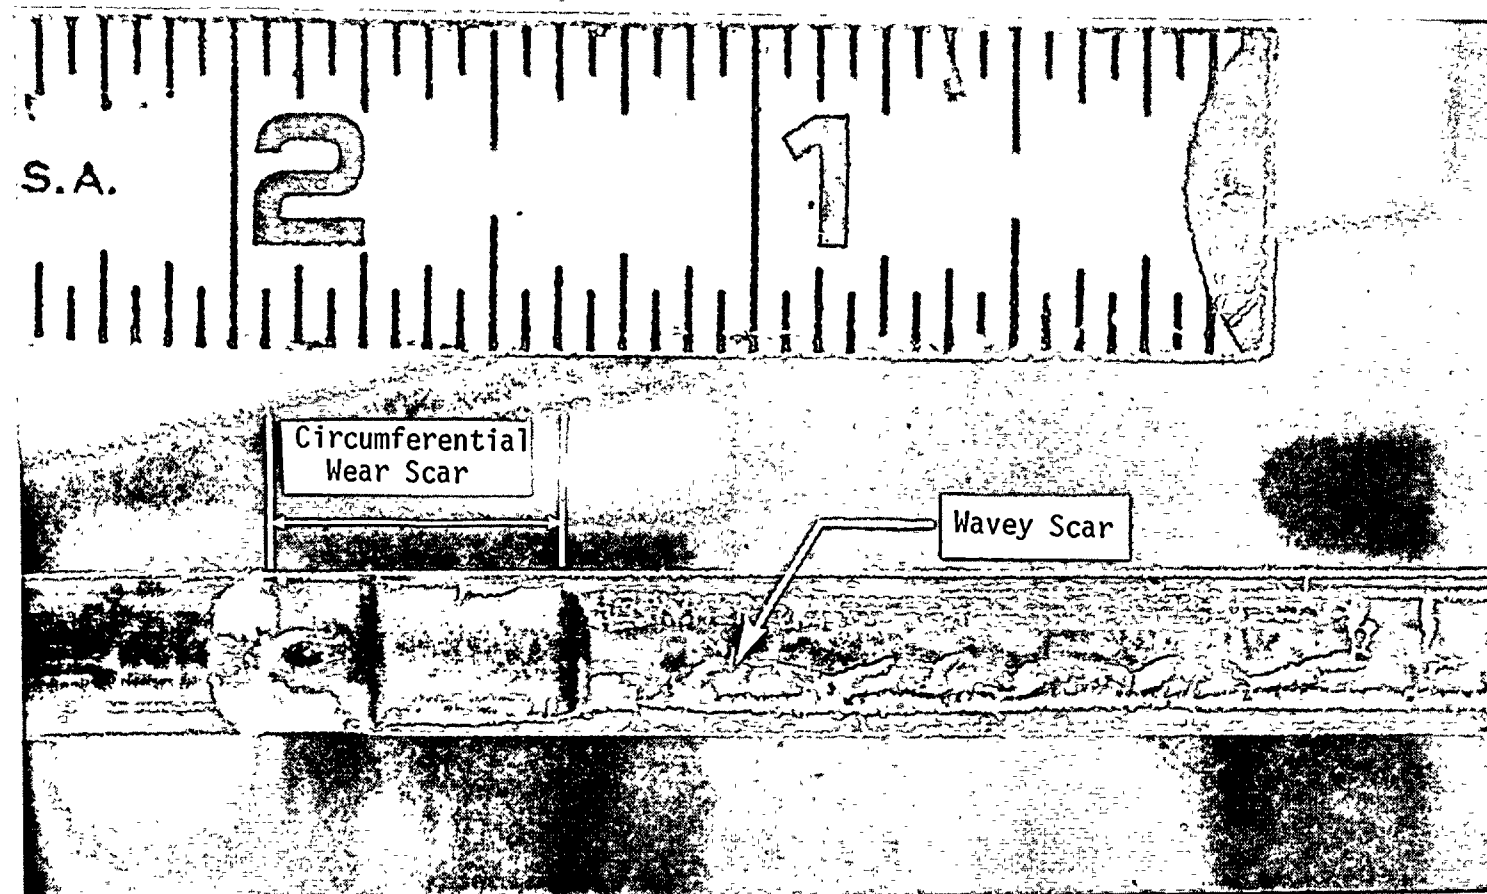
The results of the surface examination of the as-received thimble tube samples are illustrated in Figures 2.1 and 2.2. Figure 2.1 illustrates the surface appearance of the wear scar inflicted on the leaked thimble C-7. The scar which extended approximately over 0.5 in. in length is made up of two steps. The deepest step which corresponds to the most severely worn region contained a through-wall perforation contributing to the leakage.

Figure 2.1 Macro photograph Illustrating the As-Received Condition of the Leaked (Perforated) Thimble Tube "C-7"

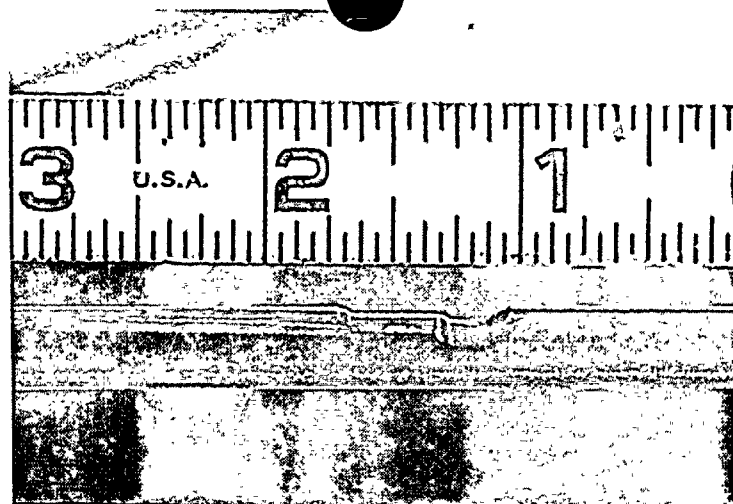
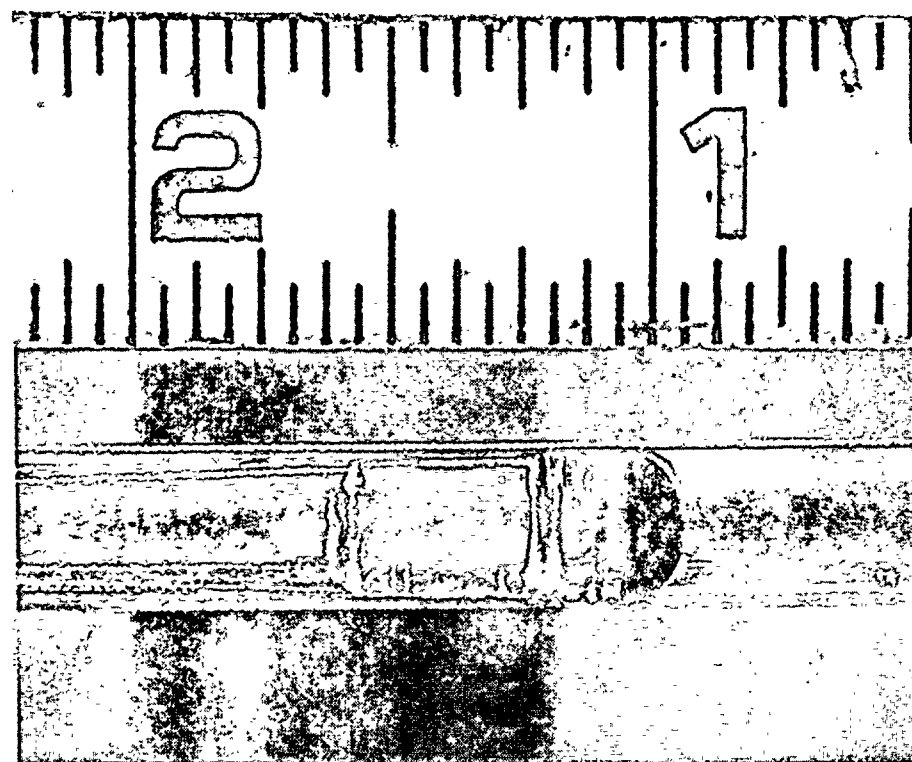
The side view shown in the top photomicrograph clearly shows the presence of circumferentially oriented wear marks associated with the wear scar. In addition to the two stepped wear scar, the presence of an axially oriented wavy scar can also be seen here. The scar appearance suggests that it may have been inflicted by surface scraping or tooling action against a sharp corner most likely during insertion or retraction of the thimble. Figure 2.2 illustrates the surface appearance (side and top views) of the wear scar in thimble A-9. The scar appearance is very similar to the one seen in thimble C-7. The two stepped wall thinning and the presence of circumferential wear marks can be clearly seen. The thinning at the deepest scar location appears to have just fallen short of a through-wall perforation. The total length of the two stepped wear region again corresponded to approximately 0.5 in. in length.

Macro photograph illustrating the As-Received Appearance of Severely Worn Thimble Tube "A-9"

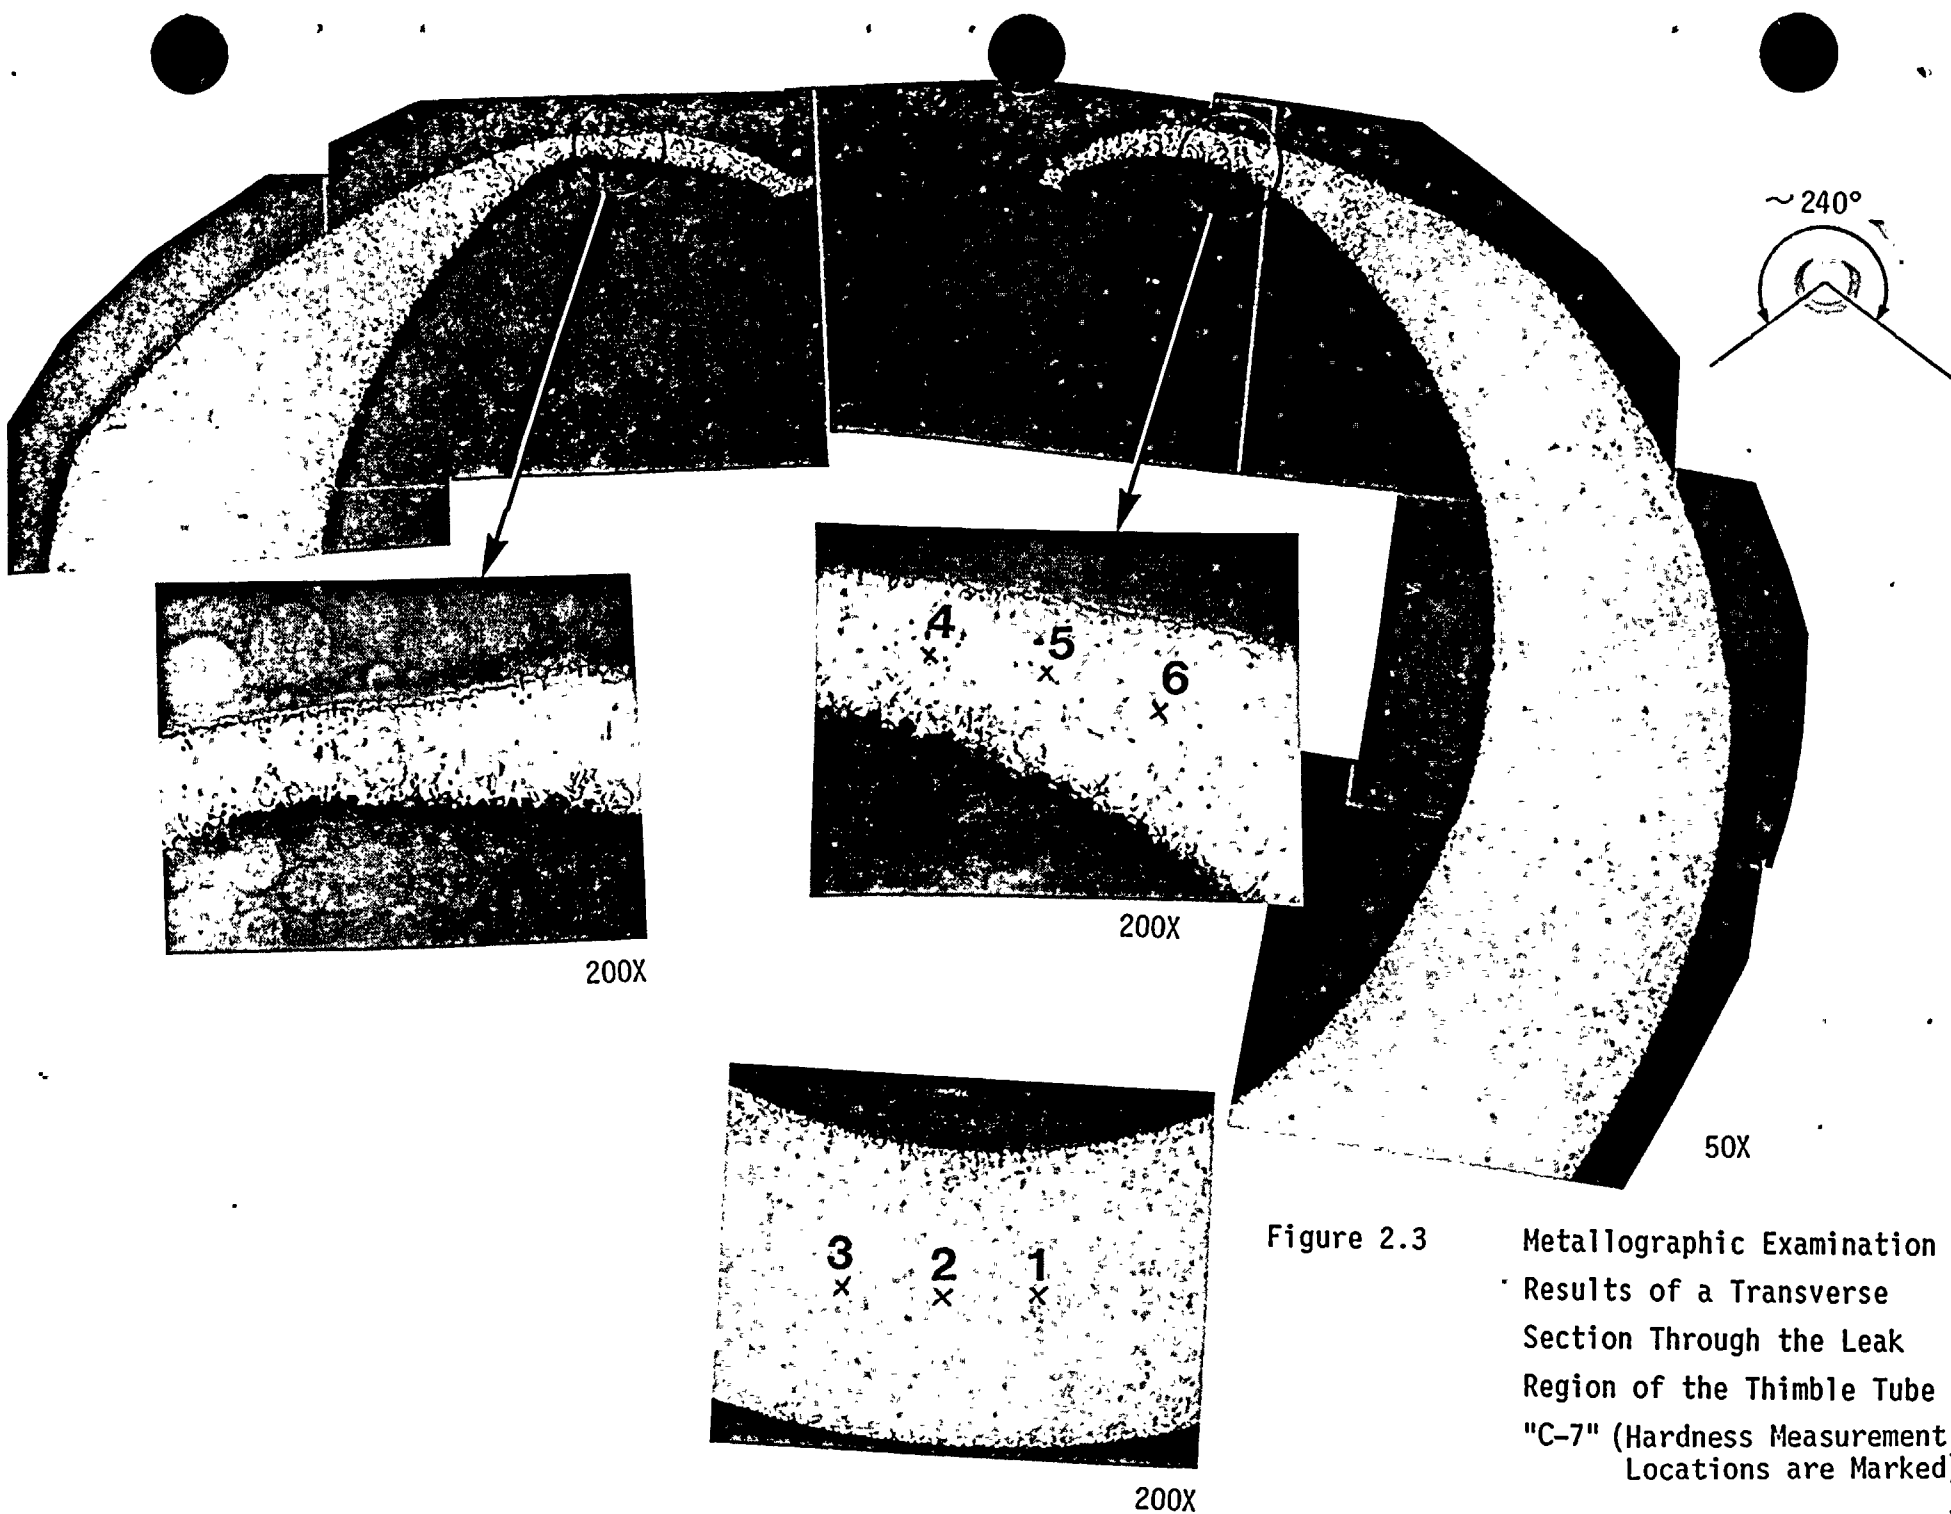
The results of the metallographic examination of the thimble tube samples are illustrated in Figures 2.3 and 2.4. Figure 2.3 illustrates the metallography results of a transverse section through the through-wall perforation on thimble tube C-7. The locations where hardness measurements were taken from are also indicated here. Several significant observations are apparent from the illustration. The thimble tube wear (thinning) appears to have extended circumferentially over an angular region of 240° . The general microstructure did not reveal any evidence of substructure characteristics of deformation except at the thinnest region of the terminations near the perforation. The thinnest section near the terminations measured approximately 0.06 in. thick. No evidence of any cold work was apparent at the wear surface. The hardness measurements (summarized in Table 1) confirmed some work hardening of the thin

Figure 2.3 Metallographic Examination
Results of a Transverse
Section Through the Leak
Region of the Thimble Tube
"C-7" (Hardness Measurement
Locations are Marked)

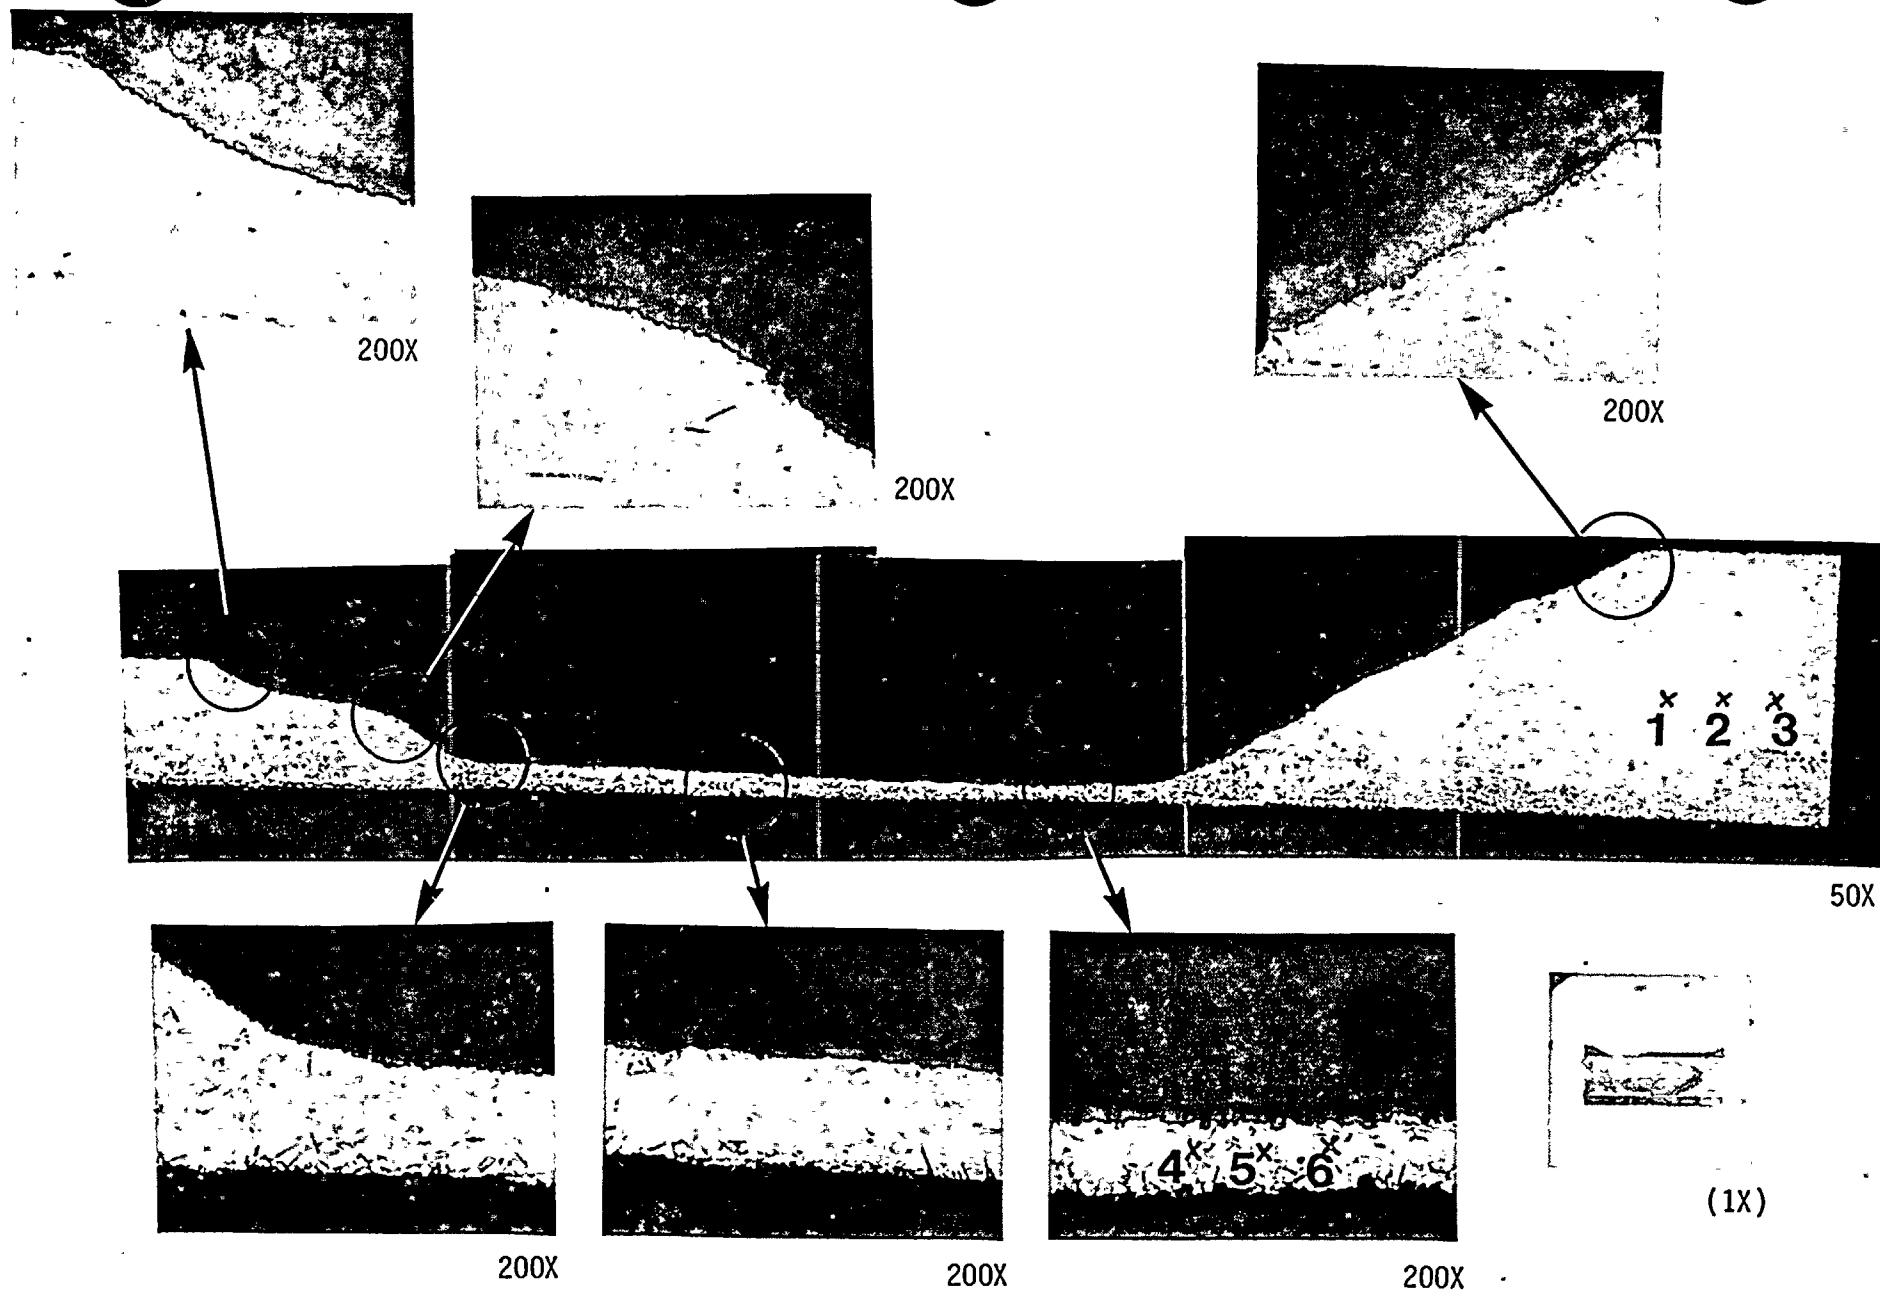
terminations presumably due to bending at the perforation. Figure 2.4 illustrates the metallography results of an axial section through the worn region of the thimble A-9. Here again, although there is a significant reduction in wall thickness due to wear, no gross deformation or coldwork is seen in the material. This is further evidenced by the hardness values listed in Table 1. The hardness values at the thinnest region here are comparable to the hardness values taken from the region affected by wear. These observations suggest that the contact and/or impact loads involved in the wear process may have been relatively low. Noticeable is the lack of deformation or bending at the thin ligament section of the wear scar in Figure 2.4.

Figure 2.4 Metallography Results of An Axial Section Through the Severly Worn Region of the Thimble Tube "A-9" (Hardness Measurement Locations are Indicated)

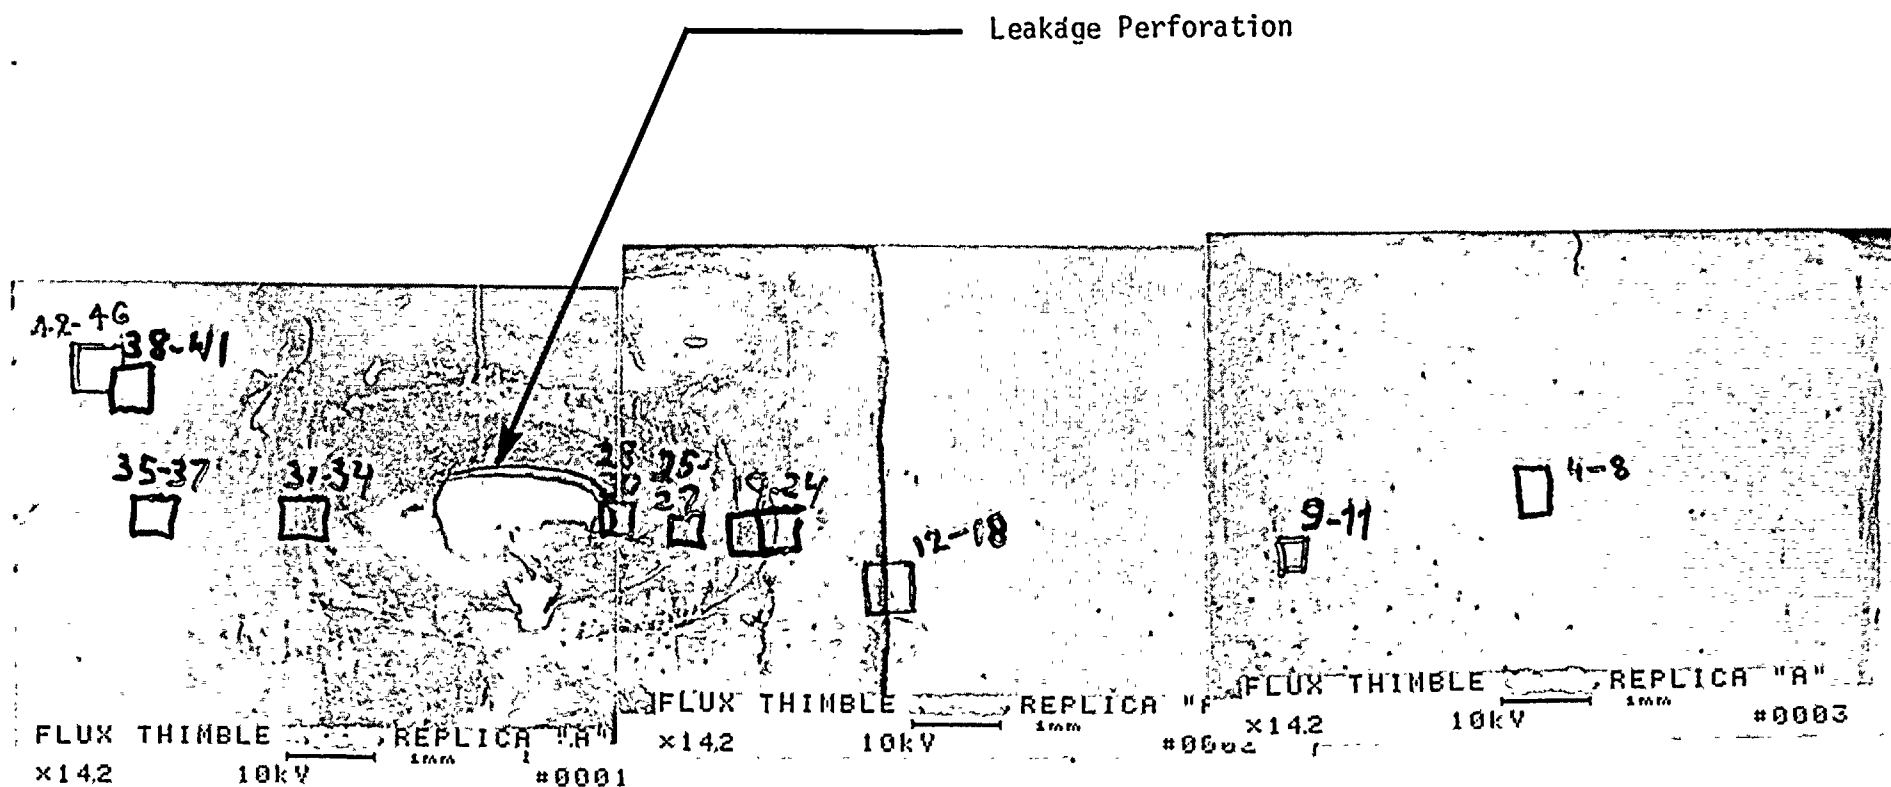
The higher magnification scanning electron microscopy results of the wear morphology by surface replication are illustrated in Figures 2.5 through 2.17. Figures 2.5 through 2.7 illustrate the low magnification photomicrographs of the surface replicas taken from the worn regions of the C-7 and A-9 thimbles identifying locations where higher magnification SEM was conducted. Figures 2.8 through 2.17 illustrate the higher magnification scanning electron micrographs detailing the wear morphology seen at designated locations (indicated in Figures 2.5 through 2.7). Figure 2.8 illustrates the surface morphology of the unaffected (as finished) and wear affected regions in thimble C-7. The unaffected region (micrograph #16) suggests the presence of mechanical tooling marks perhaps characteristic of the tube fabrication process while the morphology seen at the affected region appears distinctly different, characterizing the wear process. Figure 2.9 illustrates the region of intersection of worn and unaffected regions in thimble C-7. The axially oriented (horizontal) tooling marks representing the unaffected surface region terminates into a worn region of circumferentially oriented (vertical) wear scars. Similar observations seen at the unaffected and wear regions of thimble A-9 are illustrated in Figures 2.13 and 2.16. Figures 2.10 and 2.17 illustrate the typical wear morphology seen at the less severely worn regions (upper step region of wear scar) of the thimbles C-7 and A-9. The morphology resembles circumferentially oriented, regularly spaced "boat shaped" shallow marks. Higher magnification views of these marks, illustrated in Figures 2.10(b) and 2.11 suggests a surface formed by rubbing or fretting action. The morphology seen here also suggests some rate of jetting or erosive action of the fluid. A second type of wear morphology seen at the more severely (deep)

Figure 2.5 Scanning Electron Macrograph Illustrating the Overview of the Plastic Replica of the Worn Region in Thimble Tube C-7 Identifying Locations and Micrograph Numbers Where Higher Magnification SEM was Conducted.

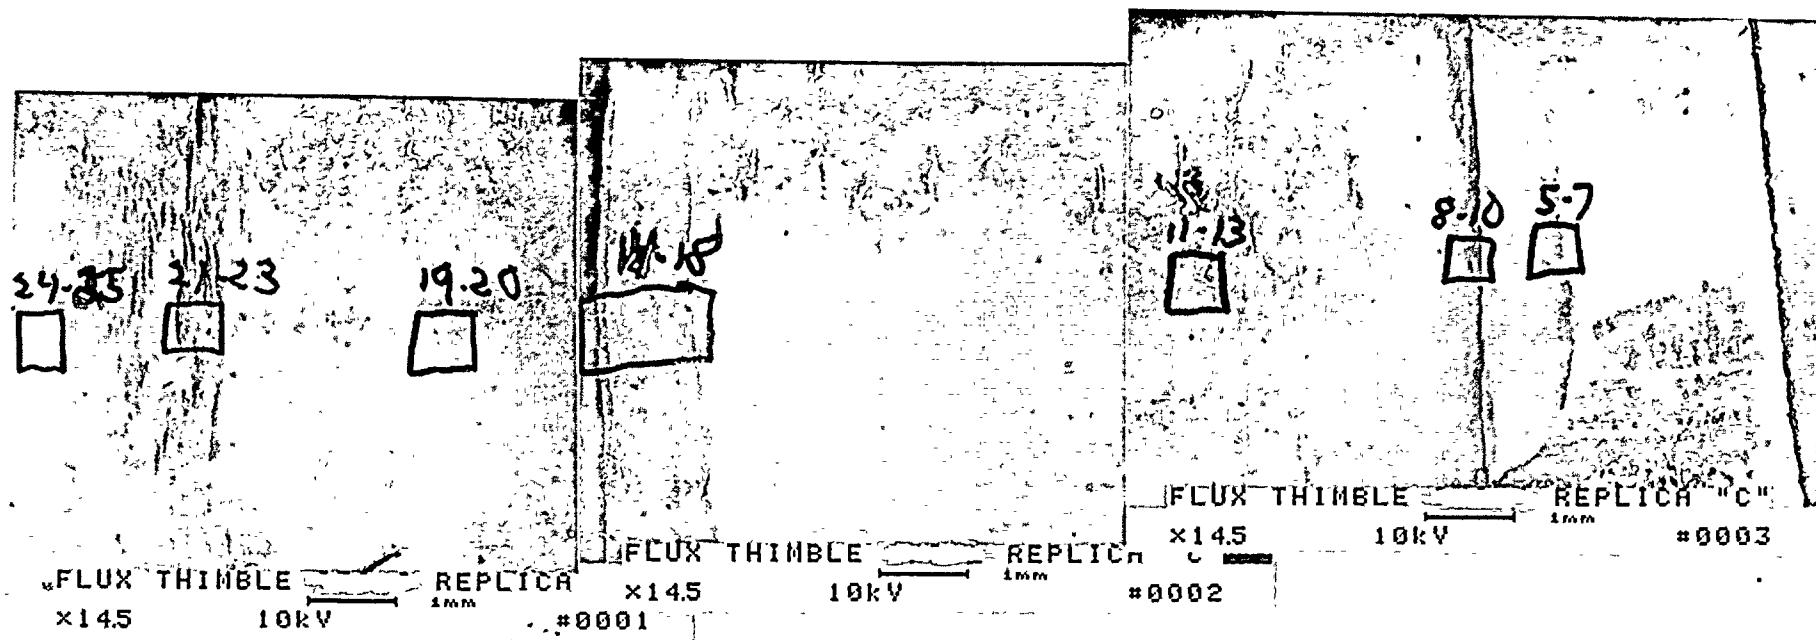
Figure 2.6 Scanning Electron Macrograph of the Plastic Replica Taken from the Worn Region of Thimble Tube "A-9" Identifying Locations and Micrograph Numbers Where Higher Magnification SEM was Conducted.

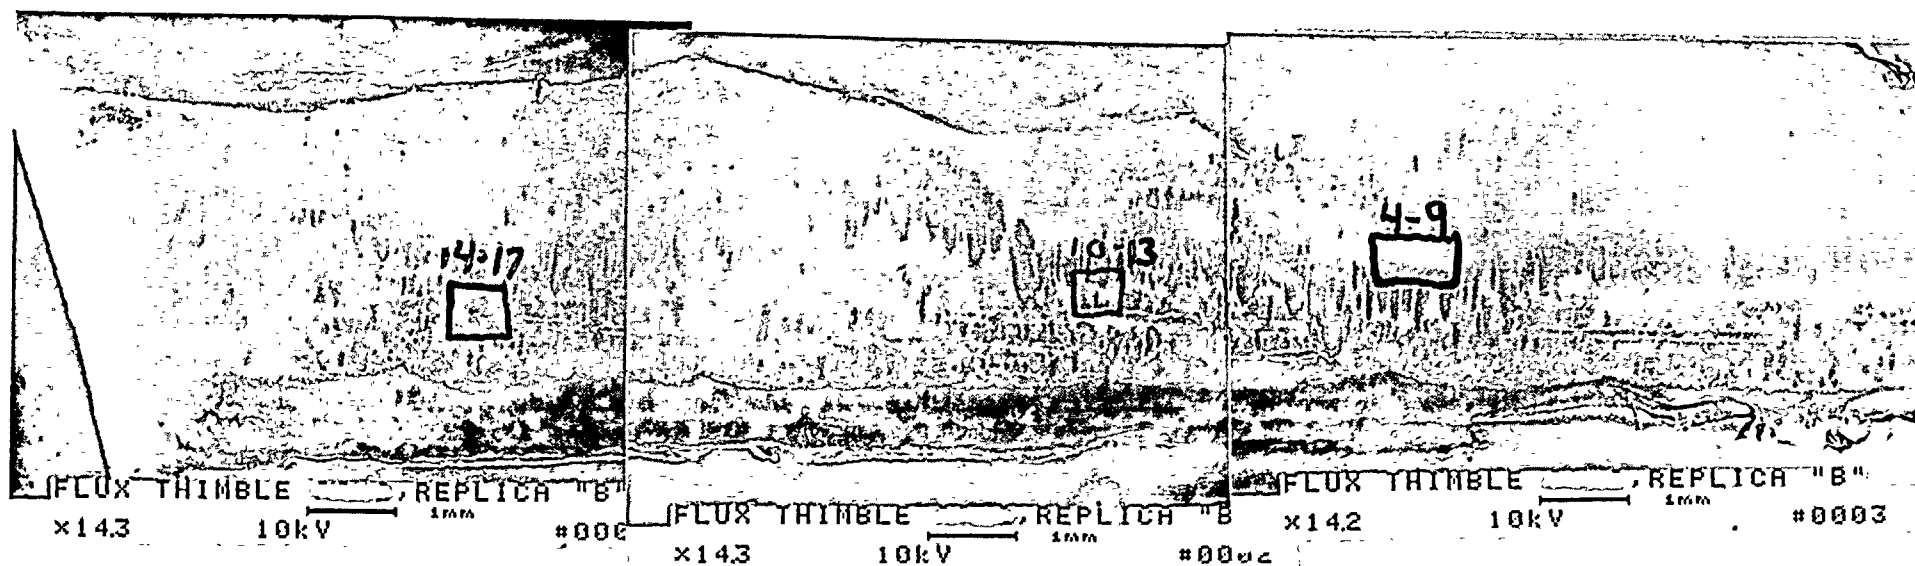
Figure 2.7 Scanning Electron Macrograph of the Plastic Replica Taken from the Worn Region of the Thimble Tube C-7, Identifying Locations Where Higher Magnification SEM was Conducted.

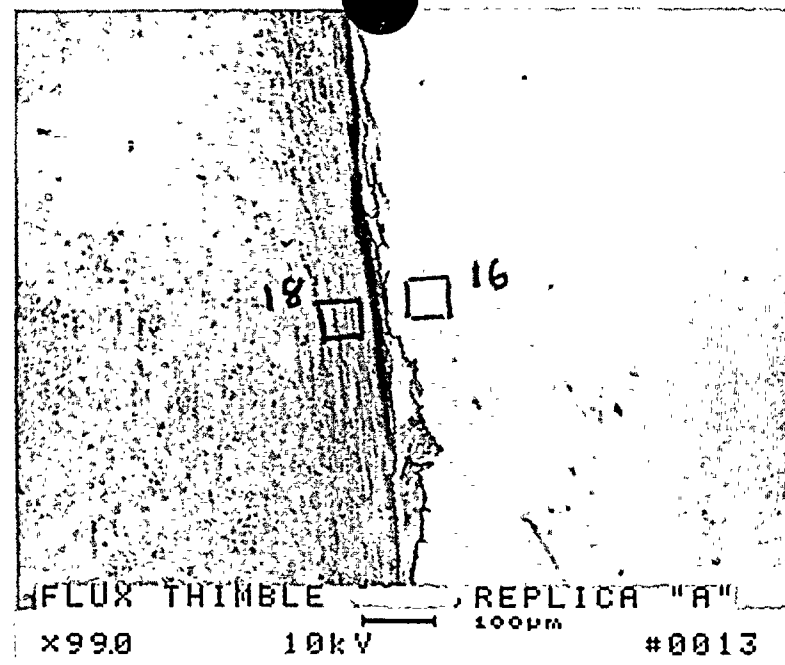
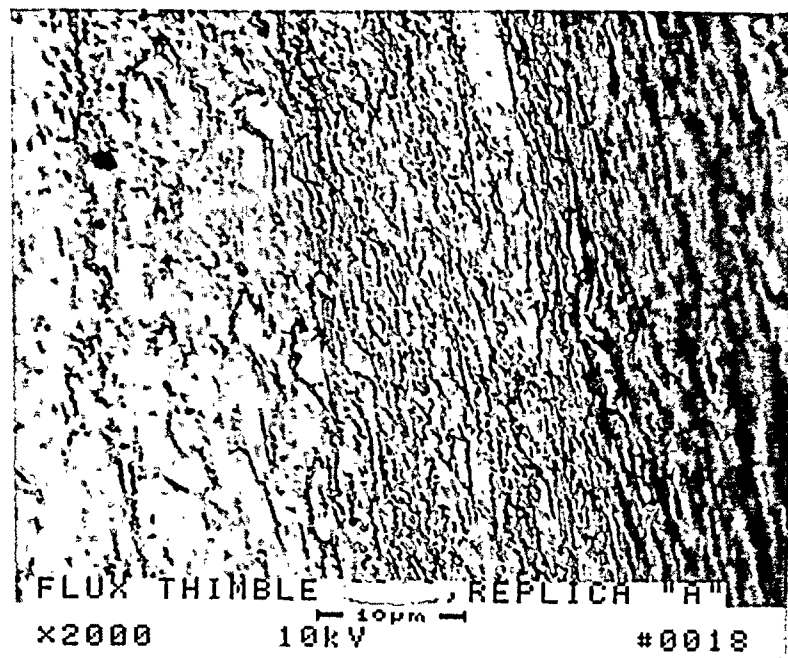
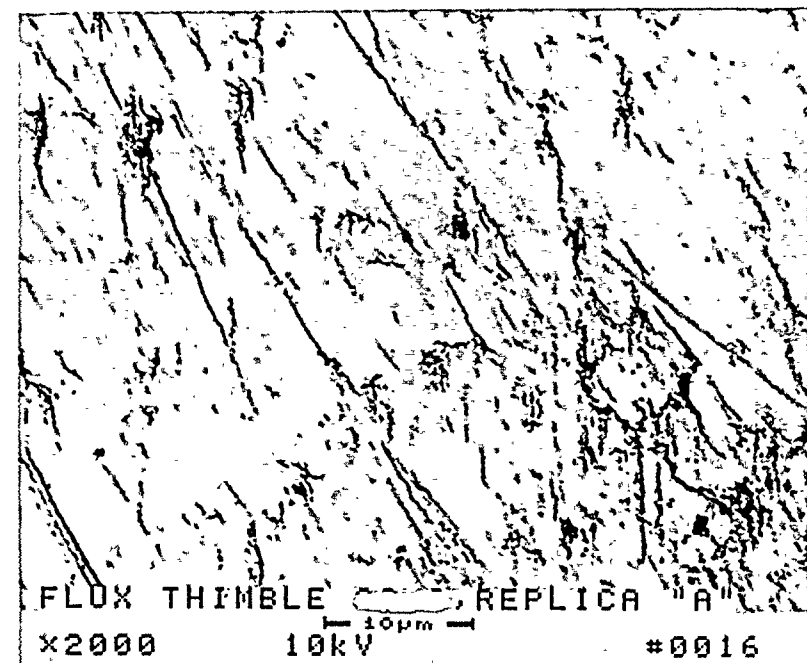
Figure 2.8 SEM Photomicrographs Illustrating the Surface Morphology of the Unscarred and Scarred Regions in Sample C-7.

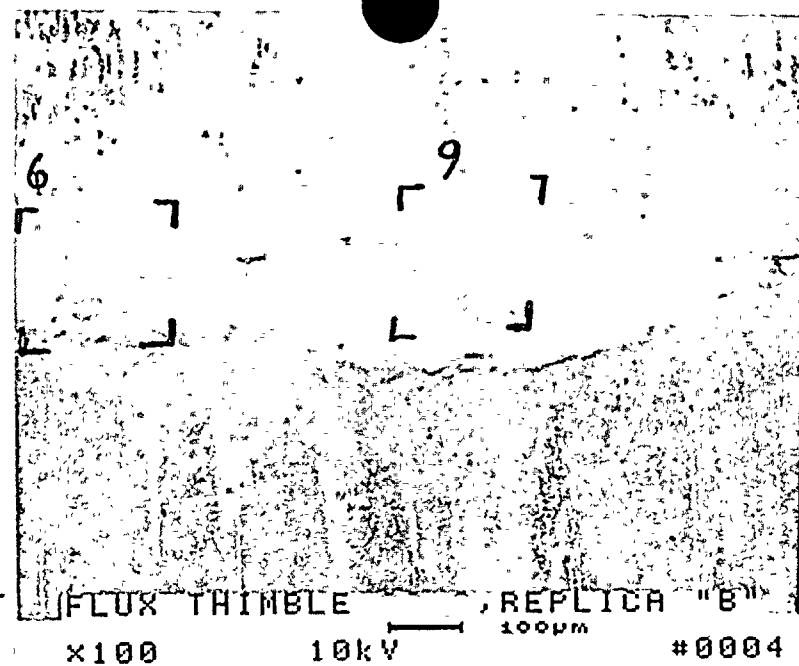
Figure 2.9 SEM Photomicrographs Illustrating the Surface Morphology of the Unscarred and Scarred Regions in Sample C-7.

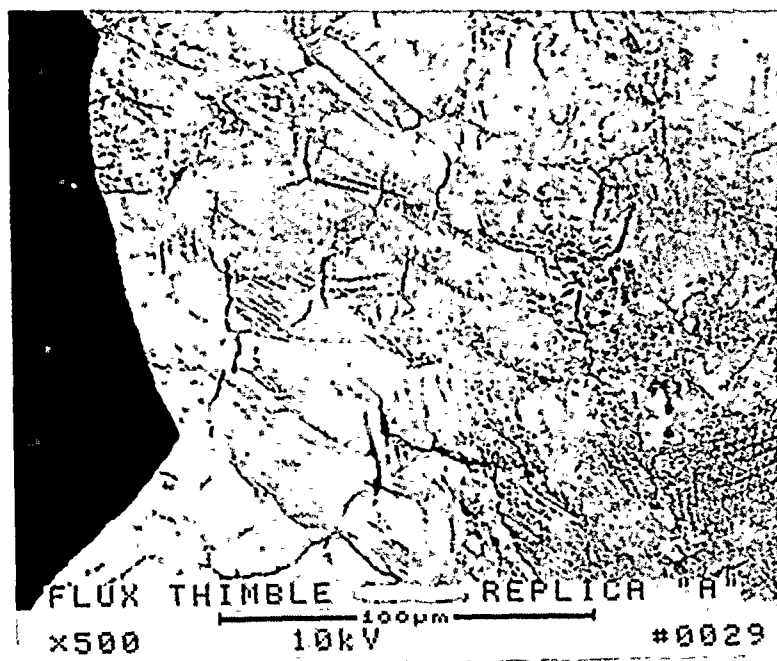
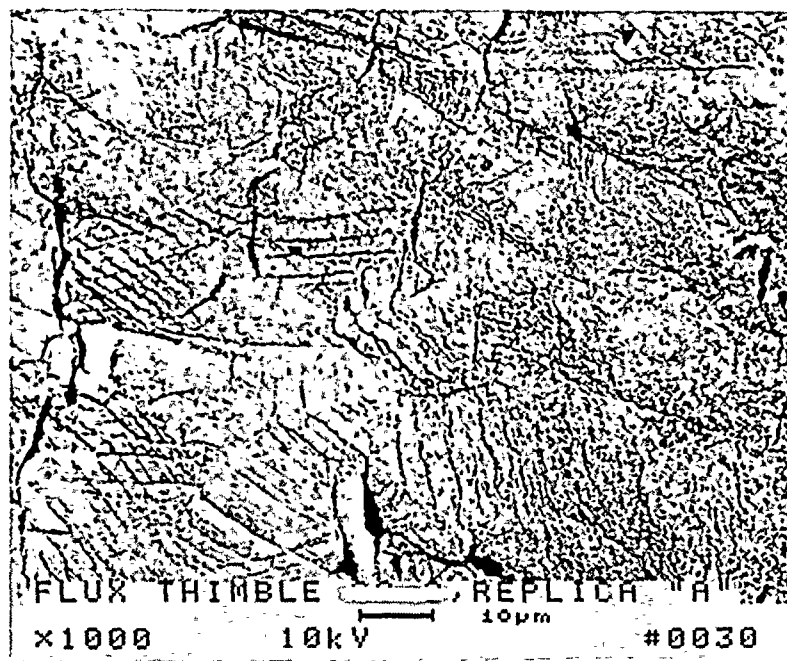
Figure 2.14 SEM Photomicrographs Illustrating the Wear Morphology Seen at Locations 29 and 30 (Figure 2-5), Close to the Through Wall Leakage Region of the Sample C-7.

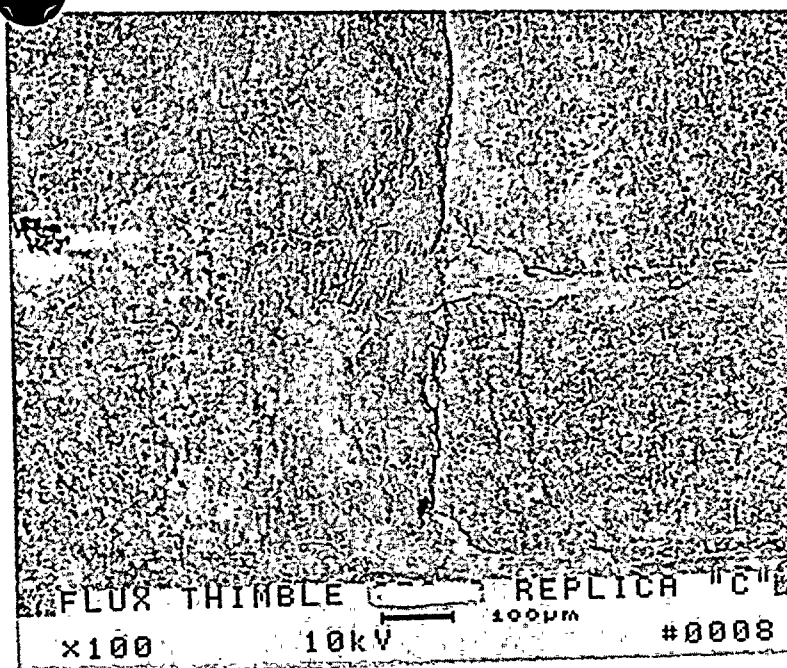
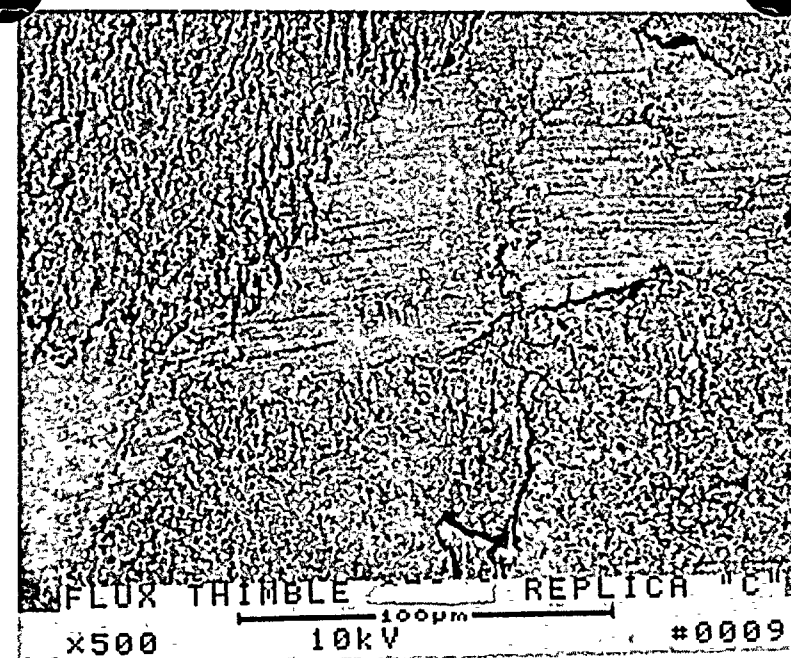
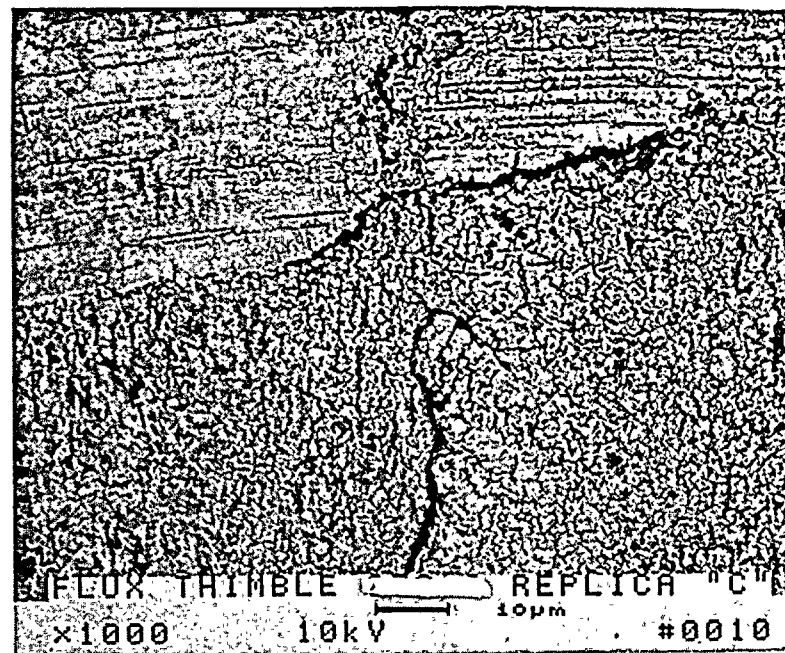
Figure 2.15 SEM Photomicrographs Illustrating the Wear Morphology Seen at Locations 8, 9, and 10 (Figure 2.6) of the Replica From A-9 Sample.

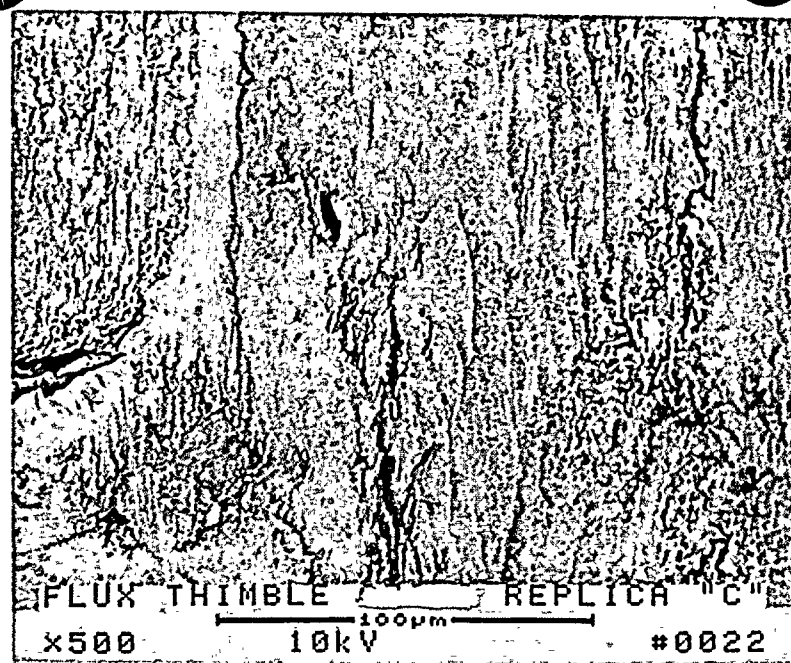
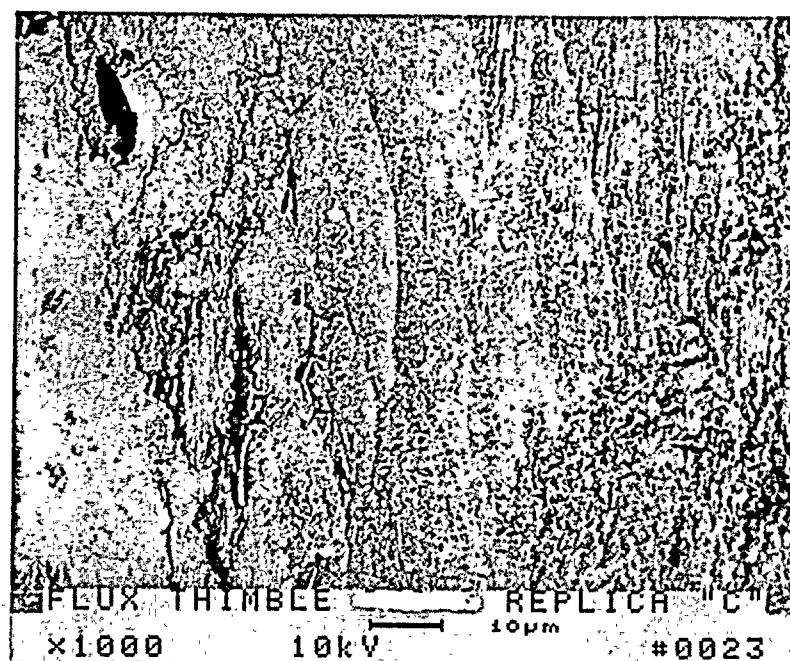
Figure 2.16 SEM Photomicrographs
Illustrating the Wear
Morphology Seen at
Locations 21, 22 and 23
(Figure 2.6) of the
Replica from Sample A-9.

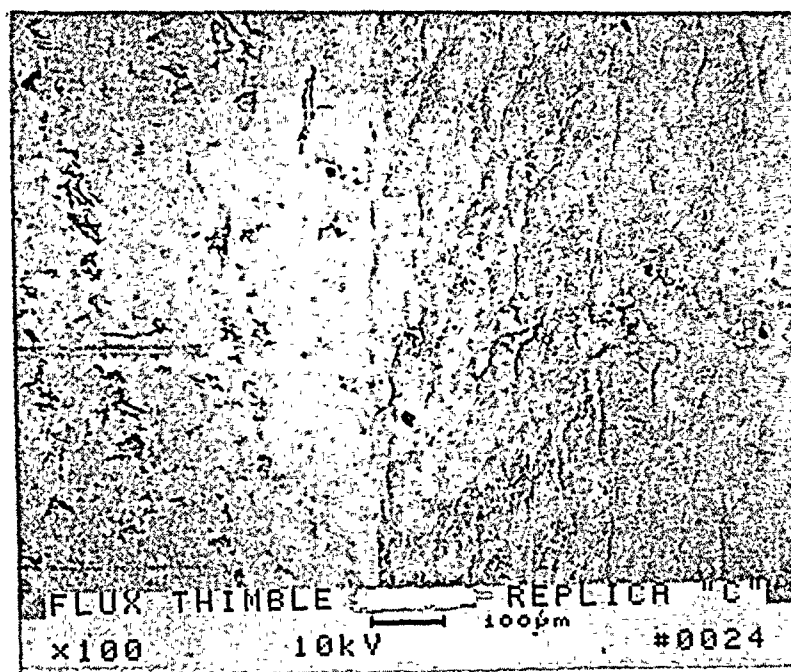
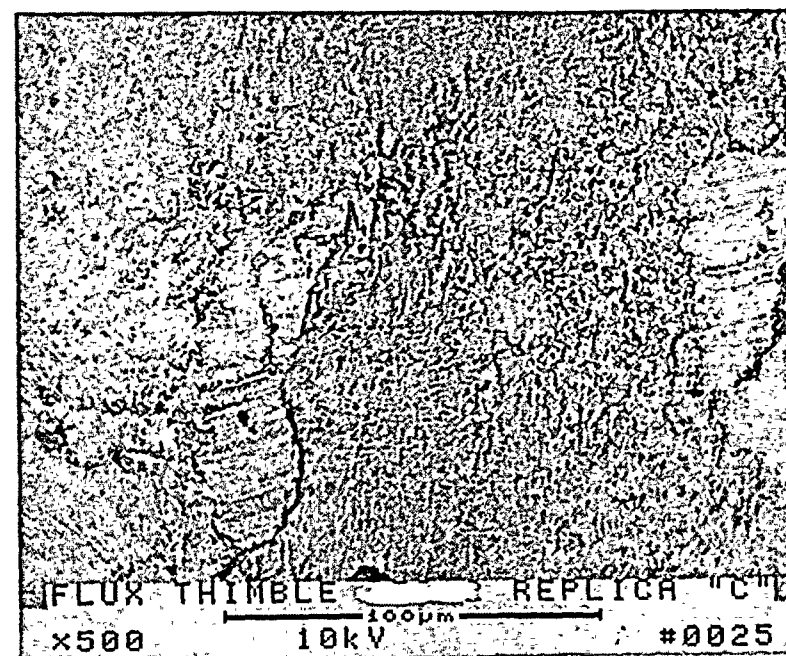
Figure 2.17 SEM Photomicrographs Illustrating the Wear Morphology Seen at Locations 24 and 25 (Figure 2.6) of the Replica from Sample A-9.

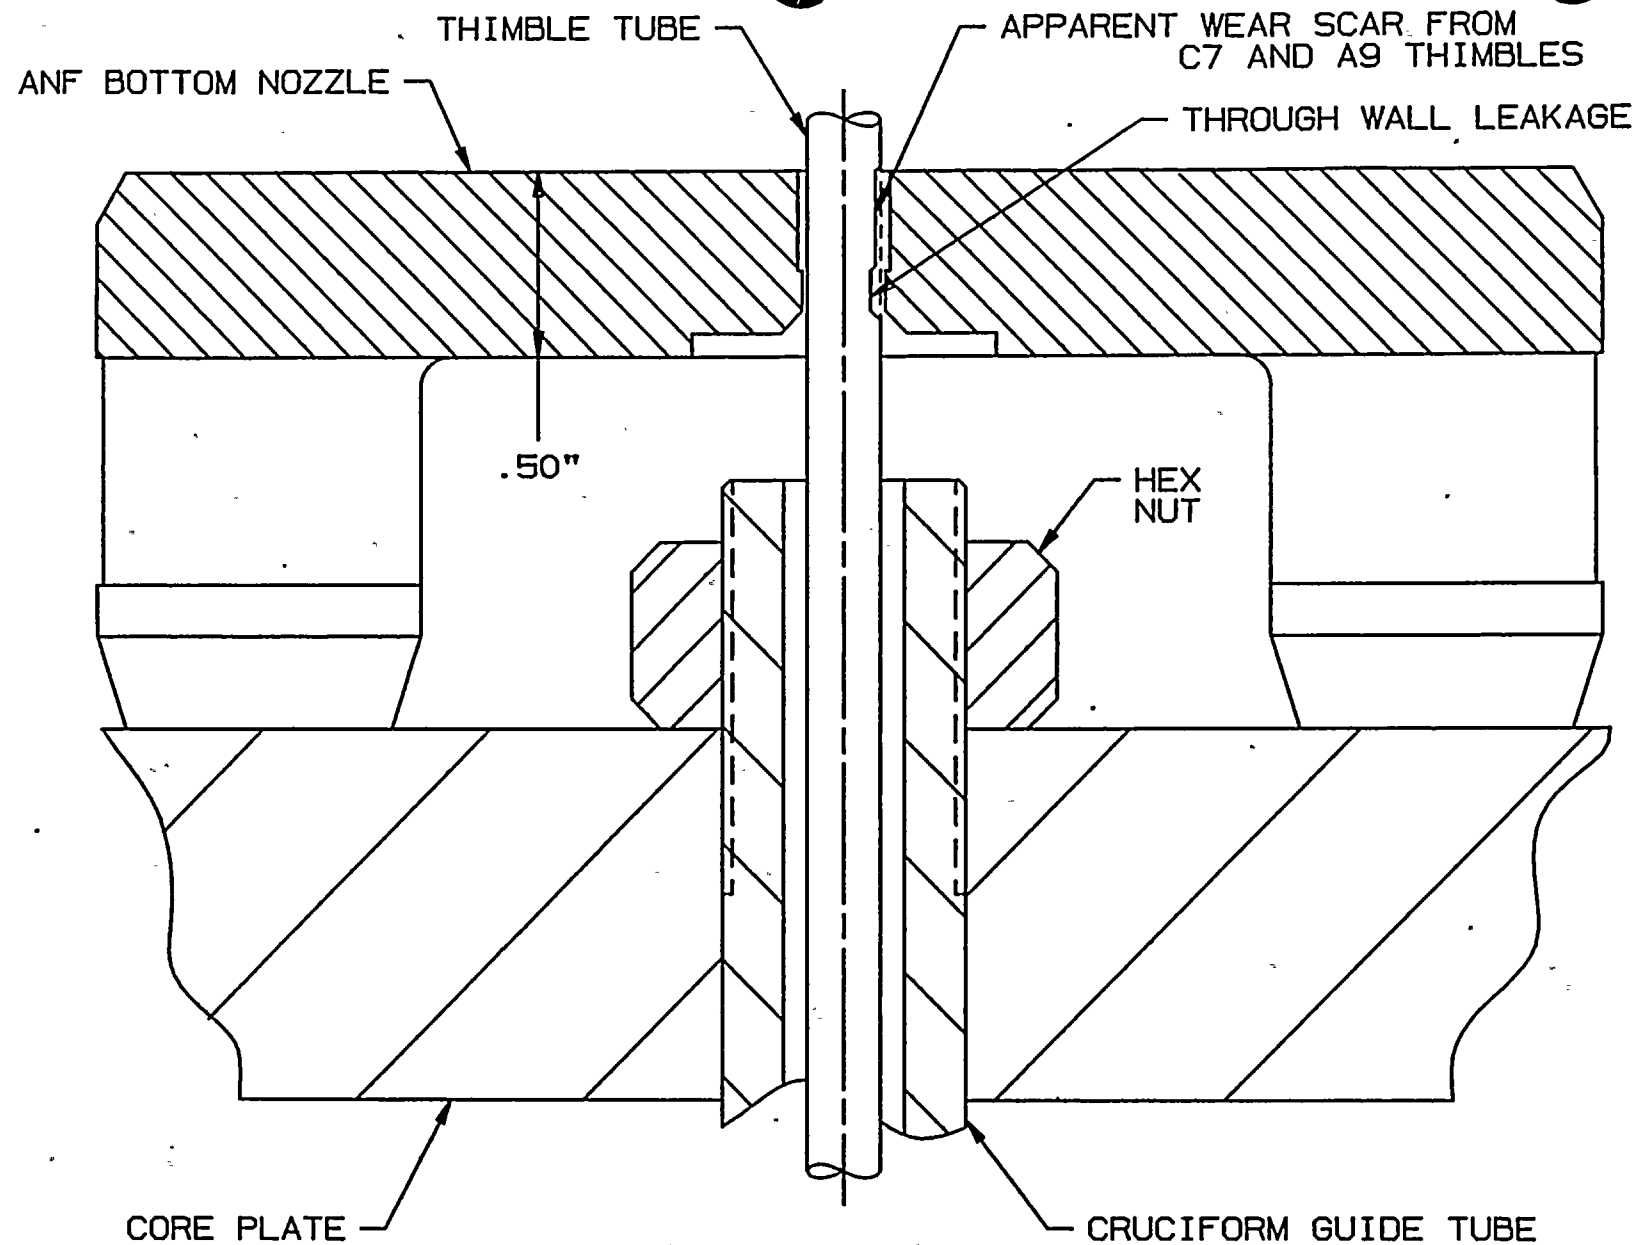
A schematic representation of the geometry of the fuel bundle bottom nozzle is illustrated in Figure 2.18. Close examinations of the nozzle inside diameter surface geometry at the thimble penetration clearly reveals a close and consistent relationship with the two stepped geometry of the thimble tube wear scar. The nozzle penetration width (0.5 in) is also in close agreement with the axial length of the wear scar. This clearly establishes that the thimble tube wear occurred by the movement of the thimble at the nozzle penetration. The primary water flow velocities and flow conditions in this region are known to induce thimble tube vibrations. It is believed that these vibrations may have caused adequate motion and contact loads resulting in the observed thimble tube wear.

Figure 2.18 Schematic Representation of the Geometry at the Thimble Tube to Fuel Bundle Bottom Nozzle Intersection Illustrating the Wear Location.
