SUBJECT: LER 89-071-04:on 891019,discovered discrepancy between
 turbine-driven auxiliary feed pump test line flow & process
 flow indication.Caused by conducting inaccurate flow
 measurements.Flow sensing switches reset.W/910730 ltr.

LICENSEE EVENT REPORT (LER)

FACILITY NAME (1) D. C. Cook Plant - Unit 2										DOCKET NUMBER (2) 0 5 0 0 0 3 1 6				PAGE (3) 1 OF 0 7									
TITLE (4) Loss of Turbine Driven Auxiliary Feed Pump Flow Retention Due to Inaccurate Flow Measurement																							
EVENT DATE (5)			LER NUMBER (6)				REPORT DATE (7)			OTHER FACILITIES INVOLVED (8)													
MONTH	DAY	YEAR	YEAR	SEQUENTIAL NUMBER	REVISION NUMBER	MONTH	DAY	YEAR	FACILITY NAMES				DOCKET NUMBER(S)										
1	0	1	9	8	9	0	1	7	0	4	0	7	3	0	9	1	0	5	0	0	0		
OPERATING MODE (8) 1			THIS REPORT IS SUBMITTED PURSUANT TO THE REQUIREMENTS OF 10 CFR §: (Check one or more of the following) (11)																				
POWER LEVEL (10) 1 0 0			20.402(b)				20.405(c)				50.73(a)(2)(iv)				73.71(b)

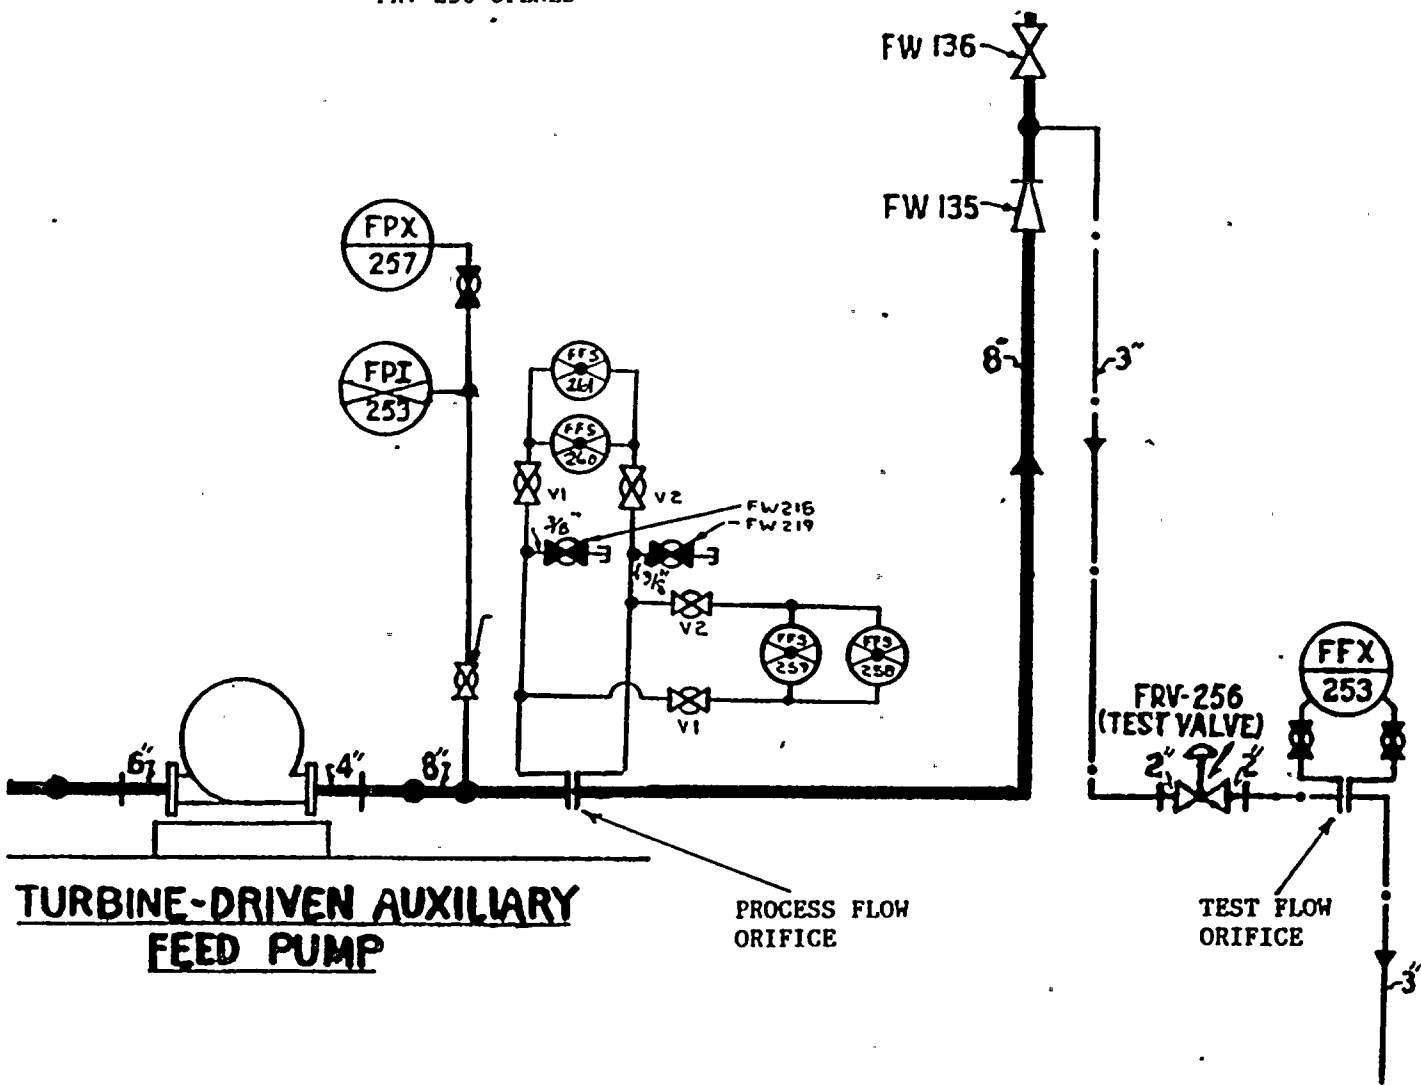
TURBINE DRIVEN AUXILIARY FEED PUMP RECIRCULATION LINEUP

On October 19, 1989 at 0900 hours, an NRC Inspector conducting an IST Audit discovered an instrument discrepancy between the Turbine Driven Auxiliary Feedpump (TDAFP) (EIIS/BA-P) test line flow indication (FFX-253) and the in-series process flow indicating flow switches (FFS-258 and FFS-260) (EIIS/BA-FS). Attached is a drawing describing the configuration of these instruments. Instrumentation at the process flow switches indicated a flow of 550 gpm while test instrumentation indicated a flow of 700 gpm. The process flow switch actuates a flow retention signal when the TDAFP flow reaches 975 gpm. This flow retention function prevents pump runout during feedwater line break. With the process instrumentation reading 78 percent of actual flow, the flow retention function would have actuated at a TDAFP approximate flow of approximately 1225 gpm. Therefore, flow retention would not have actuated before pump runout occurred.

A fluid dynamic situation is believed to exist in the TDAFP discharge line, causing oscillations/turbulence across the orifice and resulting in erroneous differential pressure/flow indication. The root cause for the turbulence appears to be pump induced flow oscillations.

This testing had no effect on the readings obtained from the process flow instrumentation. The test line orifice (2-FFX-253) consistently read 24% higher than the process orifice (2-FFX-259).

On October 25, 1989, the Unit 2 TDAFP process flow indicating switches, which provide flow retention actuation, were reset for proper actuation. The verified test orifice was used as a standard for determining the process orifice curve.

The system discrepancy will be resolved by a Design Change which is scheduled to be installed during the 1994 Unit 2 Refueling Outage.
