REGULATORY INFORMATION DISTRIBUTION SYSTEM (RIDS)

SUBJECT: LER 91-005-00:on 910718,design documents not discovered to
 demonstrate capability of DG ventilation & exhaust
 structures to w/stand effects of tornado.Cause unknown.
 Mods completed on outside structure.W/910816 ltr.

FACILITY NAME (1) D. C. Cook Nuclear Plant, Unit 1										DOCKET NUMBER (2) 0 5 0 0 0 3 1 1 5										PAGE (3) 1 OF 17																	
TITLE (4) Design Documents could not be located that would demonstrate the capability of the Diesel Generators Ventilation and Exhaust structures to withstand the effects of a tornado.																																					
EVENT DATE (5)			LER NUMBER (6)				REPORT DATE (7)			OTHER FACILITIES INVOLVED (8)																											
MONTH	DAY	YEAR	YEAR	SEQUENTIAL NUMBER	REVISION NUMBER	MONTH	DAY	YEAR	FACILITY NAMES						DOCKET NUMBER(S)																						
0	7	1	8	9	1	9	1	0	0	5	0	0	0	8	1	6	9	1	Cook Plant - Unit 2						0 5 0 0 0 3 1 1 6												
OPERATING MODE (9)			THIS REPORT IS SUBMITTED PURSUANT TO THE REQUIREMENTS OF 10 CFR §: (Check one or more of the following) (11)																																		
1			20.402(b)				20.406(a)				80.73(a)(2)(iv)				73.71(b)

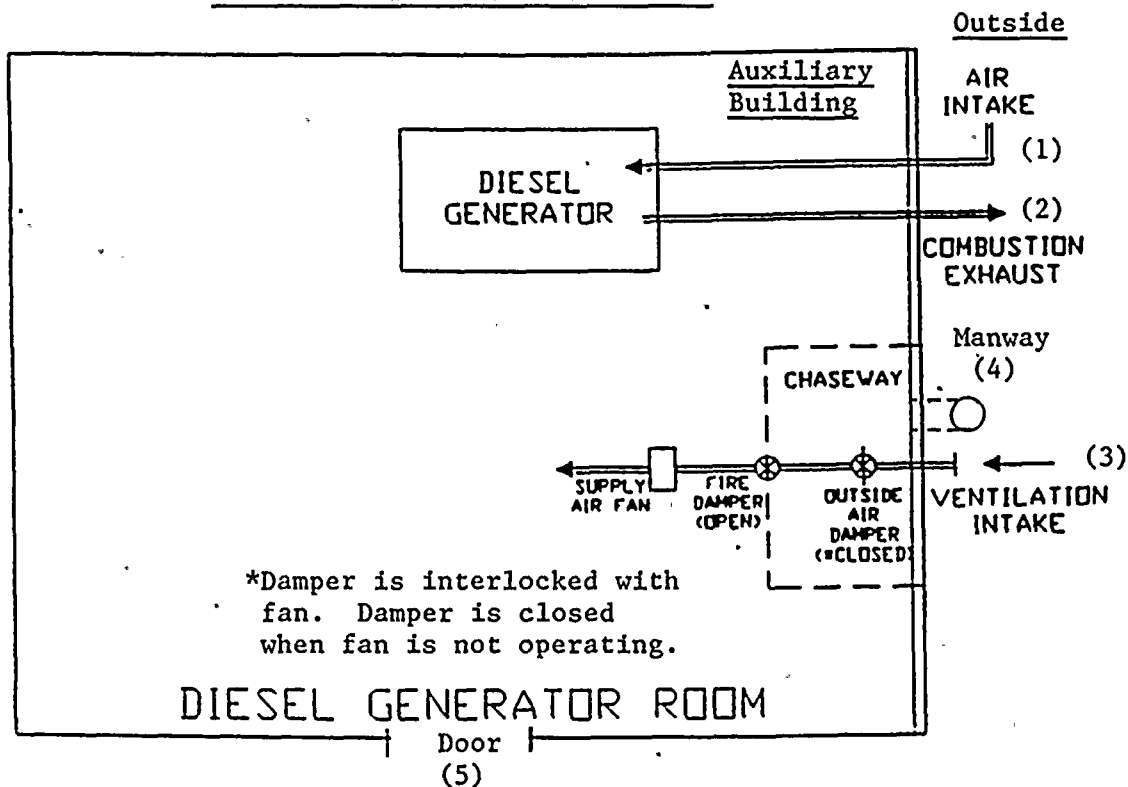
SIMPLIFIED DRAWING OF DUCT WORK

Specifically, during a tornado, the intake duct work supplying the EDG Room ventilation may be subjected to a sudden decrease in internal pressure. If the ventilation system is not running at the time the tornado passes, a damper in the line would be normally closed, effectively isolating the internal area of the upstream ducting from the EDG Room. Because this ducting passes through the EDG Room and the room might not be adequately vented, a differential pressure could be imposed across the ducting upstream of the damper (See attached figure).

For a permanent solution to the pressure differential issue, a damper will be installed in each EDG Room ventilation supply duct. This damper will isolate the duct work, internal to the Auxiliary Building, from the external effects of a tornado. These dampers are scheduled to be delivered to the site about October 25, 1991. Design and installation details are currently being developed. Installation is expected to be complete by December 31, 1991. The administrative controls currently in place to provide an equalization path for the supply ventilation duct work will remain in effect until their damper installation is completed.

- (1) Structural supports added to Air Intake.
- (2) Structural supports added to Exhaust Stack and Silencer.
- (3) Replaced sheet metal duct work with duct work fabricated from plate steel (provisions made for future installation of tornado damper).
- (4) & (5) Opened doors and manways, under Administrative Control, to provide equalization path.
