# ACCELERATED DISTRIBUTION DEMONSTRATION SYSTEM

SUBJECT: LER 91-006-00: on 901129, during design change process  
 resulting in being outside design basis for separation of  
 safety related & non-safety related circuits. Due to error of  
 personnel. Design procedures revised. W/910823 ltr.

FACILITY NAME (1) D. C. COOK NUCLEAR PLANT - UNIT 1										DOCKET NUMBER (2) 0   5   0   0   0   3   1   5   1   OF   0   8															
TITLE (4) PERSONNEL ERROR DURING THE DESIGN CHANGE PROCESS RESULTED IN BEING OUTSIDE THE DESIGN BASIS FOR SEPARATION OF SAFETY RELATED AND NON-SAFETY RELATED CIRCUITS																									
EVENT DATE (5)			LER NUMBER (6)					REPORT DATE (7)			OTHER FACILITIES INVOLVED (8)														
MONTH	DAY	YEAR	YEAR	SEQUENTIAL NUMBER	REVISION NUMBER	MONTH	DAY	YEAR	FACILITY NAMES					DOCKET NUMBER(S)											
1	1	2	9	9	0	9	1	0	0	6	0	0	0	8	2	3	9	1	0	5	0	0	0		
OPERATING MODE (9)		THIS REPORT IS SUBMITTED PURSUANT TO THE REQUIREMENTS OF 10 CFR §: (Check one or more of the following) (11)																							
6		20.402(b)					20.406(a)					50.73(a)(2)(iv)					73.71(b)								
POWER LEVEL (10)		0   0   0					20.406(a)(1)(i)					50.73(a)(2)(v)					73.71(c)

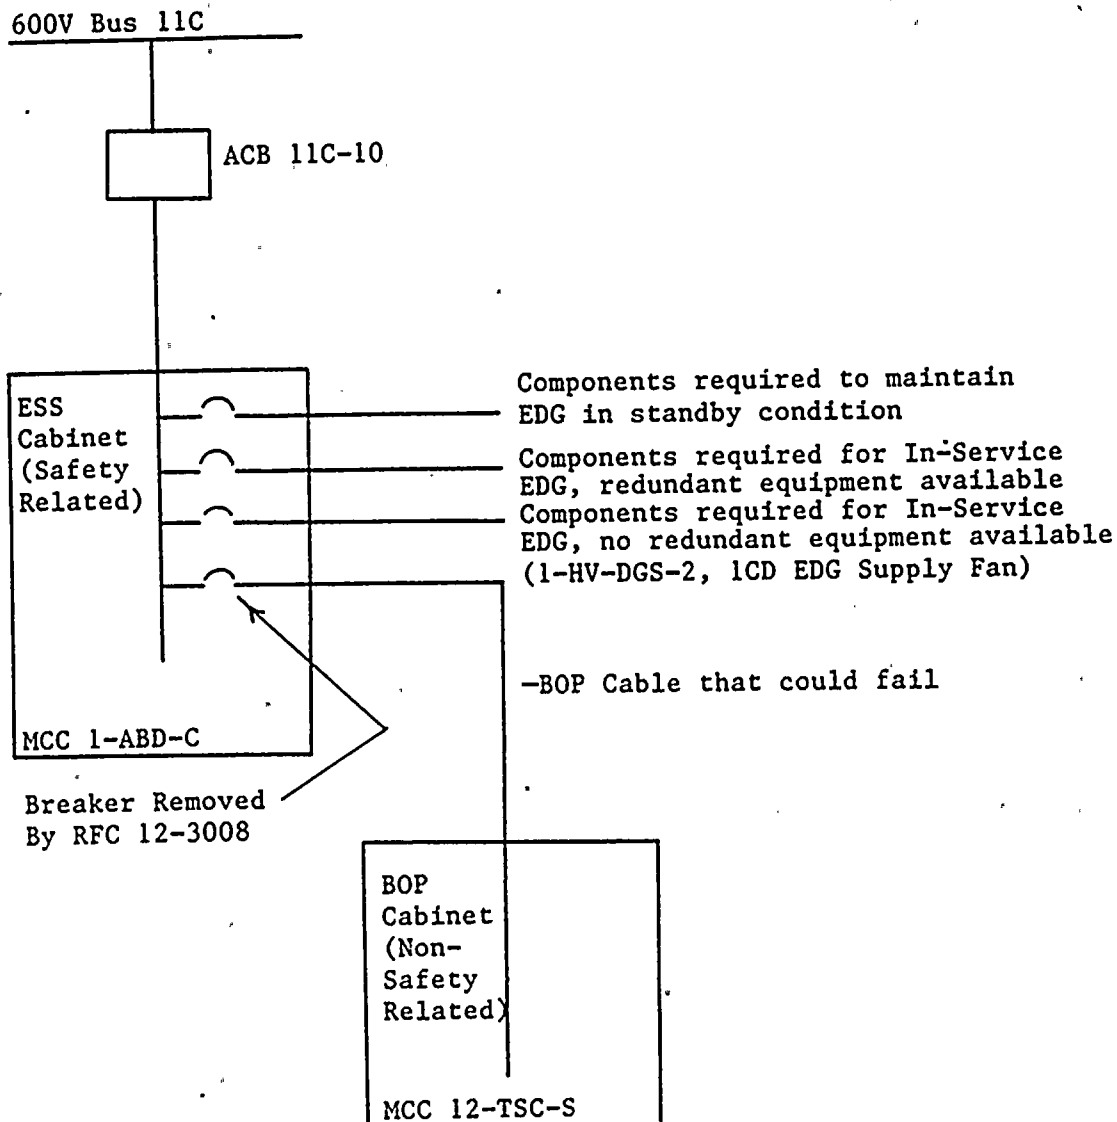
FIGURE NO. 1

On November 29, 1990, Design Change RFC 12-3008 removed a circuit breaker (EIIS:EC-BKR) from an Engineered Safety System (ESS) Motor Control Center (MCC 1-ABD-C) (EIIS:EK-MCC). The ESS MCC supplies power to certain safety-related diesel generator auxiliary systems (EIIS:EC-FAN), as well as, balance of plant (BOP) MCC 12-TSC-S. The circuit breaker which was removed by the design change provided isolation between the ESS and BOP circuits (See Figure 1). When it was removed, the BOP circuit was connected directly to the ESS source. If a fault had occurred on the BOP feeder cable subsequent to the removal of this breaker, the breaker feeding the ESS MCC (600V Air Circuit Breaker 11C10) would have tripped, causing a loss of power to the diesel auxiliaries. If a fault had occurred simultaneously with a condition requiring the diesel generator to operate, the loss of power to the diesel auxiliaries may have prevented the diesel generator from operating for an extended period of time.

ESS MCC 1-ABD-C supplies power to BOP MCC 12-TSC-S and certain auxiliary system components associated with DG1CD. With the breaker removed from the feed to the BOP circuit, a fault occurring on the cable connecting the MCC 1-ABD-C to MCC 12-TSC-S would have prevented the MCC 1-ABD-C feeder breaker from being reclosed until the fault was removed from the circuit. A portion of the auxiliary system components associated with DG1CD would have been left without a source of power.

DISTRIBUTION SKETCH

Design Change 01-MM-228 reinstalled the removed breaker on July 24, 1991.
