REGULATORY INFORMATION DISTRIBUTION SYSTEM (RIDS)

SUBJECT: LER 91-009-00: on 911112, ice condenser flow passage insp did not include entire flow area assumed in analyses presented in updated FSAR. Caused by inadequate definition of TS insp requirements. Test procedures revised. W/911212 ltr.

FACILITY NAME (1) D. C. COOK PLANT - UNIT 2										DOCKET NUMBER (2) 0 5 0 0 0 3 1 6										PAGE (3) 1 OF 08	
TITLE (4) INOPERABLE ICE CONDENSER DUE TO INCORRECT FLOW PASSAGE INSPECTIONS																					
EVENT DATE (5)			LER NUMBER (6)				REPORT DATE (7)			OTHER FACILITIES INVOLVED (8)											
MONTH	DAY	YEAR	YEAR	SEQUENTIAL NUMBER	REVISION NUMBER	MONTH	DAY	YEAR	FACILITY NAMES			DOCKET NUMBER(S)									
1	1	2	9	1	0	0	1	2	1	COOK PLANT-UNIT 1			0 5 0 0 0 3 1 5								
1	1	2	9	1	0	0	1	2	1				0 5 0 0 0								
OPERATING MODE (9)		THIS REPORT IS SUBMITTED PURSUANT TO THE REQUIREMENTS OF 10 CFR §: (Check one or more of the following) (11)																			
1		20.402(b)				20.405(c)				50.73(a)(2)(iv)				73.71(b)							
POWER LEVEL (10)		20.405(a)(1)(i)				50.38(c)(1)				50.73(a)(2)(v)				73.71(c)							
1 0 0		20.405(a)(1)(ii)				50.38(c)(2)				50.73(a)(2)(vii)				OTHER (Specify in Abst

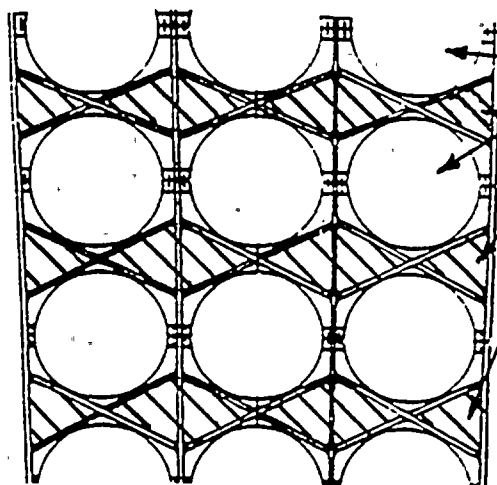
The procedure used to perform the surveillance inspections, **12 EHP 4030 STP.250, defined a flow passage as that area enclosed by the diamond-shaped portion of ice basket lattice support structure (see attached figure). On October 10, 1991, the preliminary results of an Engineering Evaluation were announced, which indicated that this definition was incorrect,

Previous Flow Passage
Description-Consisted of
triangular areas between
baskets.

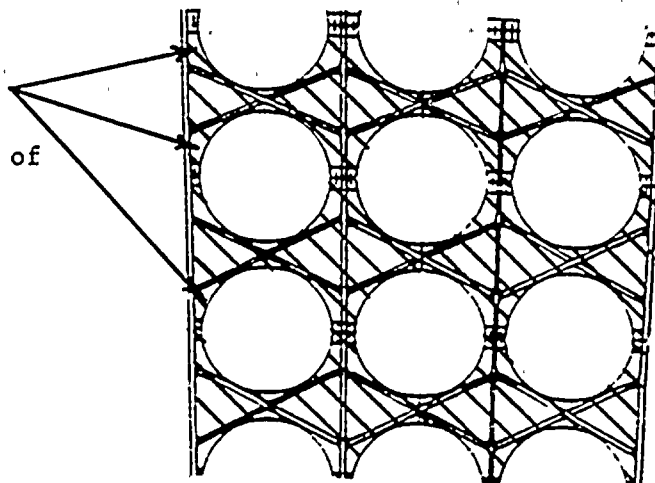
New Flow Passage Description

and that the correct flow passage definition included not only the diamond-shaped area between baskets, but also the area surrounding the basket perimeter.

This event was caused by the inadequate definition of Technical Specification inspection requirements. The flow passages which are subject to inspection under Technical Specification 4.6.5.1.b.3 are not described in the UFSAR or in supporting documentation provided by the NSSS supplier. The review which finally lead to establishing the correct definition consisted of calculating the total flow area available through the Ice Condenser (i.e., total cross-section minus basket and support frame cross-section) and comparing it to the flow area assumed in the Short Term Containment Integrity Analysis. The agreement of the calculation result with the value used in the analysis made it clear that the correct definition of flow passage included not only the diamond-shaped area between baskets but the area adjacent to each Ice Basket as well.

New Flow Passage
Description-Includes
area along perimeter of
basket.

The Flow Passage Inspection, Surveillance Test Procedure (12 EHP 4030 STP.250) was revised and Flow Passage Inspections were performed on Unit 2 on November 12, 1991 and on Unit 1 on November 13, 1991. The surveillance findings supported the October 10 and 11, 1991 reviews.
