REGULATOR INFORMATION DISTRIBUTION SYSTEM (RIDS)

SUBJECT: LER 91-007-01: on 910802, identified flowpath that diverted
 ECCS flow caused by plant design/emergency response
 guidelines. Reviewed plant specific EOPs to ensure that
 procedures are provided to plant operators. W/921124 ltr.

FACILITY NAME (1) D. C. Cook Nuclear Plant - Unit 2										DOCKET NUMBER (2) 0 5 0 0 0 3 1 6 1 0 0 6										PAGE (3) 1 OF 0 6																		
TITLE (4) Simulator Scenario Identified Flowpath that Diverted ECCS Flow Caused by Plant Design/Emergency Response Guidelines																																						
EVENT DATE (5) MONTH: 0 8 DAY: 0 2 YEAR: 9 1 9 1									LER NUMBER (6) YEAR: 1 9 SEQUENTIAL NUMBER: 0 0 7 REVISION NUMBER: 0 1									REPORT DATE (7) MONTH: 1 1 DAY: 2 4 YEAR: 9 2									OTHER FACILITIES INVOLVED (8) FACILITY NAMES: D. C. Cook - Unit 1 DOCKET NUMBER(S): 0 5 0 0 0 3 1 5											
OPERATING MODE (9) 3									THIS REPORT IS SUBMITTED PURSUANT TO THE REQUIREMENTS OF 10 CFR §: (Check one or more of the following) (11)																													
POWER LEVEL (10) 0 0 0									20.402(b)									20.406(c)									50.73(a)(2)(iv)									73.71(b)

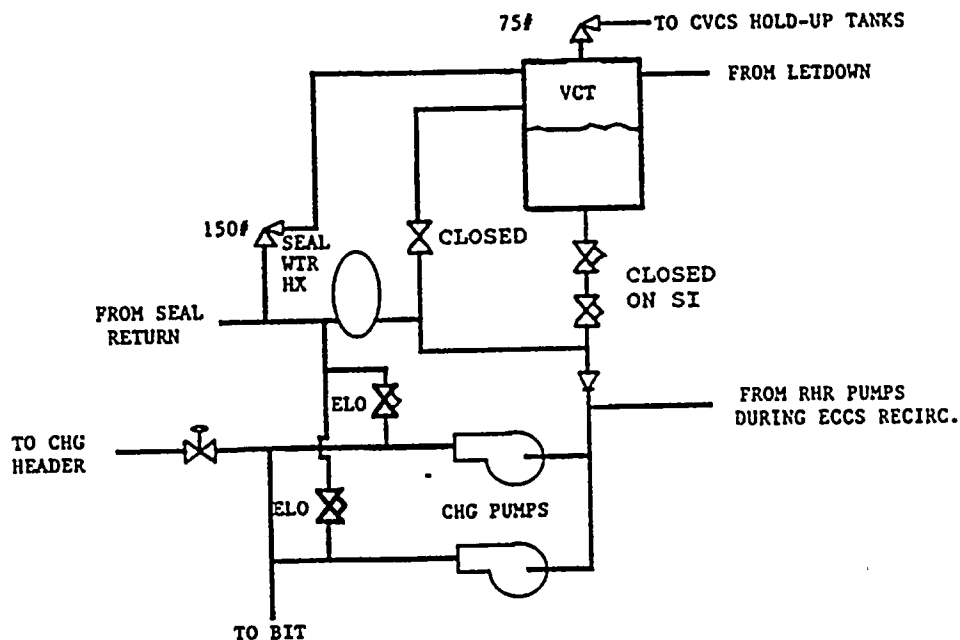
FIGURE 1

Description of systems (reference Figure 1):

Upon receipt of a safety injection signal (EIIS/JE-ACO), the safety injection system (SIS) centrifugal charging pump (CCP) (EIIS/BQ-P) suction transfers from the volume control tank (VCT) (EIIS/CB-TK) to the refueling water storage tank (RWST) (EIIS/BP-TK). The CCP emergency leakoffs (ELO) isolation valves (EIIS/BQ-LOV) close and then reopen if the Reactor Coolant System (RCS) pressure increases to greater than 2000 psi. If the accident has progressed to the point of switchover from the RWST to the containment recirculation sump (EIIS/NH-RVR), the CCP suction is realigned to the discharge of the residual heat removal (RHR) pumps (EIIS/BP-P). With the RHR pump supplying the suction to the CCP, the CCP suction pressure could be as high as 205 psig (RHR pump shutoff head pressure). Since the suction to the CCP is supplied by the discharge of the RHR pump and the CCP ELO (if opened) is returned to the suction of the pump, the pressure in the ELO line could be in excess of the 150 psig pressure setpoint for safety valve SV-54 (EIIS/CB-RV) located upstream of the seal water heat exchanger (EIIS/CB-HX). If SV-54 lifts and one CCP is in operation, then approximately 60 gpm flow would be diverted from the Emergency Core Cooling System (ECCS) into the VCT. If not terminated, the VCT would fill and then lift the VCT safety valve SV-53 (EIIS/CB-RV). SV-53 is set at 75 psig and will divert flow to the chemical and volume control system (CVCS) holdup tanks (EIIS/WD-TK).

The potential divert flowpath identified by the simulator scenario was caused by steps in the Emergency Operating Procedure (EOP). The EOP instructs the operators to open the CCP ELO isolation valves in preparation for switchover of the CCP discharge from the ECCS lineup through the boron injection tank (BIT) (EIIC/BQ-TK) to the normal charging discharge lineup.

1. The affected Emergency Operating Procedure was revised to caution the operator to establish minimum charging flow to protect the operating CCP if cold leg recirculation has been initiated, and to verify proper operation of the CCP emergency leakoff valves, during SI conditions.
2. The Westinghouse letter provided several potential means for resolving the issue. One specific option was to review plant specific EOPs to ensure that procedures are provided to plant operators to depressurize and cooldown during a postulated small break LOCA, and to modify the EOPs to ensure that the charging pump miniflow lines are isolated during recirculation.

Following conversations with Westinghouse that preceded receipt of the letter described above, we made modifications to our EOPs that meet the intent of the Westinghouse recommendation. The EOP, ES-1.3 (Transfer to Cold Leg Recirculation) has been modified such that it instructs the operator to open a pressurizer PORV, as necessary, to reduce RCS pressure and to maintain minimum charging pump flow. The procedure instructs the operator to close the charging pump miniflow valves as part of the switchover from injection to recirculation. (Precautions are included, however, that instruct the operator to shut off a redundant charging pump or to open the miniflow valves if conditions that ensure adequate pump protection are not met.)
