SUBJECT: LER 93-003-00: on 921016, discovered that charcoal filter face dampers were closed instead of open as indicated. Caused by incorrect solenoid installation. Procedures revised & dampers verified to be installed correctly. W/930408 ltr.

LICENSEE EVENT REPORT (LER)

FACILITY NAME (1) D. C. COOK PLANT - UNIT 2										DOCKET NUMBER (2) 0 5 0 0 0 3 1 6 1 OF 0 5				PAGE (3) 1 OF 05								
TITLE (4) ESF Ventilation System Filter Train Damper Control Malfunction Due to Incorrect Solenoid Installation																						
EVENT DATE (5)			LER NUMBER (6)				REPORT DATE (7)			OTHER FACILITIES INVOLVED (8)												
MONTH	DAY	YEAR	YEAR	SEQUENTIAL NUMBER	REVISION NUMBER	MONTH	DAY	YEAR	FACILITY NAMES				DOCKET NUMBER(S)									
1	0	1	6	9	2	9	3	0	0	3	0	0	0	4	0	8	9	3	0 5 0 0 0			
OPERATING MODE (9) 5			THIS REPORT IS SUBMITTED PURSUANT TO THE REQUIREMENTS OF 10 CFR §: (Check one or more of the following) (11)																			
POWER LEVEL (10) 0 0 0			20.402(b)				20.405(c)				50.73(a)(2)(iv)				73.71(b)

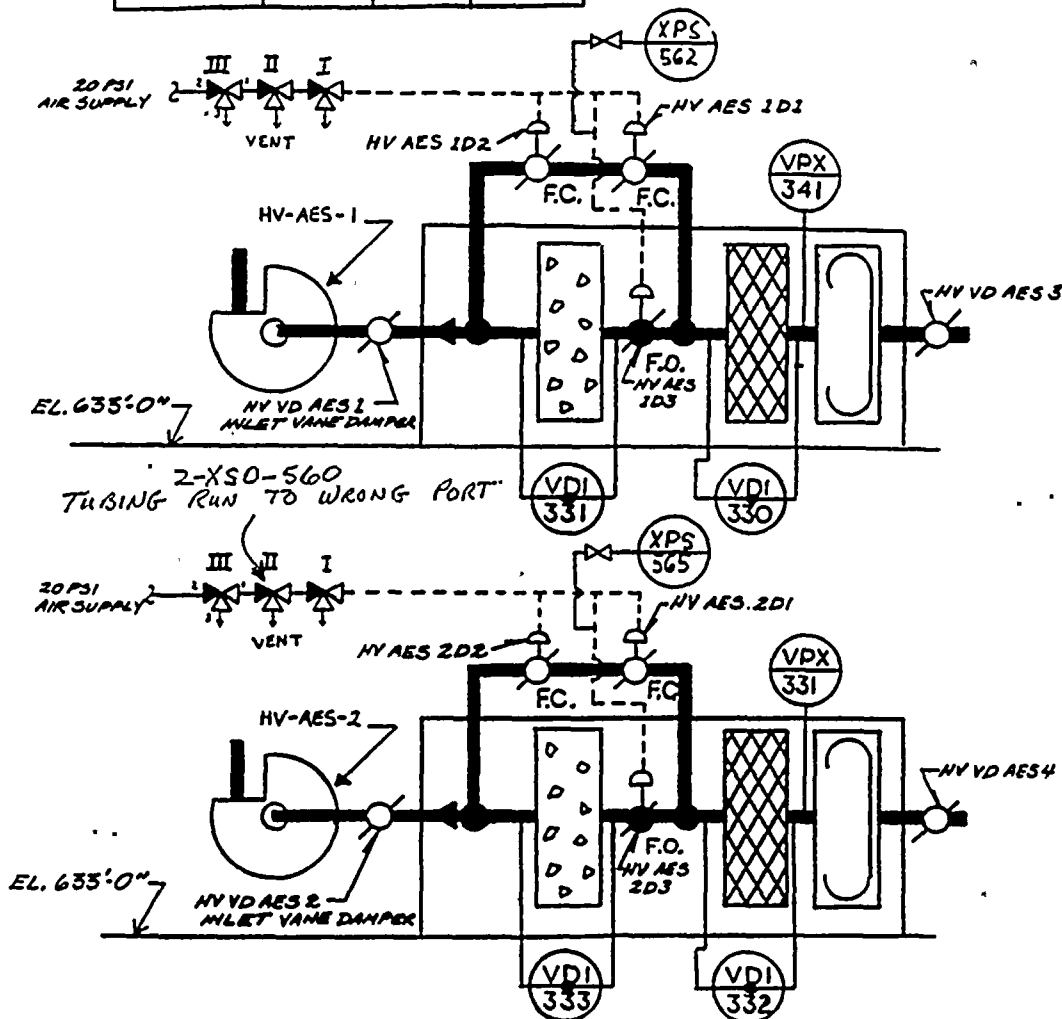
An investigation revealed that the incorrect position of the 2-HV-AES-2 face and bypass dampers was caused by an incorrect piping configuration (air supply piped to wrong solenoid part) of the instrument air supply to solenoid valve (2-XSO-560) (EIIS/LF-SOL) which provides the control air for the damper operation (see attached drawing). Upon actuation of a Containment Isolation Phase B (CI-B) signal, both ESF Ventilation Trains start with flow going through the associated charcoal filters. Solenoid Valve 2-XSO-560 actuates from a Train-A CI-B signal, or from the Train A fan being out of service and provides a cross-train feature to reposition the Train-B ESF Ventilation Filter Dampers. Solenoid 2-XSO-560 ensures cross-train backup for Solenoid Valve 2-XSO-564, which actuates on a Train-B, CI-B signal. If solenoid 2-XSO-564 would have failed during an accident, the supply air piping error would have prevented solenoid 2-XSO-560 from performing its backup design function for the Train-B ESF Ventilation Filter dampers and prevented use of the manually actuated Solenoid Valve 2-XSO-565 to correctly position the dampers.

This drawing shows the correct solenoid installation.

UNIT	XSO-I	XSO-II	XSO-III
HV-AES-1	561	563	562
HV-AES-2	564	560	565

XSO-562, 565 ARE IN THE CONTROL CIRCUIT

XSO-560, 561 ARE POWERED FROM TRAIN A

XSO-563, 564 ARE POWERED FROM TRAIN B

SOLENOIDS I & II TO DE-ENERGIZE ON CONTAINMENT ISOLATION PHASE "B" SIGNAL
CAUSING AIR TO FLOW THROUGH FILTER

The tubing configuration was corrected and 2-HV-AES-2 was returned to service on November 7, 1992. Proper operation of the circuit was verified by opening the breaker for Fan 2-HV-AES-1 and ensuring that the AES-2 Face and Bypass Dampers cycled to the correct position, directing flow through the charcoal filter in 2-HV-AES-2. The solenoid piping and associated drawings, for the remaining AES System solenoids for both Units 1 and 2, were verified to be correct.

To ensure that the system continues to operate as designed, procedure change requests have been issued for surveillance procedures which test these systems. Revisions to the ESF time response Train-A and Train-B Procedures will include verification that each AES fan's dampers will move to the charcoal filtration mode when the opposite Train receives a Safety Injection signal. These procedure revisions are scheduled to be completed by December 15, 1993 (prior to the next scheduled test). The drawing has been revised to show the correct piping configuration.
