SUBJECT: SALEM NUCLEAR GENERATING STATION, UNIT NO. 1 – SUMMARY OF
OCTOBER 27, 2017, CONFERENCE CALL WITH PSEG NUCLEAR LLC
RE: FALL 2017 STEAM GENERATOR INSPECTIONS (CAC NO. MG0215;
EPID L-2017-LRO-0028)

SALEM NUCLEAR GENERATING STATION, UNIT NO.1

FALL 2017 STEAM GENERATOR TUBE INSPECTIONS

SALEM NUCLEAR GENERATING STATION, UNIT NO. 1
STEAM GENERATOR TUBE INSPECTION DISCUSSION POINTS
(DRAFT INFORMATION)

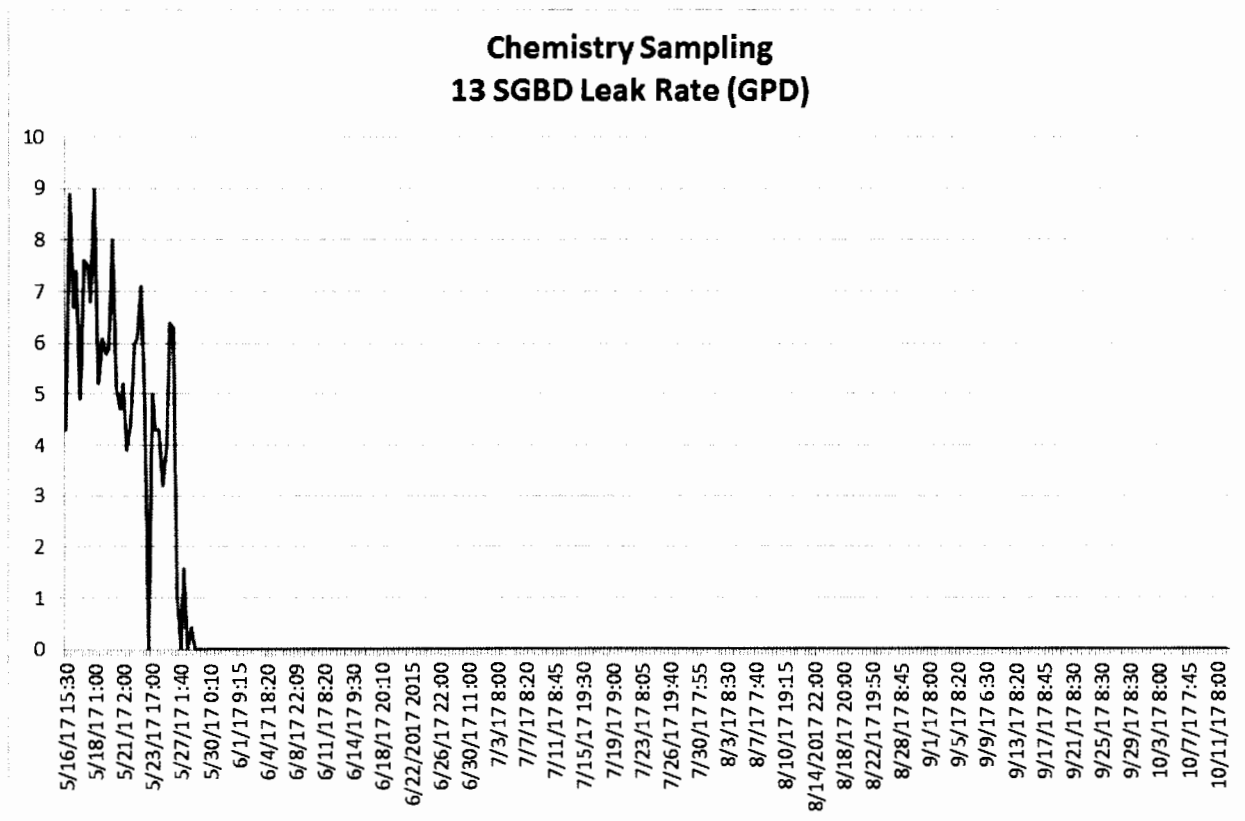
On Monday May 15, 2017 at approximately 1800, operators in the Salem-1 Control Room identified a rise in the primary-to-secondary leakage from radiation monitor indications. The small leak was identified in SG 13, and went below detection around May 28, 2017. Below is the chemistry grab sample results for the duration of the leak event, including up to the start of outage 1R25 (October 12, 2017). Subsequent to May 28, 2017, the leak remained below detection. Online radiation monitors provided similar trend.
