SUBJECT: LER 94-015-01: on 941230, high vibration noted on outboard motor bearing, along w/ smell of smoke. Caused by worn outboard motor sleeve bearing. Motor returned to mfg for insp & repair. W/950531 ltr.

LICENSEE EVENT REPORT (LER)

DONALD C. COOK NUCLEAR PLANT

CANCELLATION OF LER 94-015-00

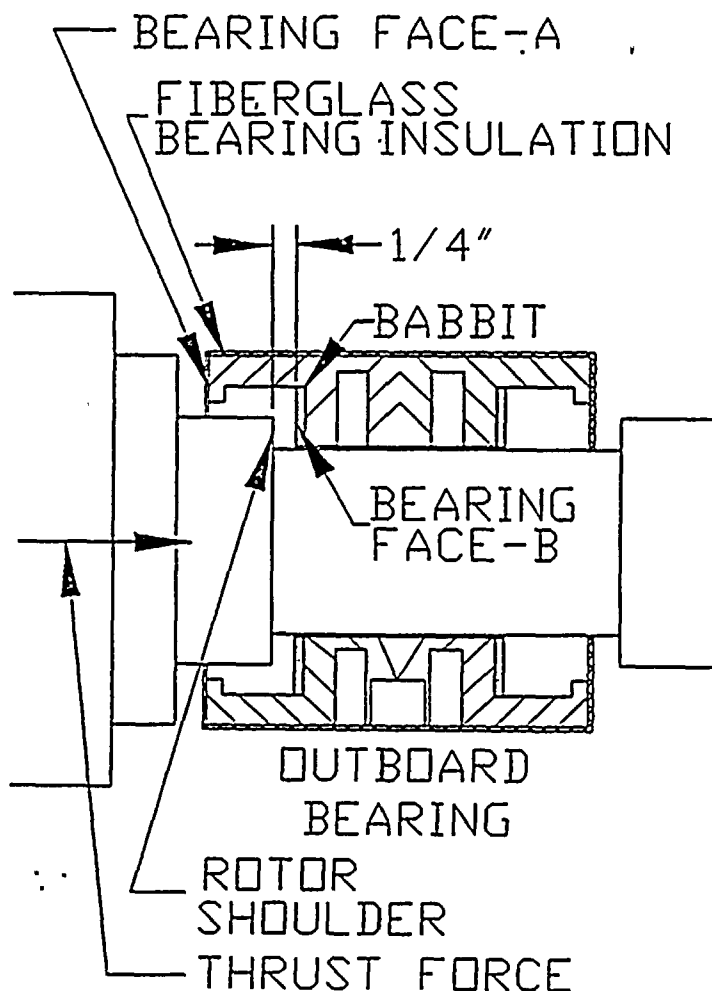
SKETCH OF 1E MDAFP
OUTBOARD BEARING

The motor is manufactured by Reliance, rated 3600 RPM, 500 HP, 4160 Volt. The motor is designed with sleeve bearings, which are simply babbit-lined steel cylinders. The babbit is a soft lead based alloy. The bearings are designed so that oil will be brought up from a sump beneath the bearing, letting it then flow down onto the journal to spread out between the journal and shaft surfaces. During operations the shaft does not ride on the bearing but on a thin film of oil between it and the bearing. The bearings are designed to support the shaft radially, which is perpendicular to the shaft axis. Sleeve bearings are not designed to have a continuous thrust load capacity in the axial direction, a direction parallel to the motor shaft. This motor does have some ability to take very limited thrust, which is sometimes experienced during start-up and shutdown. An attachment shows the fit between the motor shaft and the bearing. As can be seen, there is a very small thrust face and limited babbit to support this thrust.

As can be seen by the attached sketch, there is also a second bearing face that has fiberglass insulation. This face is not designed to carry any thrust load. The fiberglass insulation is used on the bearing so that this end of the motor shaft will not be grounded. The fiberglass insulation is exposed to very low voltage levels which prevents circulating current in the shaft. Loss of the insulation is not critical in the short term and its only significance is in preventing long term damage by circulating current.

Inspection of the bearing indicated that the external thrust load caused the motor shaft to rub up against the babbitt in the bearing face B. It continued to wear away the babbitt reducing it as the motor shaft moved axially. After a period of time, the motor shaft also began to wear against the fiberglass on bearing face A. It was the heating of the fiberglass insulation that produced the smoke described in the December 1994 failure.

A key question is whether the motor shaft was continuing to press against the bearing face or had it worn away enough bearing material so that a gap was now open. Presence of this gap would mean that the fault would not be a cascading failure, but would have stabilized. If the motor shaft was continuing to press against either bearing faces, then that bearing face would be smooth and shiny due to the rubbing, polishing effect of the motor shaft. Inspection of both bearing faces indicated that there was a clearance that had developed between the bearing and motor shaft surfaces. Bearing inspection of the face with fiberglass showed that it was not smooth but that carbon marks had deposited on its face due to localized heating of the fiberglass and oil. These carbon marks were not being worn away by further contact from the motor shaft. Inspection of the babbitt also found very little shiny babbitt. The babbitt had originally worn away on face A but further signs of wear were not present.
